**Subject: Final Submittal, Willamette Falls Locks Engineering Study
Large Scale Capital Costs**

Name of Project: Willamette Falls Locks Engineering Study
INCA Job No.: 07-013

Willamette Falls Lock Engineering Study
Large Scale Capital Costs
Final Submittal

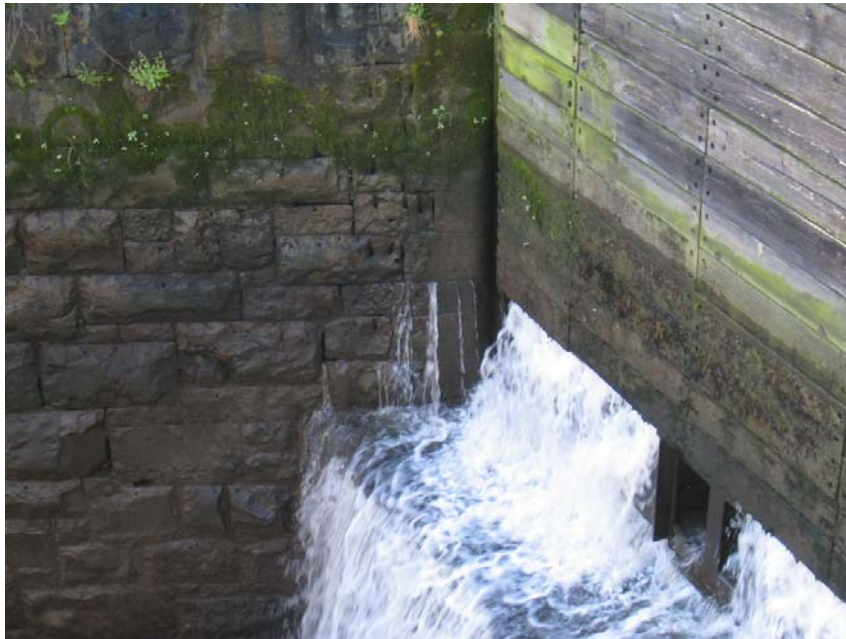
Photo 3-1 **Through Wall Leakage (Riverside)**
(Flow initiates as the chamber begins to fill)

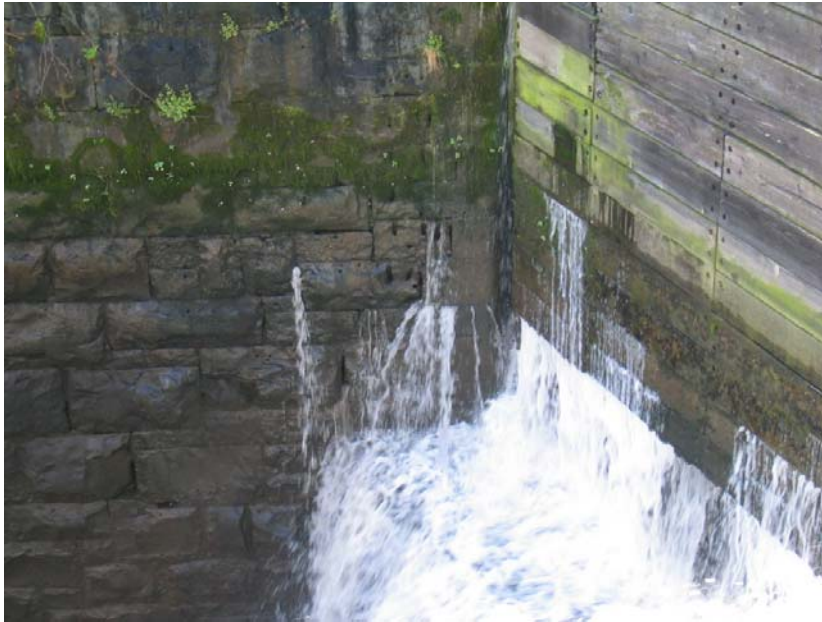
Photo 3-2 **Through Wall Leakage (Riverside)**
(Flow rate increases and flow path lengthens as the chamber fills)

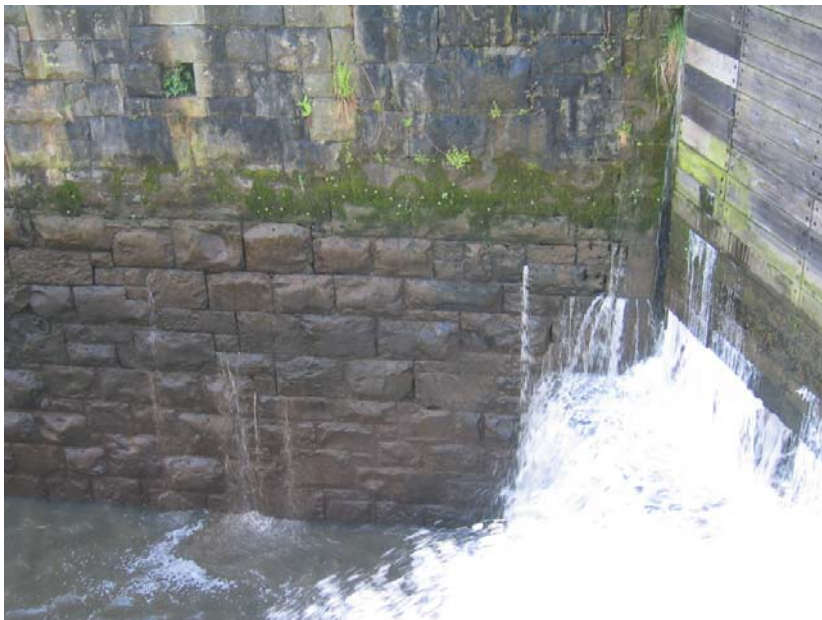
Photo 3-3 **Through Wall Leakage (Riverside)**
(Flow path continues to lengthen as the chamber fills)

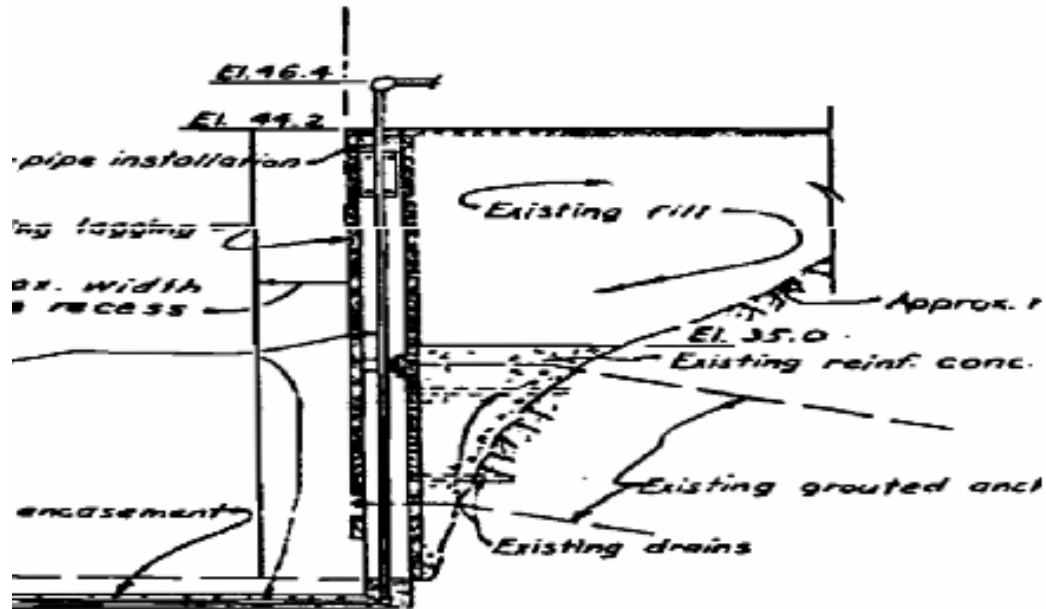
Figure 3-2 Timber Lined Excavated Rock Face with Soil and Concrete Fill

When the leak path encounters this type of lock chamber wall construction, there is potential for the movement of fill material through the wall facing. This wall section shows reinforced concrete fill with drains in the lower portion and soil fill above. In the photograph that shows the flow path extending beyond the masonry, this coincides with the paved area adjacent to the wall and the picnic table area beyond. Since the water coming through the wall appears to be clear (it does not appear to be carrying suspended solids), it is likely that the water has been collected by the drains and directed through the timber facing. The turbidity in the chamber water was due to filling and emptying the chamber immediately prior to the photograph, although it would support the hypothesis that the wall leakage is washing the soil fill through the timber facing.

If the wall leakage is washing the fill material through the wall facing, it will be necessary to implement a capital improvement project to address the situation. This case is the only situation, of all possible combinations of wall location (riverside/landside) and fill configuration (none/soil/concrete), which would require work. Possible retrofit designs would either address the leakage or address the movement of material; it would not be necessary to address both. Of these two options, the preferred option is to allow the continued leakage and provide a drain system that intercepts the flow and prevents the movement of the soil fill material. Attempting to stop the leak is problematic and may require an upstream impermeable membrane or a cutoff wall within the fill mass.

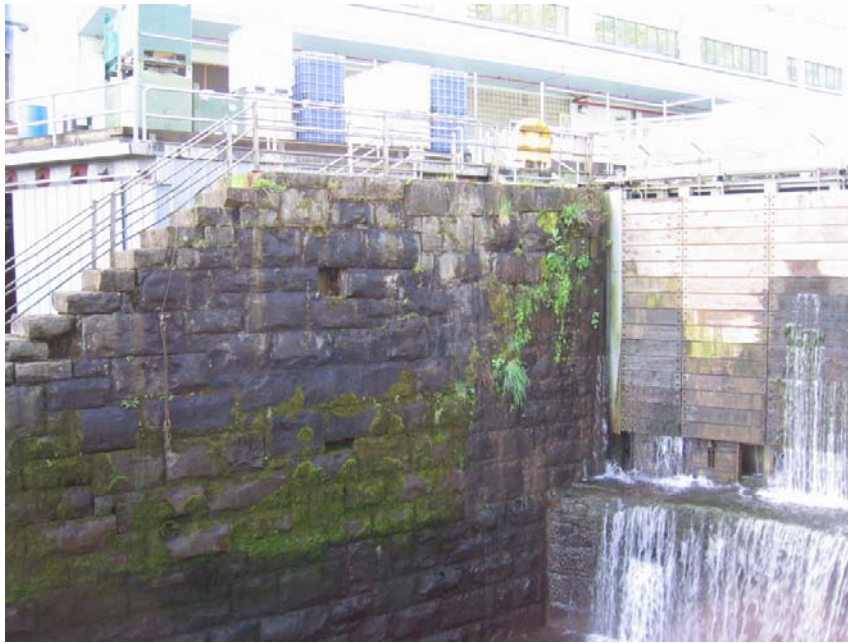
Photo 3-7 **Riverside Wall - Chamber Side at the Mill Warehouse**

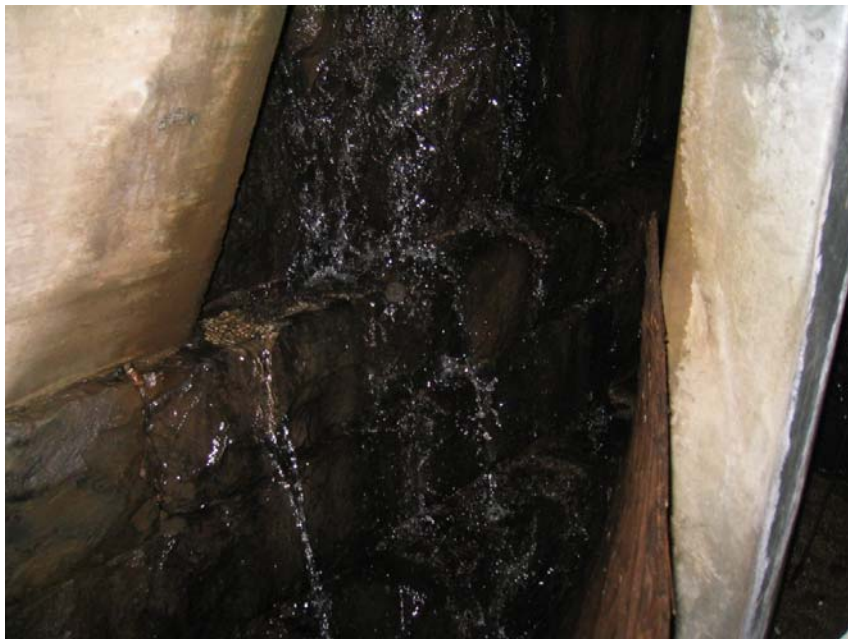
Photo 3-8 **Riverside Wall - Mill Side at the Mill Warehouse**

There are two things to notice in the photograph shown above. First, the leakage discharges from the wall as a free water surface and is carried away via surface flow. Second, a barrier (a thin sheet of plywood) has been erected to contain the splash zone.

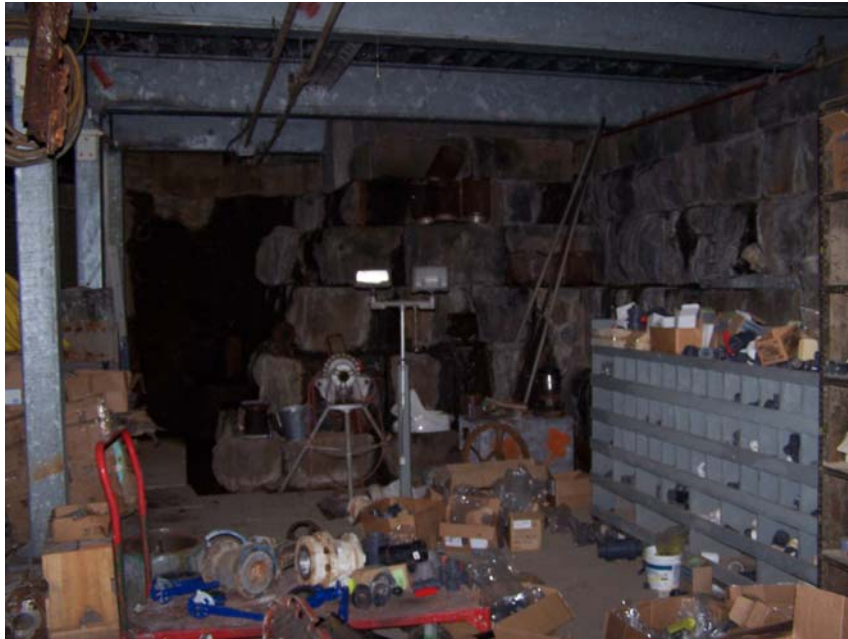
Photo 3-9 Riverside Wall - Mill Side at the Mill Warehouse

This photograph also shows the mill warehouse. It is taken at a point approximately sixty feet upstream of the previous picture. At this location, there is less through wall leakage, so the warehoused material can be closer to the chamber wall. The consequences of through wall leakage on the riverside appear to be limited to a lack of storage on the mill side of the river wall, which is significantly different than the potential for loss of fill material. There may be additional effects on the hydroelectric project (FERC No. 2233) operations that we were unable to determine during our site visit.

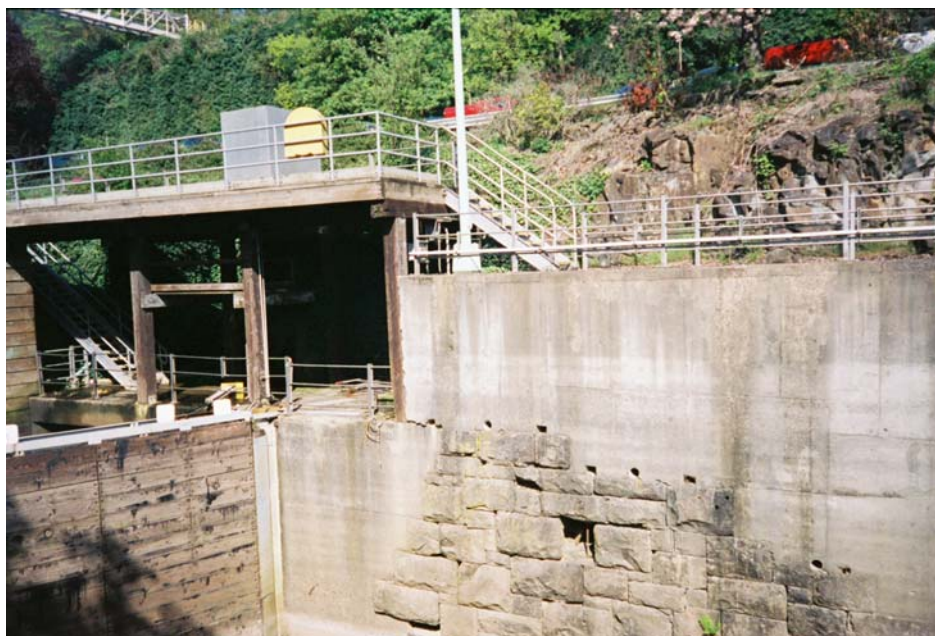
Photo 3-15 Landside Wall - Chamber 1 (*Note Core Holes for Rock Bolts*)

Based on what we could observe during the site visit, we did not find a need for a capital improvement project related to either the wall anchors or rock bolts. Monitoring the lock walls and the region behind the lock walls for movement is recommended, as discussed in Section 6.

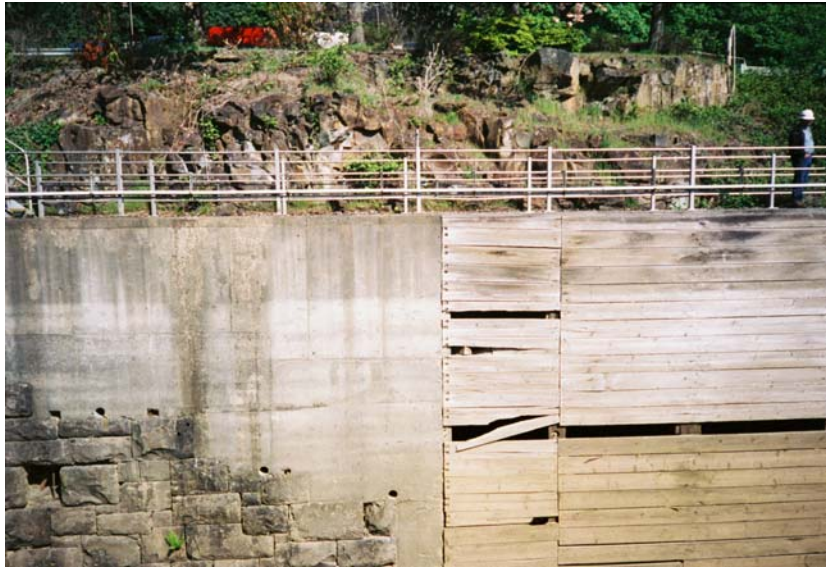
Photo 3-22 **Landside Wall - Downstream Approach**
(Note missing wall facing and core holes for wall anchors)

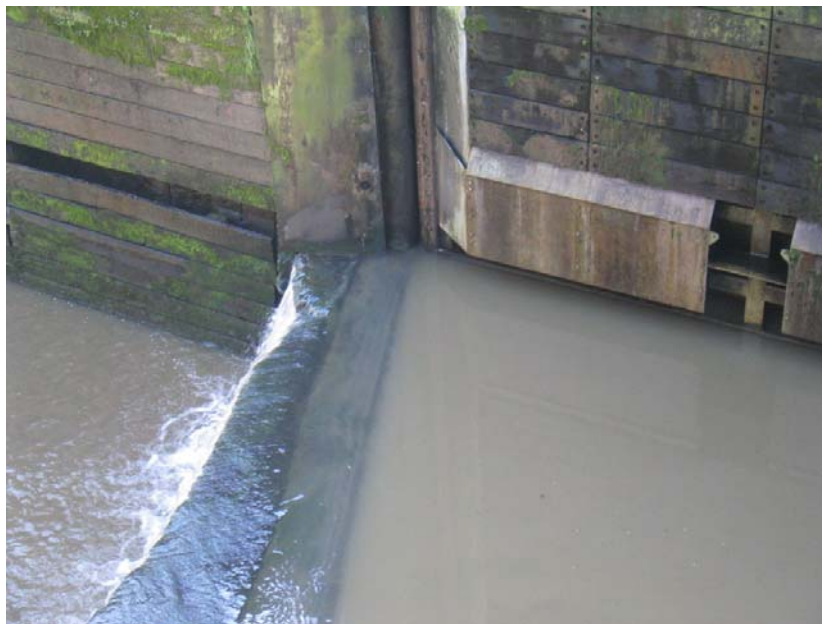
Photo 3-23 **River Side Wall - Chamber 1 One Board Missing**

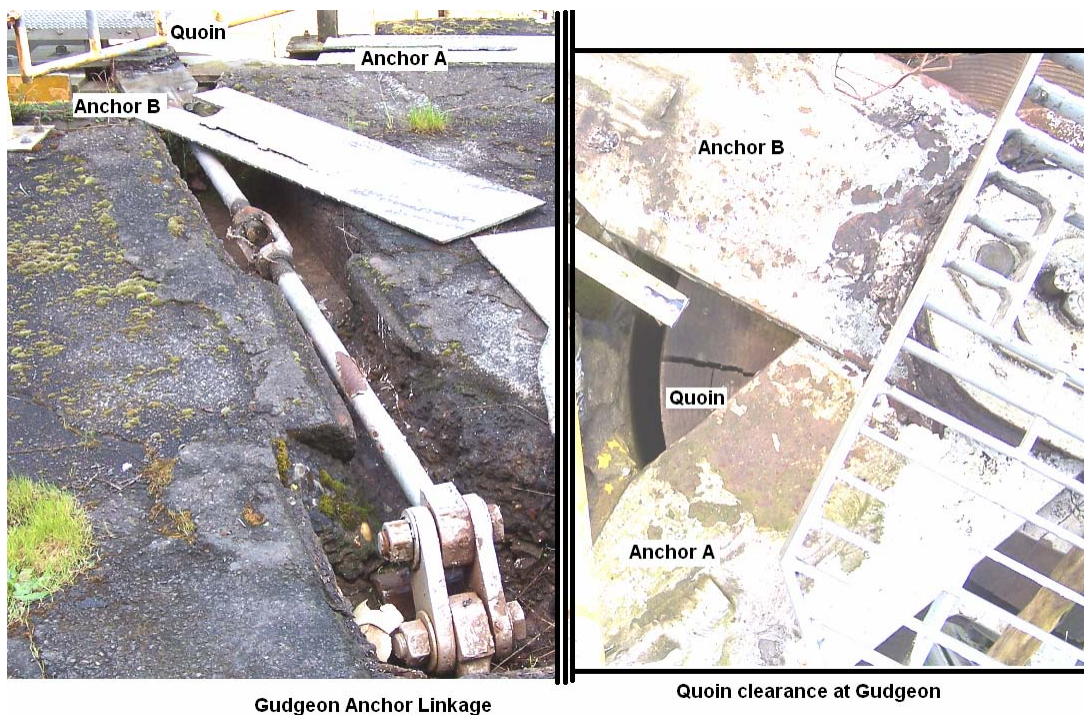
Photo 3-24 Gudgeon Linkage Gate 3

The design of the gudgeon linkages allows for more movement than is typical in current miter gate designs. The gudgeon pin is not anchored rigidly. Movement up to 3 inches is estimated based on observations during the site visit and previous inspection reports. The gate tilts free of the wall when rotating from open to closed position. When the gates miter in the middle, the leaves push each other back to seal at the abutments. Linkage design varies in how this is accomplished at different miter gates in the Willamette lock chambers. A common detail is shown in the photos below. There is a link between the ground anchor and the link to the pin that prevents the rod from resisting compression. Others locations make use of slotted rods, but, at gates #6 and #7, the tie is tension only.

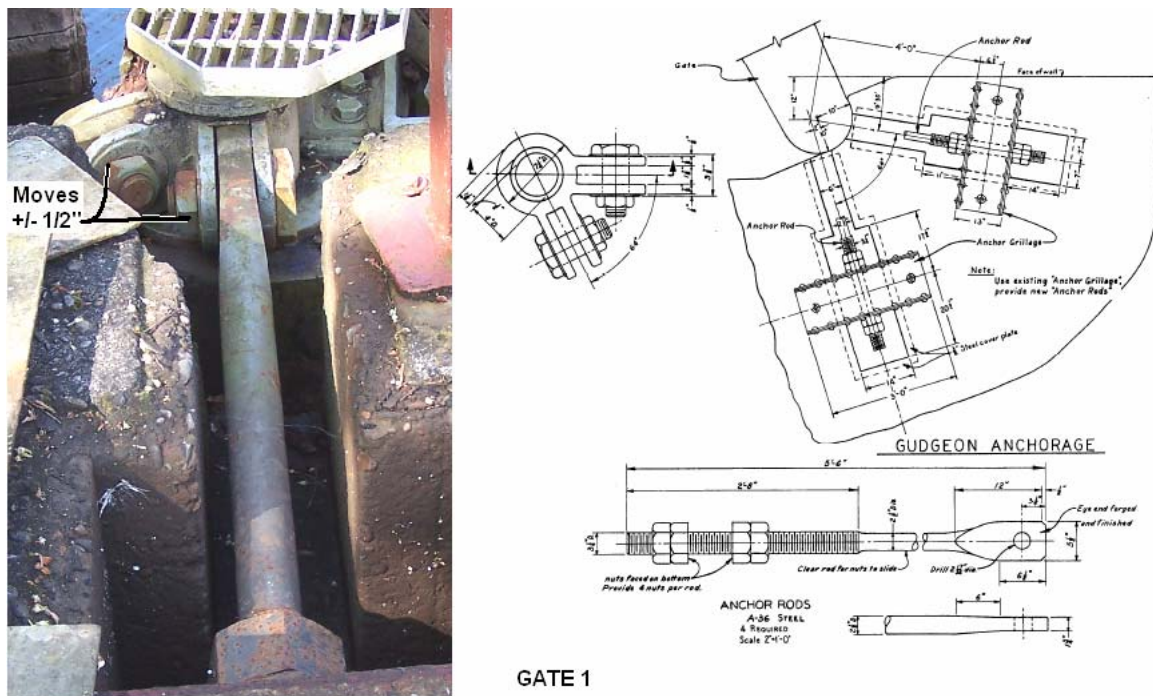
Figure 3-6 Gudgeon Anchorage at Gate 1, Mill Side

Only at gate #1 does the design detail in the figure below appear to show a fixed gudgeon pin attachment. The drawing shows a rigid attachment and closely fitting pins. The photos below show where field motion was observed in the linkage.

Field observation of movement at the gudgeon attachment of a half inch may be due to wear and not due to intentional slotting seen at other gates. Gate #1 is taller than the other gates and large movements could create greater problems.

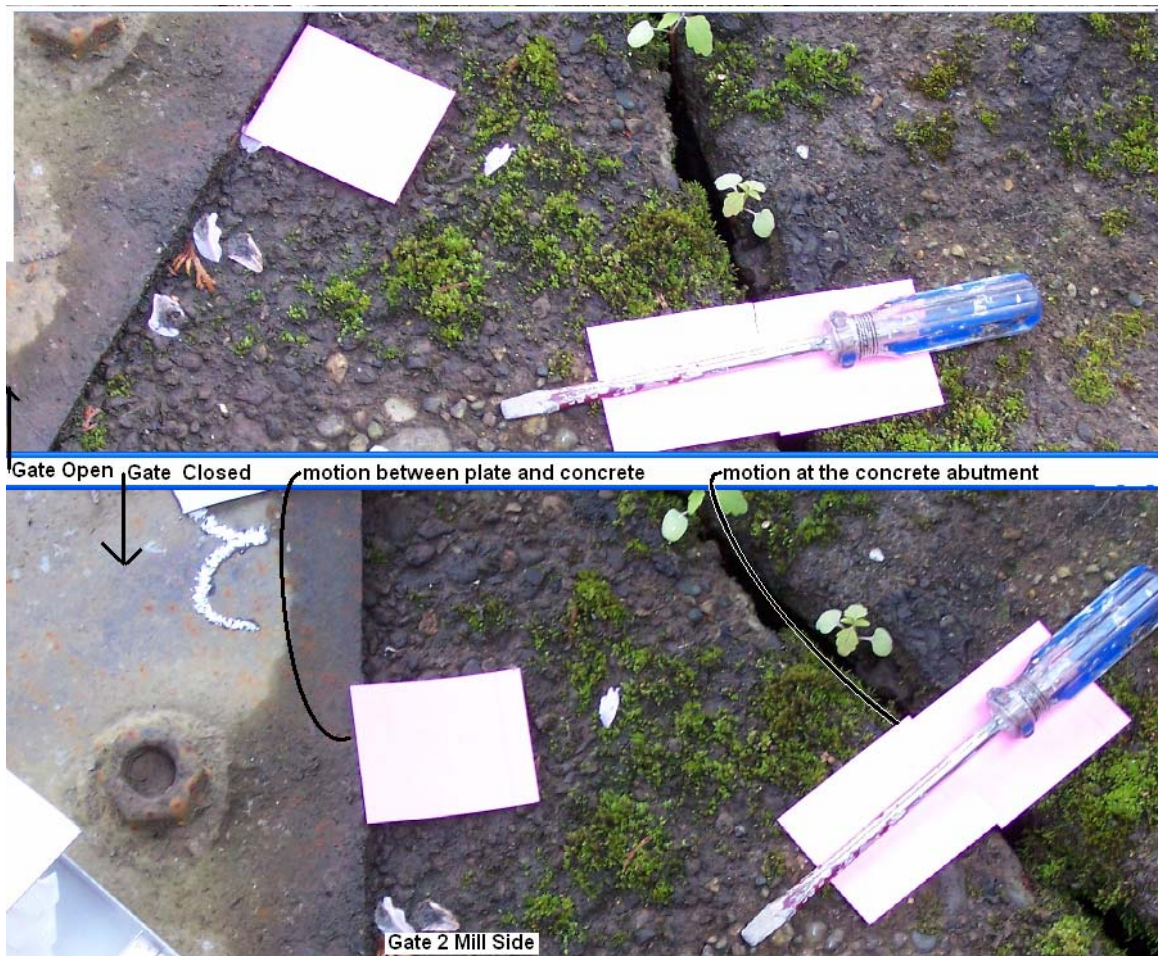
Based upon the site visit observation, some movement occurs somewhere in the linkage that was not intended at most gates. This movement occurs at loose abutments, noted at gate #2 where the Corps' side has recently been modified to reduce movement, and is also observable on the mill side. The photos below show that relative movement occurs between the block to which the plate is bolted and the adjacent block, and also between the plate and the block. At other gates, relative motion in the operator was also noted.

Photo 3-25 Motion Observed between Open and Closed Position, Gate 2

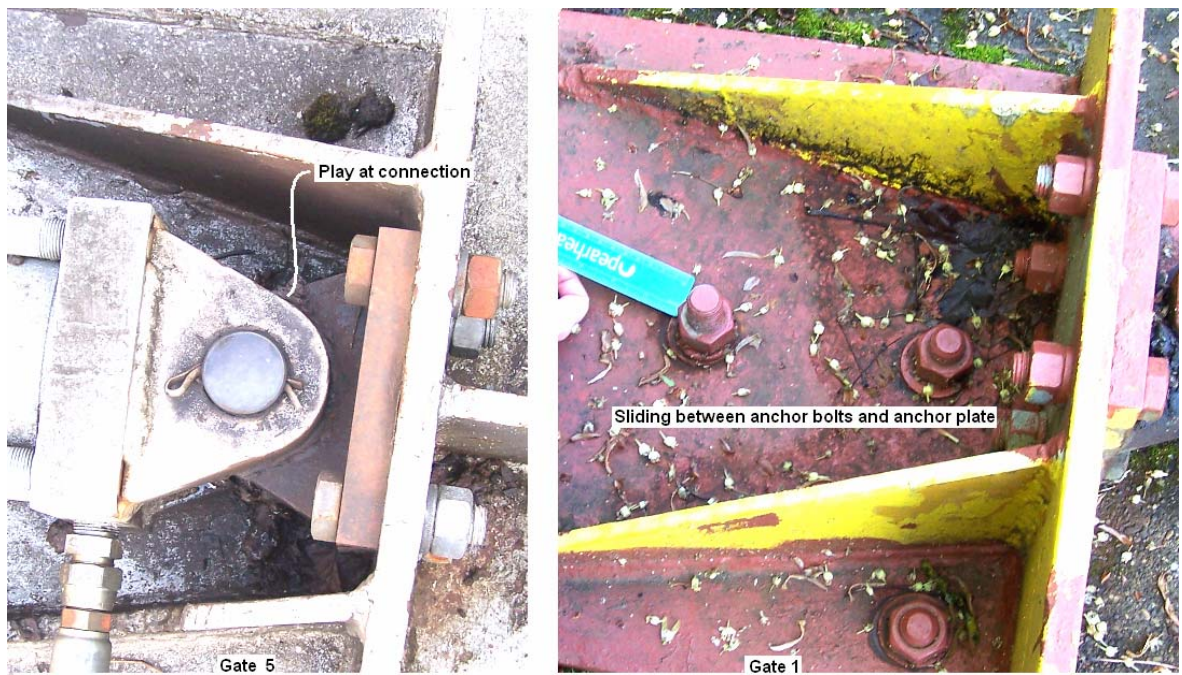
At gate #1, there is relative sliding between the anchor bolts and the anchor plate. At gate #5, the anchorage is very rigid and relative motion occurs at the pin connection.

Photo 3-26 Operator Anchorage Motion Observed at Gate 5 and Gate 1

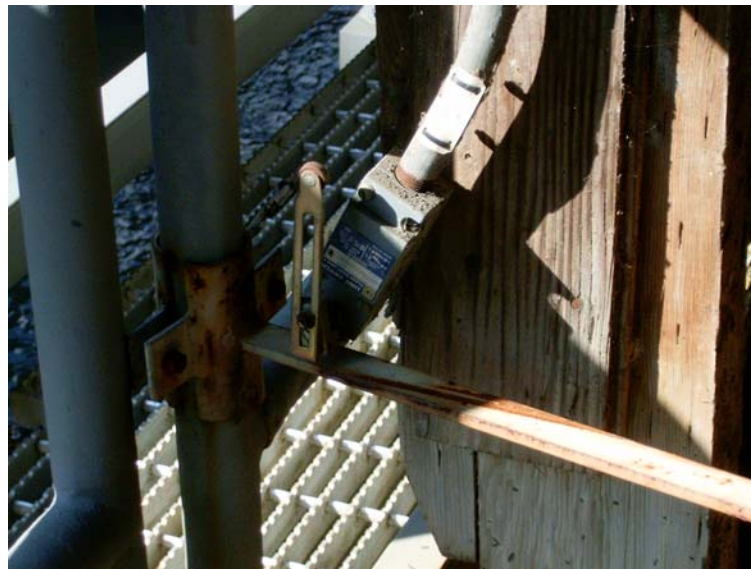
It was noted that several of the limit switches, installed on or near the miter gates, are not operational. In some cases, the operating levers are not functioning and, in other cases, the devices used to operate the switches are missing or not aligned. With a lack of up-to-date drawings, it is not known if the original function of these switches is still necessary. Since the miter gates are operating as intended, the absence of these switches appears to make little, if any, difference, except as noted in the mechanical operation portions of the report such as Sections 3.2.3.2 and 4.1.

Photo 4-4 Limit Switch Not Making Contact

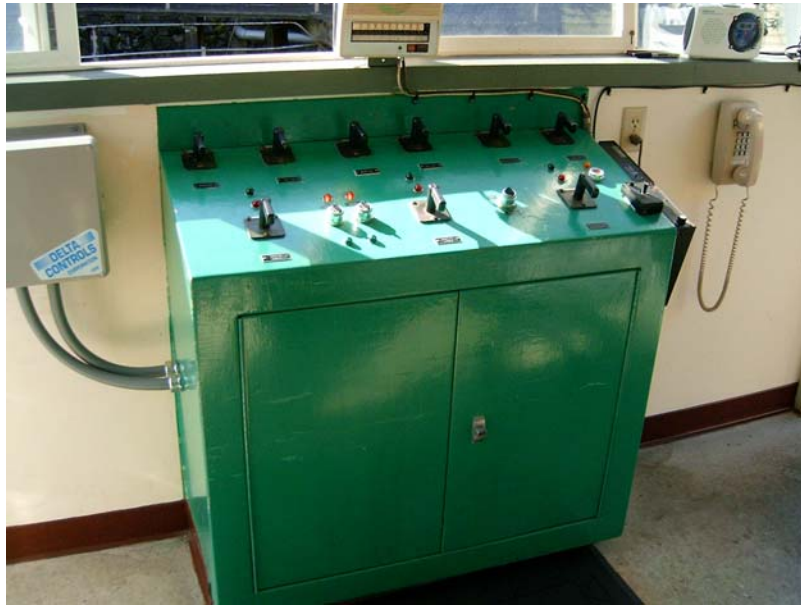
another manufacturer. If the original manufacturer no longer supports the model in use and spare parts are not available, the system usually requires replacement. Due to the rapid advance in technology governing digital controls, systems are normally only supported for 20 years or less. Based upon the available information, the existing digital controls are estimated to be approximately 10 years old. It would, therefore, be prudent to anticipate replacing the existing digital controls within the next 10 years or so, assuring its performance for the 20-year period of this study.

Photo 4-5 Existing Control Panel

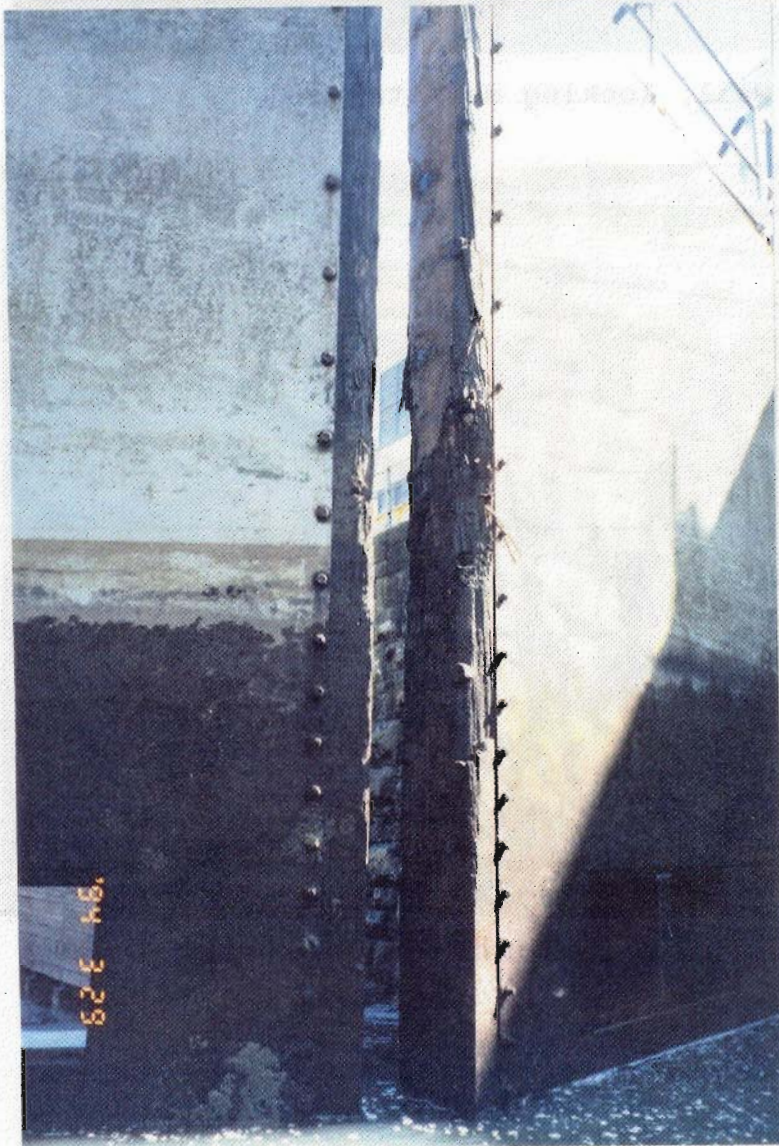
11. Gate 3, impact wear on miter posts.

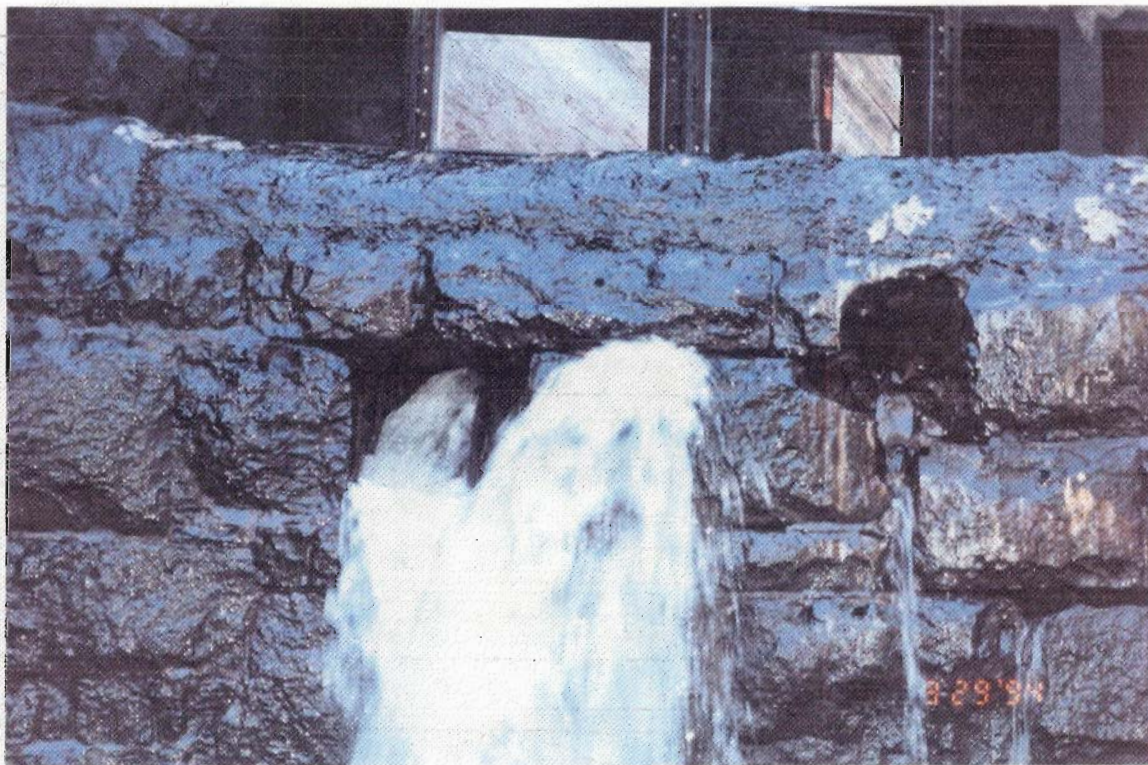
12. Gate 3 sill, right side, missing blocks (bypassing sump)

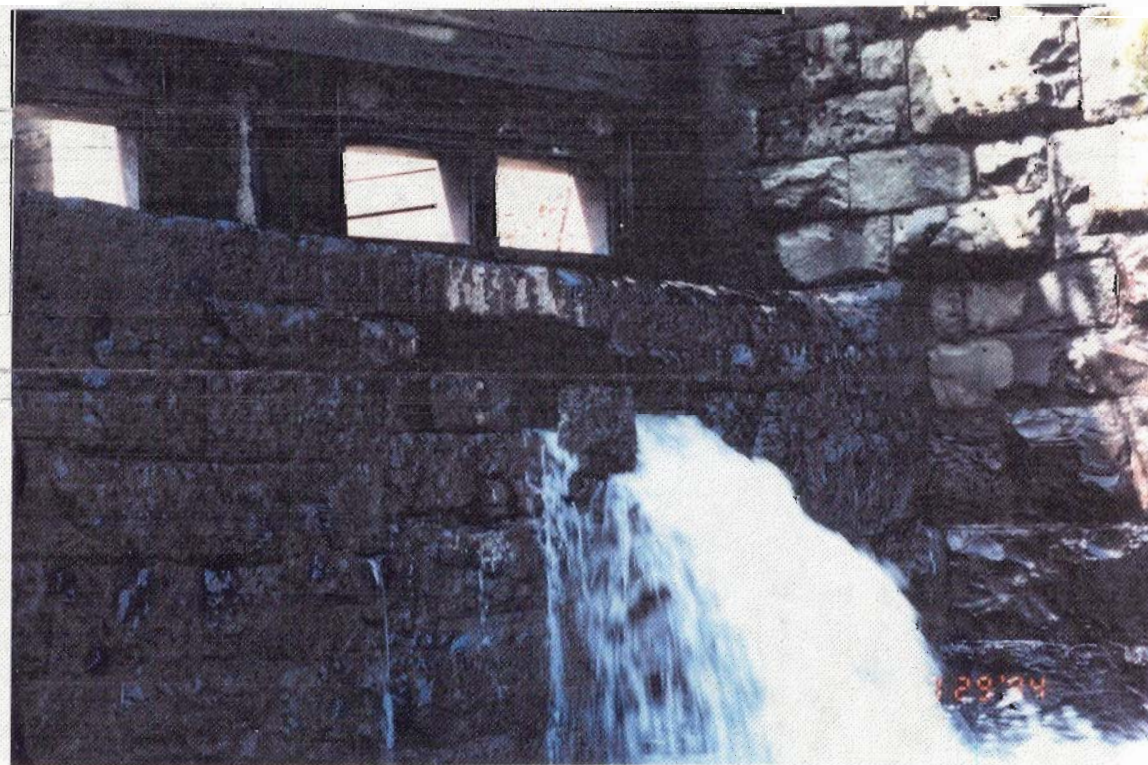
13. Gate 3 sill, left side, missing blocks.

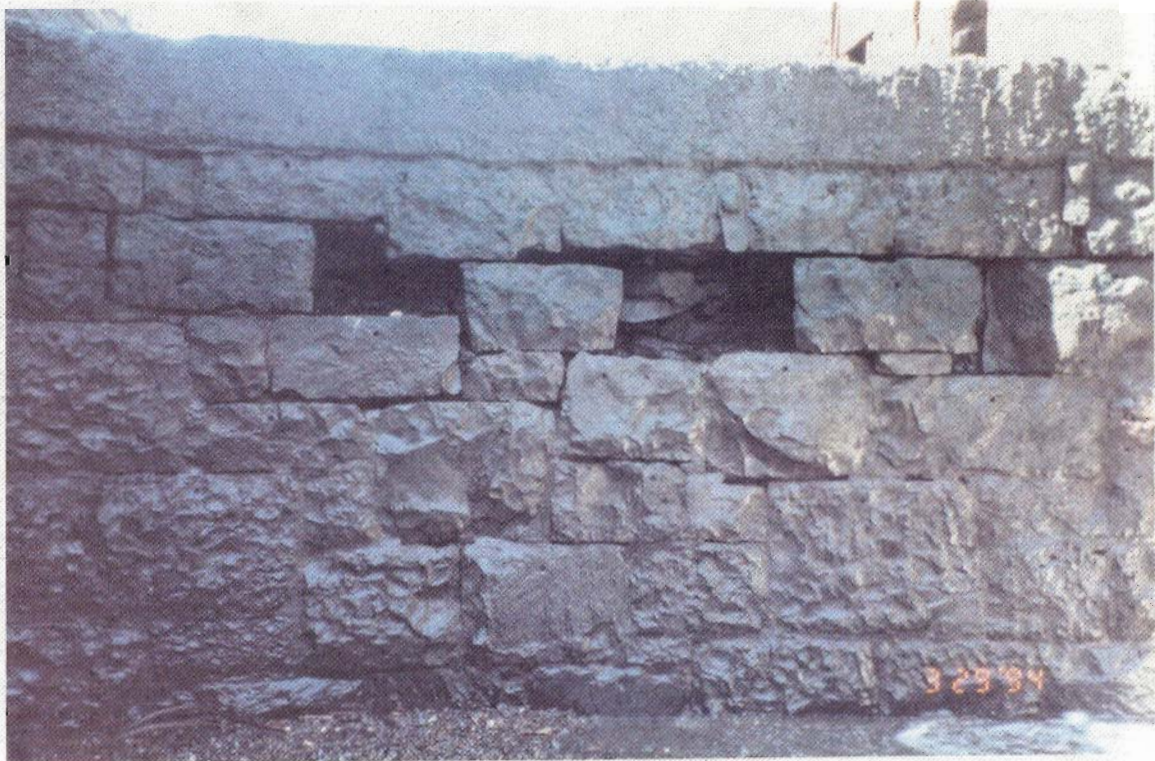
17. Gate 4 sill (blocks missing just left of centerline).

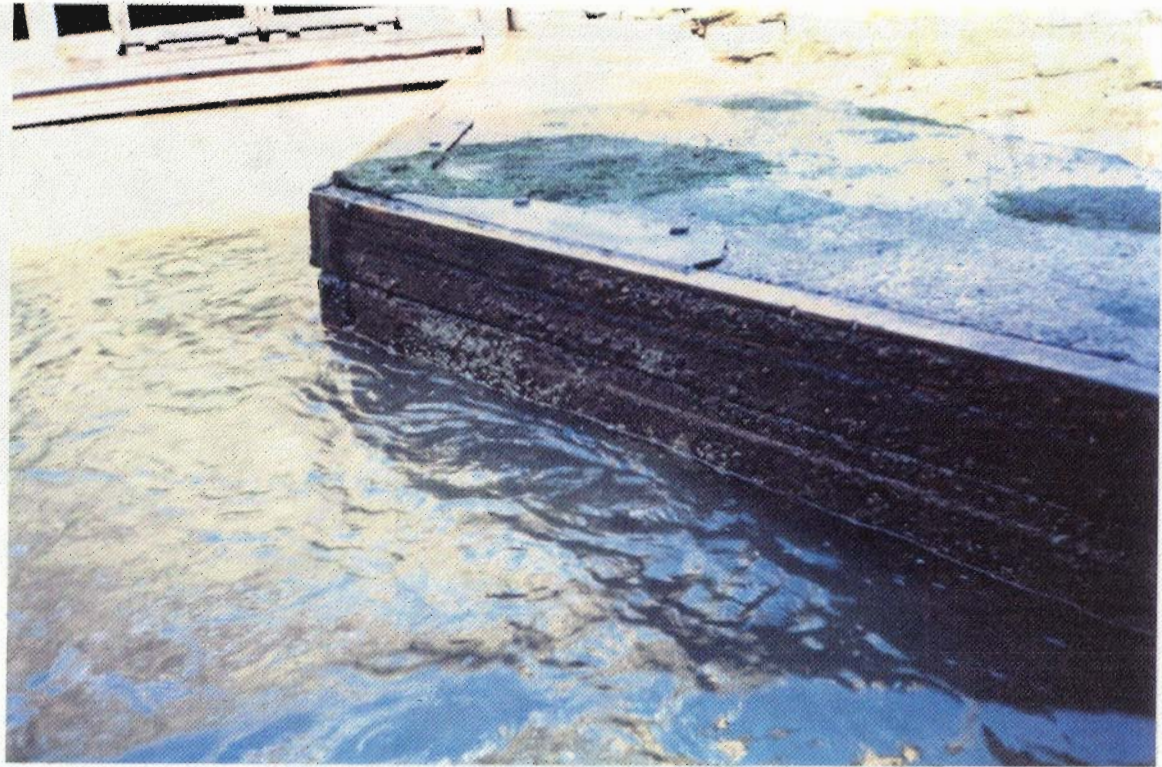
20. Gate 4, sill seal angle, loose for 8-feet each side of centerline.

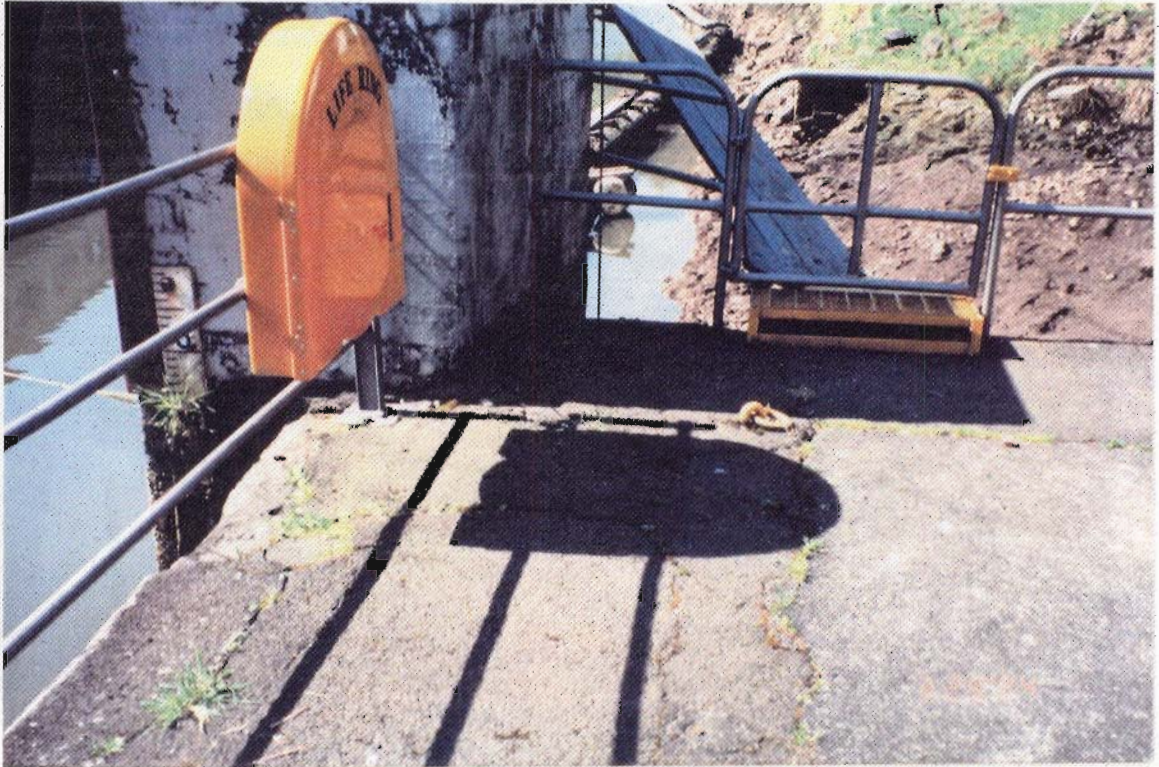
28. Upstream of gate 5, loose concrete guide block (1/2-inch separation between block and asphalt).

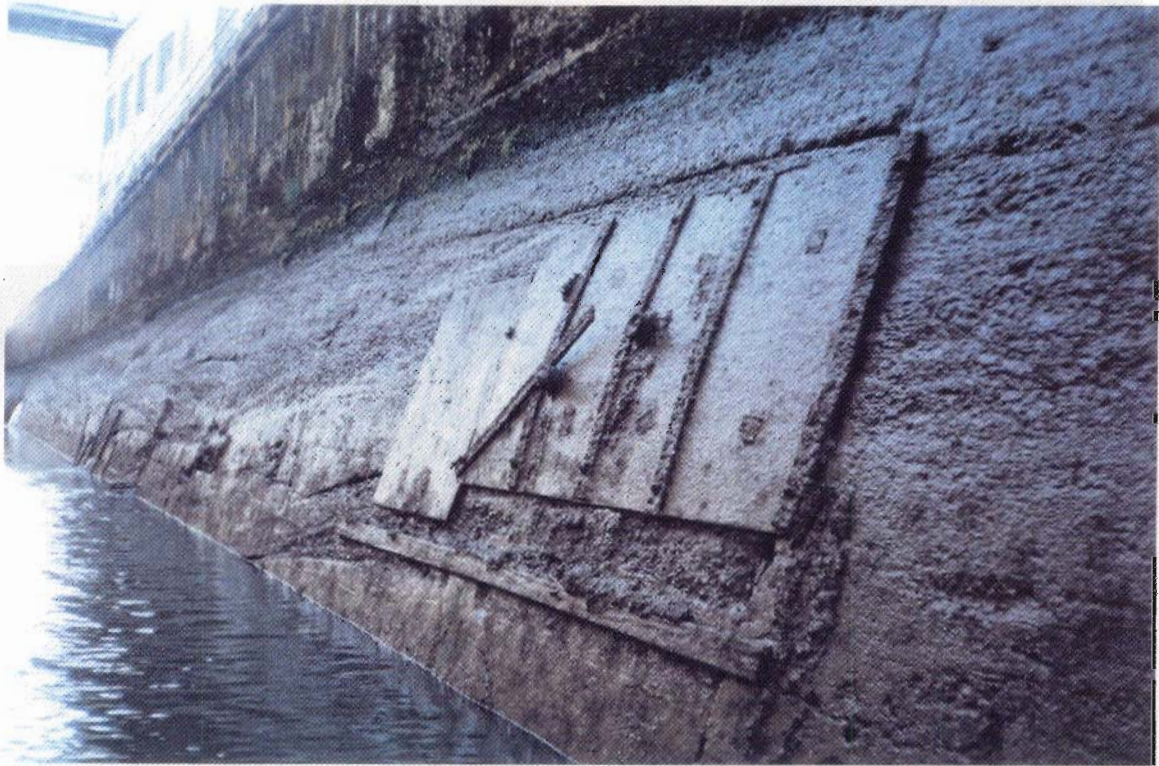
32. Concrete wall on right side of canal at PGE forebay, note former repair areas.

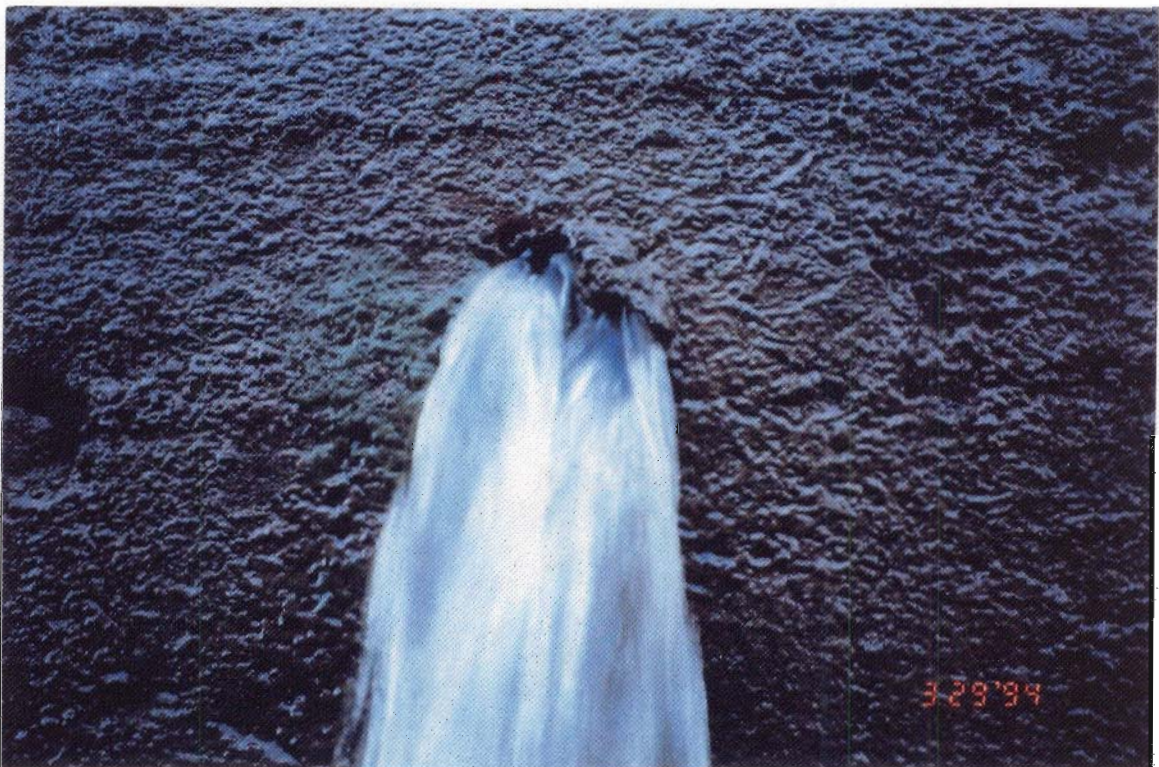
33. Close-up of leaks through concrete wall (left end of above photo).

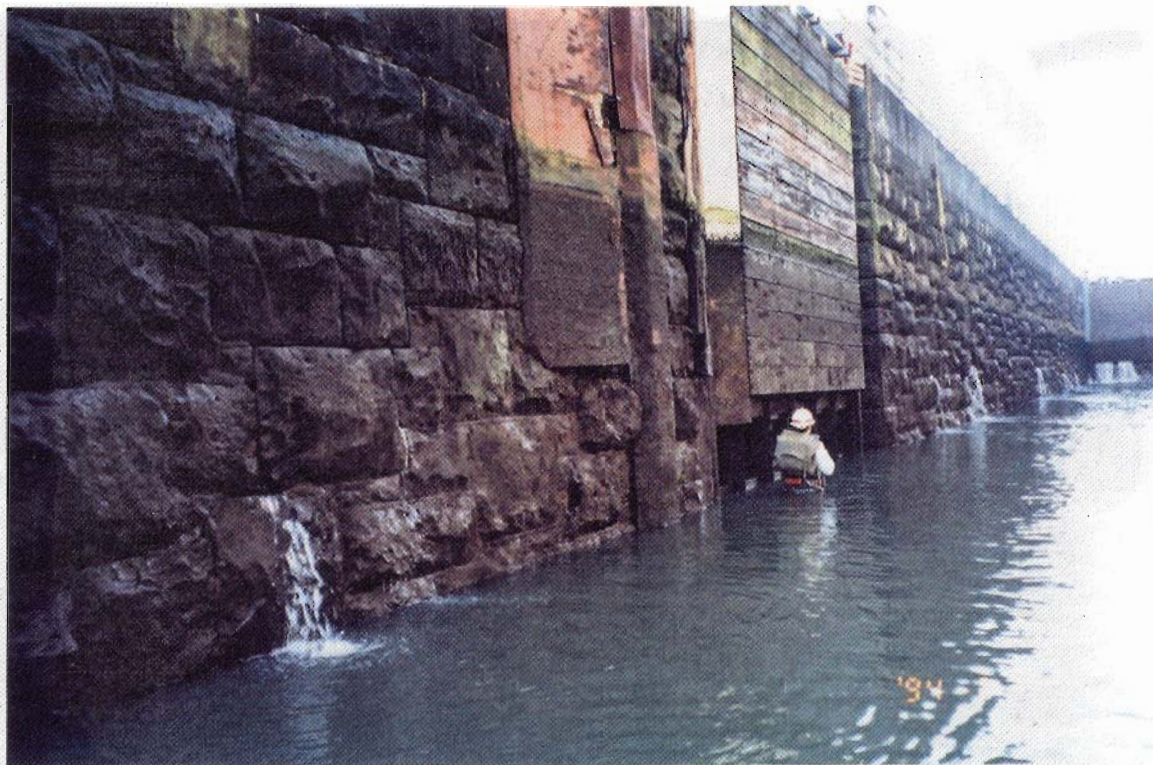
34. Gate 6 and guard lock, right side (note leaks in wall).

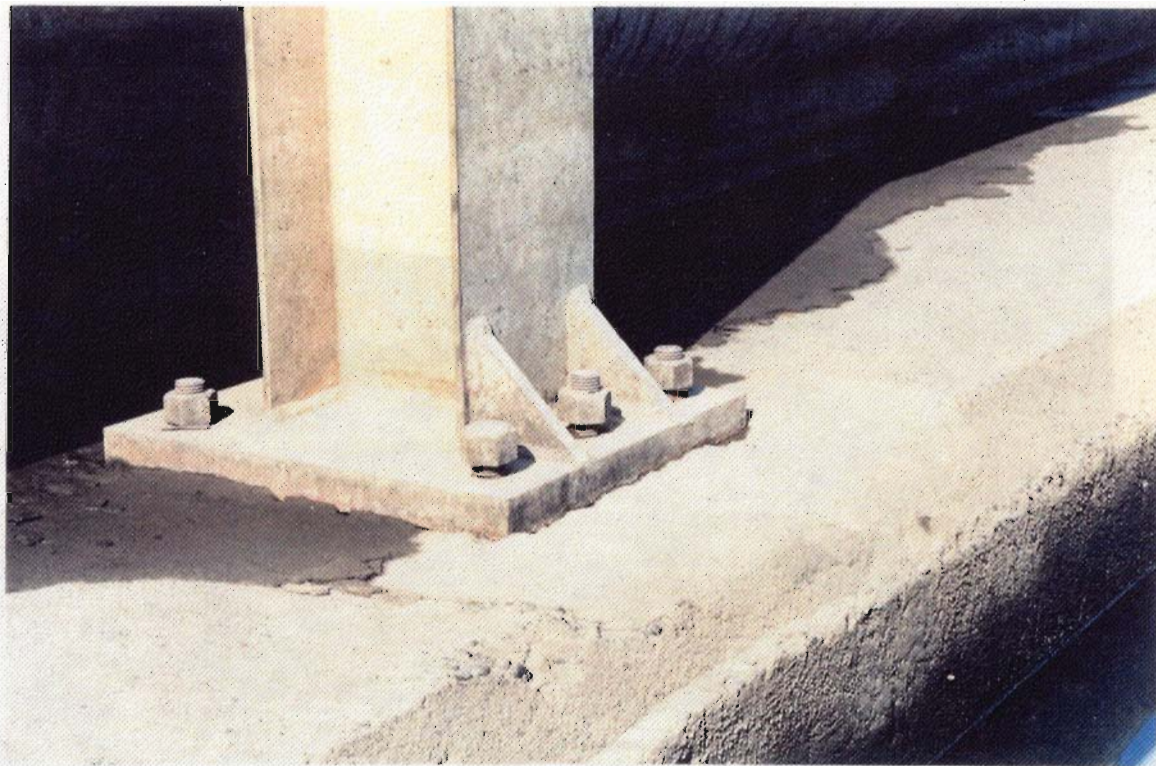
39. Downstream floating dock, upstream base on river side, loose nuts on anchor bolts.
