# PEN 1 & PEN 2 Seepage and Stability Analyses

# Peninsula Drainage Districts No. 1 and No. 2

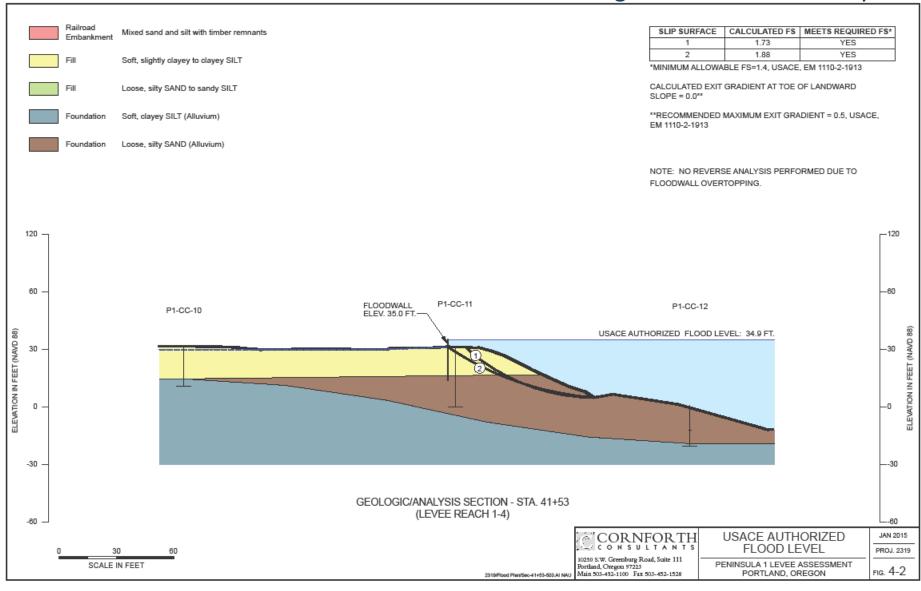
#### PEN 1 – N Marine Drive Floodwall - USACE authorized design water elevation analysis

Floodwalls meet USACE structural stability standards

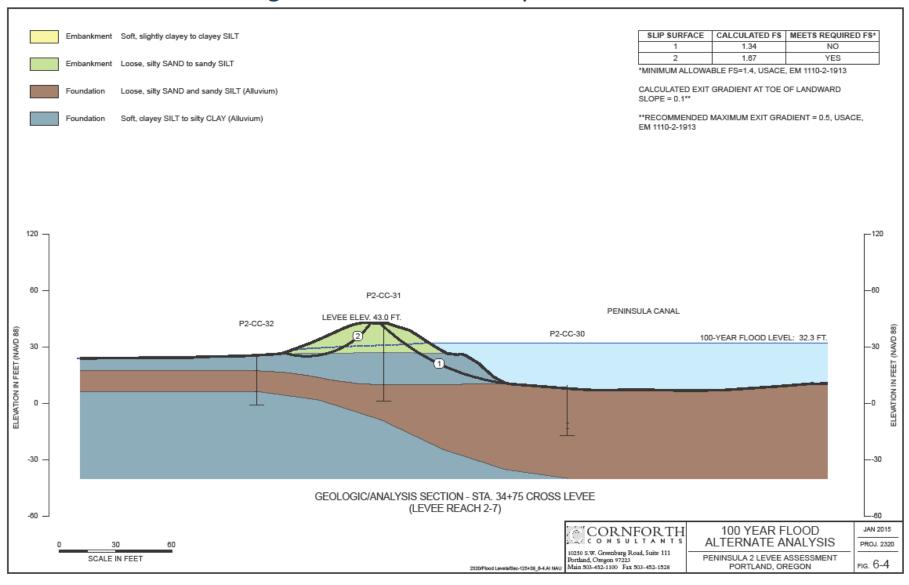
#### PEN 2 – Peninsula Drainage Canal - 100 Year Analysis

Problem areas focused on Peninsula Drainage Canal & freeboard in Reach 2-5

Seepage & stability issues along Peninsula Drainage Canal could likely be addressed with modifications to existing levee
