Scope of Work Overview

October 10, 2018 Conditions Assessment Report is based on the following information:

Summary of Conclusions

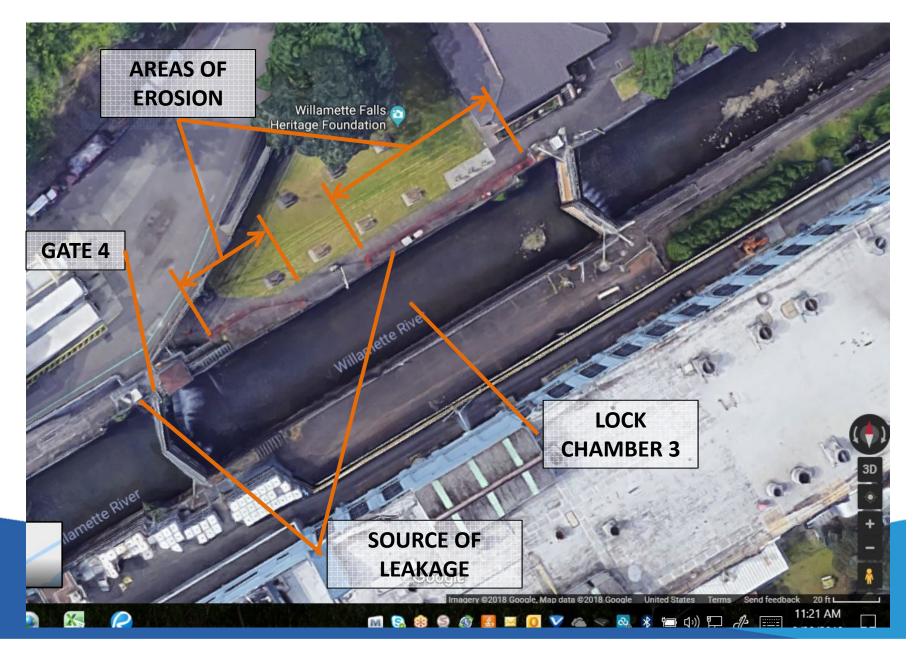
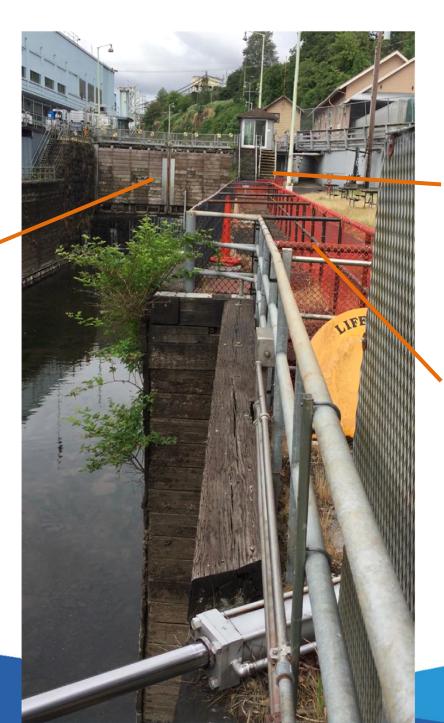
GATE 4

NOTE ORANGE
BARRICADES DUE
TO CURRENT
STATE OF
EROSION

1. Erosion Repair at Chamber 3 & Gate 4

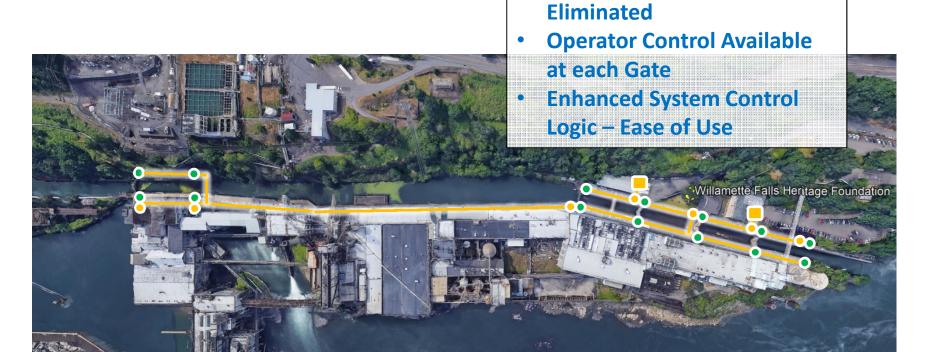
Recommended Future

Hydraulic Piping Under Lock

New Networked Control Wiring

- New HPU (14 places)
- New Human Machine Interface (HMI)
- New Human Machine Interface (HMI) + Programmable Logic Controller (PLC) In Control House
