Willamette Falls Canal and Locks

Independent Condition Assessment and Recommendations for Recommissioning

Prepared for:
Willamette Falls Locks Commission (WFLC)

October 10th 2018

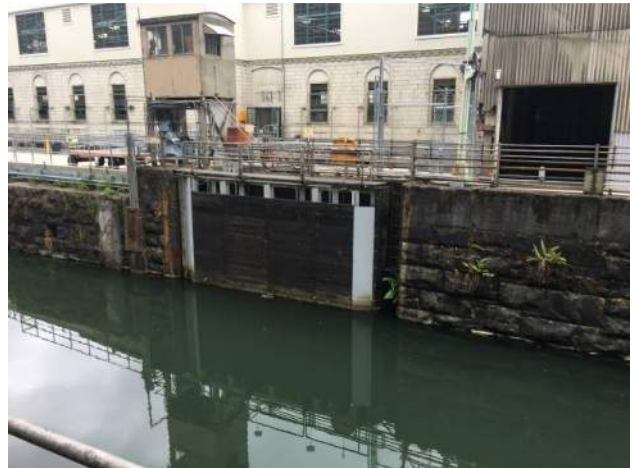
Photo #23

Note that LCS3 located on an elevated structure adjacent to Miter Gate 6 is in very poor condition. Project staff indicated that this structure has been condemned and is no longer used. Operation of

Miter Gate 6 and 7 is accomplished using the local control stations on the HPU or from LCS2 adjacent to Miter Gate 4. (See Photo #23)

Analyze Lock Control Stand at Gate 6 (Mill Side): The structure of the lock control stand has been condemned. At this point, there is no need to analyze the structure since it has already been deemed unsafe structurally. If the control stand is needed, the structure would need to be replaced. This activity would have added complexity with all of the utilities routed around, underneath and into the control stand. With the recommended operational methodology, the control stand is no longer needed.
