Peninsula Drainage District No. 1 Levee Engineering Assessment Portland, Oregon

**PENINSULA DRAINAGE DISTRICT NO. 1
LEVEE ENGINEERING ASSESSMENT**

October 2, 2014

Cornforth Consultants, Inc
10250 SW Greenburg Road, Suite 111
Portland, Oregon 97223

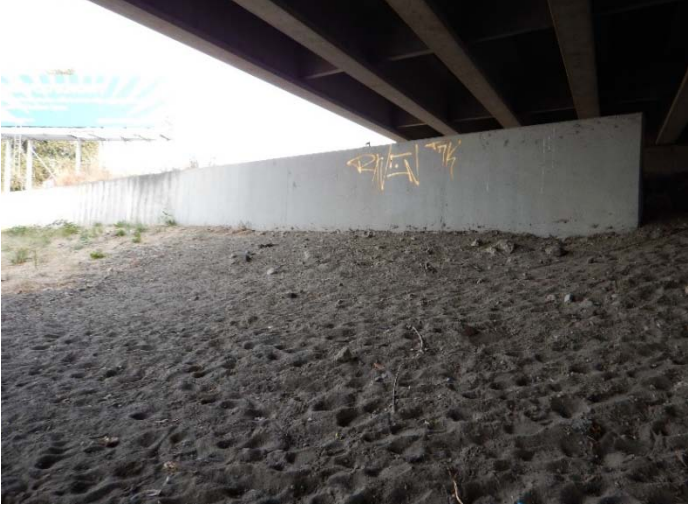
| Photo No. 1 | |

| <p>Description: Interstate 5 functions as the cross-levee between PEN 1 and 2. The structure is large and wide, at times spanning a distance of 100 feet. The flood wall stops underneath the Interstate 5 bridge in the northeast corner of PEN 1.</p> | |

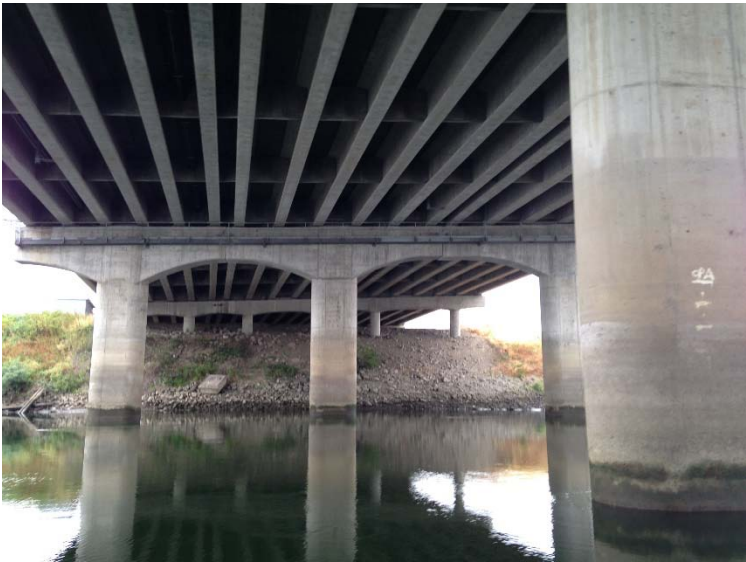
| Photo No. 2 | |

| <p>Description: Interstate 5 functions as the cross-levee between PEN 1 and 2. There is a flood wall on the landward side of the levee adjacent to the Oregon Slough at this location.</p> | |

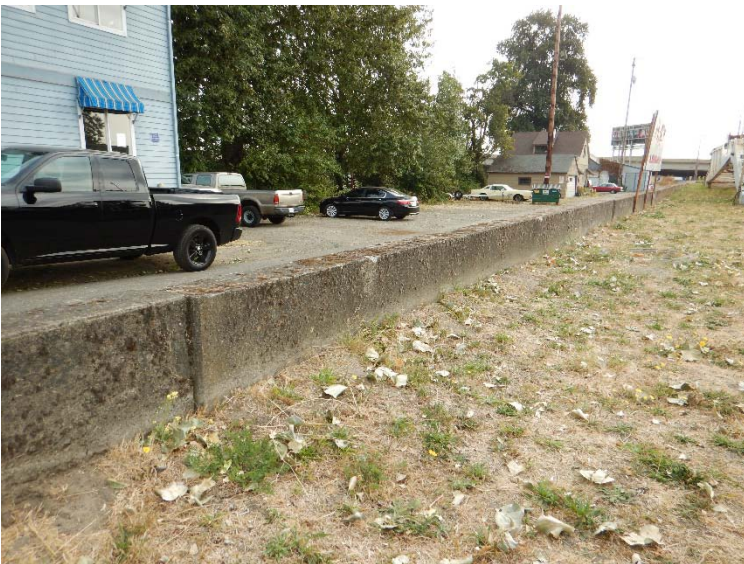
| <p>Photo No. 3</p> | |

| <p>Description: The flood wall is smaller in height in the northeast corner of PEN 1. At this location, the flood wall is going through private property and is 2 feet tall.</p> | |

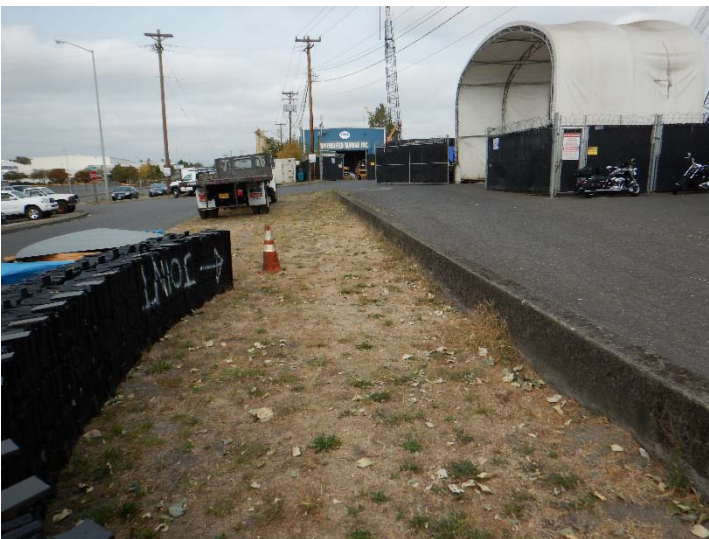
| <p>Photo No. 4</p> | |

| <p>Description: The flood wall is smaller in height in the northeast corner of PEN 1. At this location, the flood wall is going through private property and is 1 foot tall. It ends where the ground becomes equal in height.</p> | |

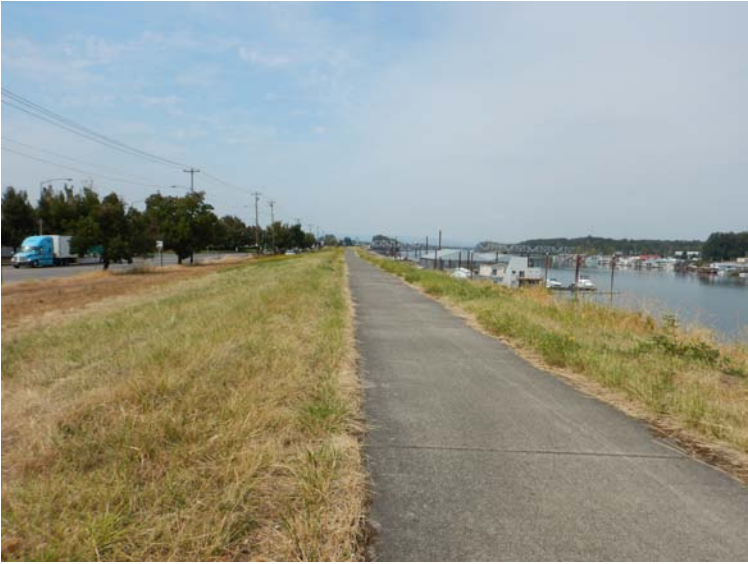
| <p>Photo No. 5</p> | |

| <p>Description: A Portland Parks and Recreation multi-use path runs on top of the levee on the north end of PEN 1. Marine Drive is to the south of the levee and the Oregon Slough is to the north.</p> | |

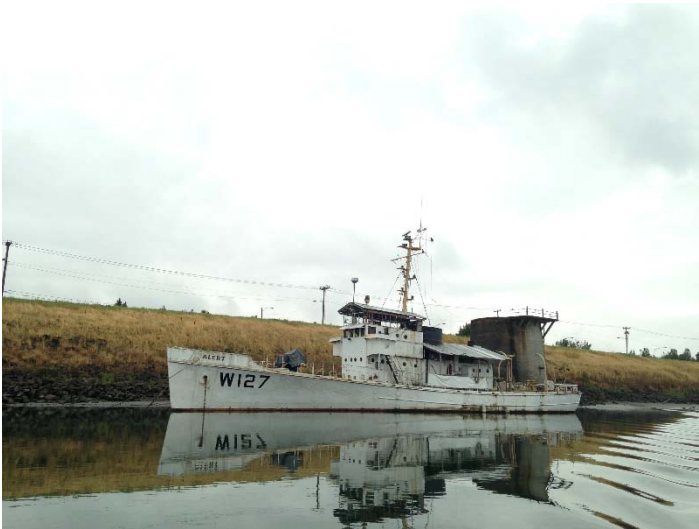
| <p>Photo No. 6</p> | |

| <p>Description: The eastern corner of the north side of PEN 1 has minimal development as well as a few floating homes on the Oregon Slough. The encroachments in this section are constructed on the overbuild.</p> | |

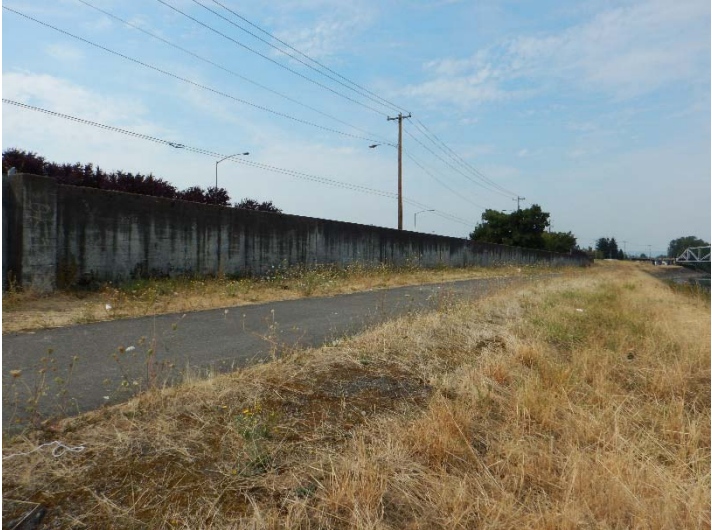
| <p>Photo No. 7</p> | |

| <p>Description: Flood wall along the north section of PEN 1. A Portland Parks and Recreation multi-use path is located in front of the flood wall.</p> | |

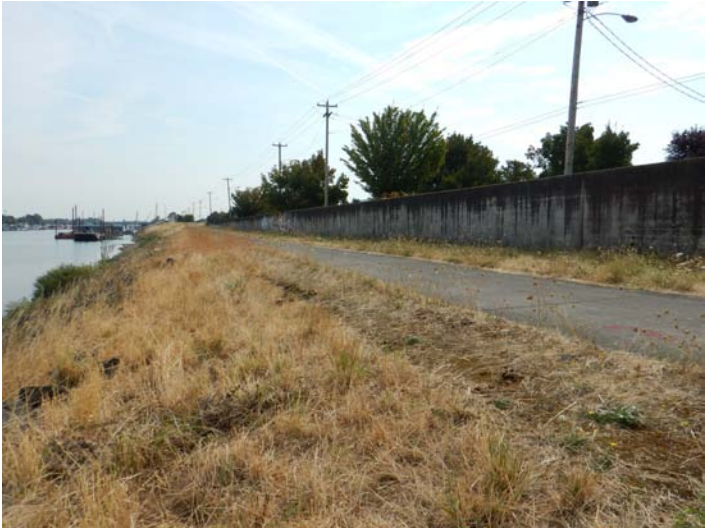
| <p>Photo No. 9</p> | |

| <p>Photo Date: 9/16/2014</p> | |
| <p>Orientation: Southeast</p> | |

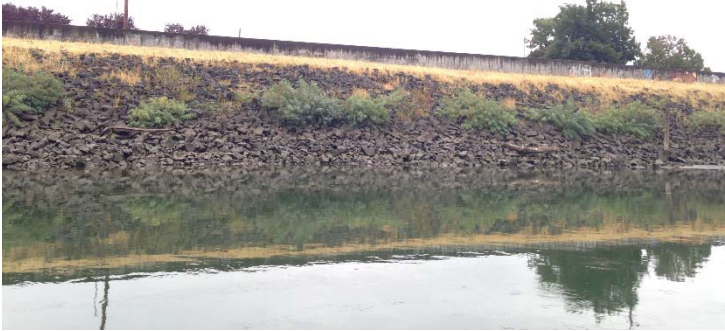
| <p>Photo No. 10</p> | |

| <p>Description: The floodwall can be seen on top of the levee. An outfall with an operating flap gate can be seen daylighting above the toe of the levee.</p> | |

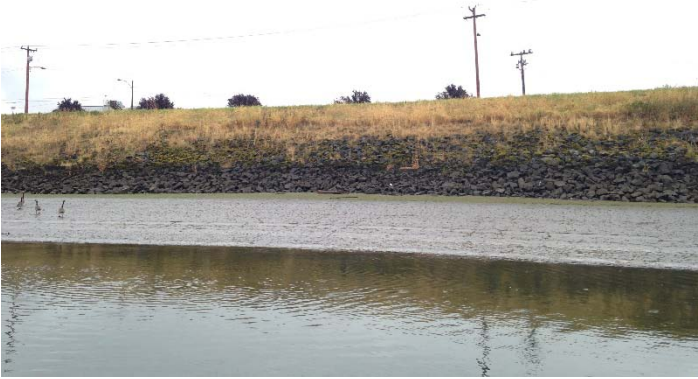
| Photo No. 11 | |

| <p>Description: The rip rap along the waterward side of the levee is large in size. The waterward toe of the levee is visible.</p> | |

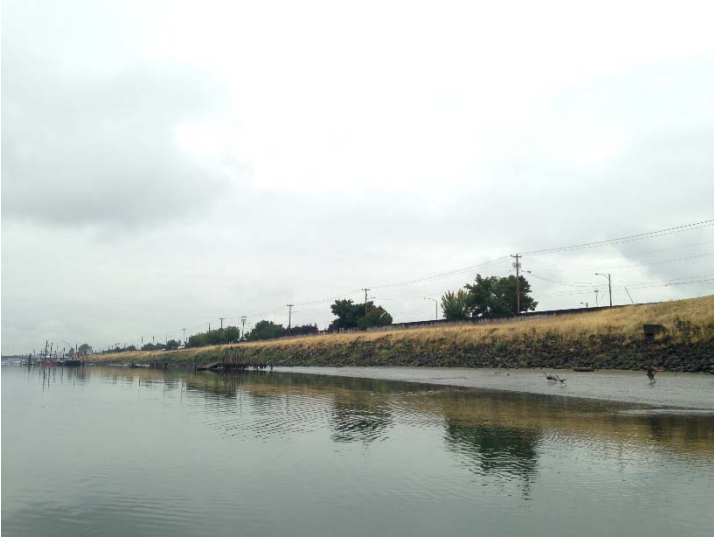
| Photo No. 12 | |

| <p>Description: The levee on the north side of PEN 1 protects the district from high water in the Oregon Slough along the Columbia River. The flood wall is visible on top of the levee.</p> | |

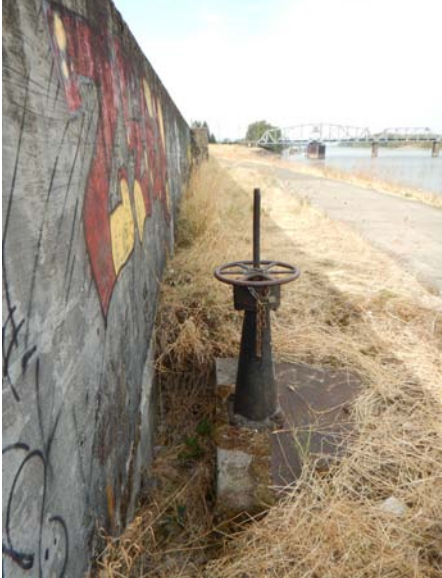
| Photo No.13 | |

| <p>Description: Multiple outfalls traverse the levee, south to north, from the Graphic Packaging property in the northwest corner of PEN 1. The outfalls convey stormwater as well as process water. Each outfall has a properly operating flap gate and closure valve.</p> | |

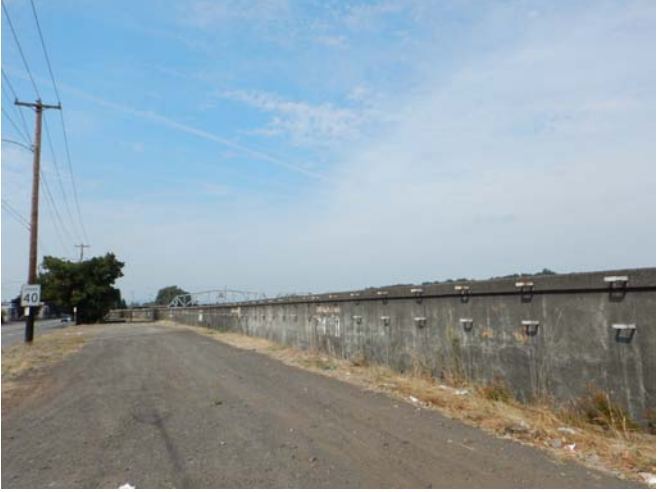
| Photo No.14 | |

| <p>Description: South side of the flood wall. Marine Drive lies to the south of the flood wall.</p> | |

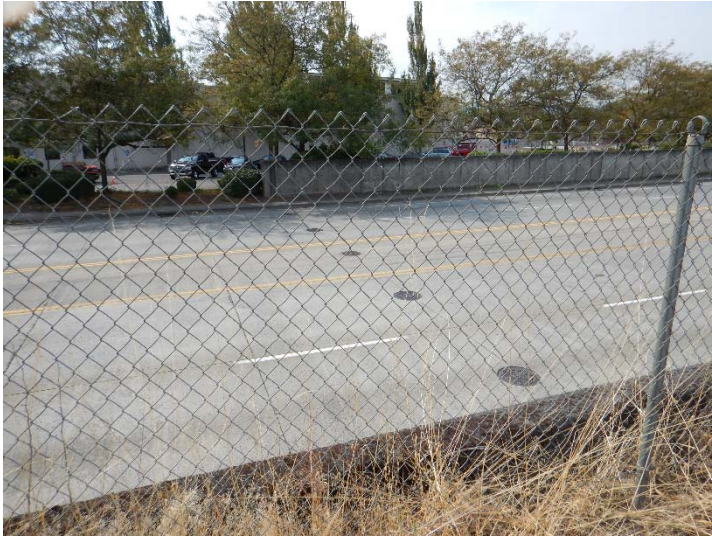
| Photo No. 15 | |

| <p>Description: The flood wall on the north side ties into the flood wall on the south side with a closure structure that goes across Marine Drive. The closure structure is installed by the City of Portland Bureau of Transportation, as MCDD has an IGA with the bureau. The closure structure closes Marine Dr.</p> | |

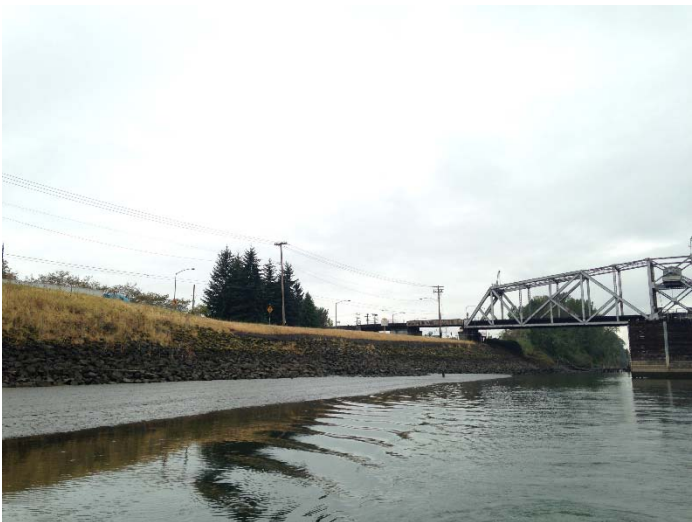
| Photo No. 16 | |

| <p>Description: The railroad bridge connects to the railroad embankment that forms the northwest corner of PEN 1. The north side of PEN 1 is protected by the levee from the Oregon Slough on the Columbia River. The rip rap is visible along the toe of the levee.</p> | |

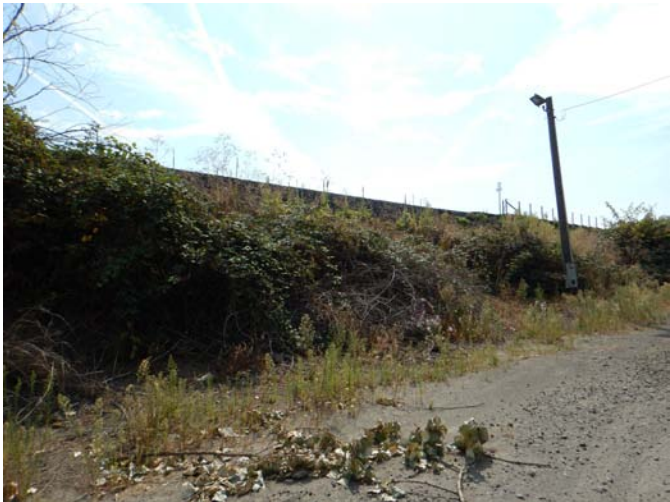
| <p>Photo No. 17</p> | |

| <p>Description: A railroad embankment runs along the western edge of PEN 1. The waterward side of the railroad embankment can be seen in the photo. The embankment was built on top of a wooden trestle in the early 1900s. An active rail line is located on top of the embankment.</p> | |

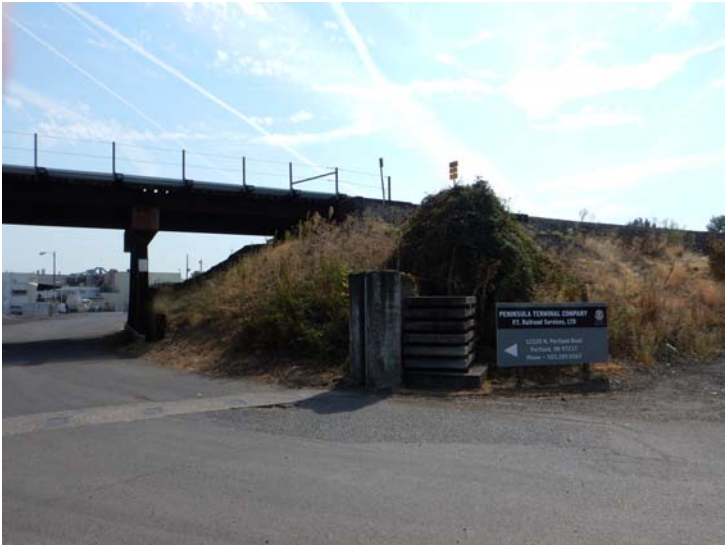
| <p>Photo No. 18</p> | |

| <p>Description: On the northern end of the railroad embankment there is a closure structure that goes across the Peninsula Terminal Co.'s rail line and connects the embankment. This closure structure is also installed by the City of Portland's Bureau of Transportation.</p> | |

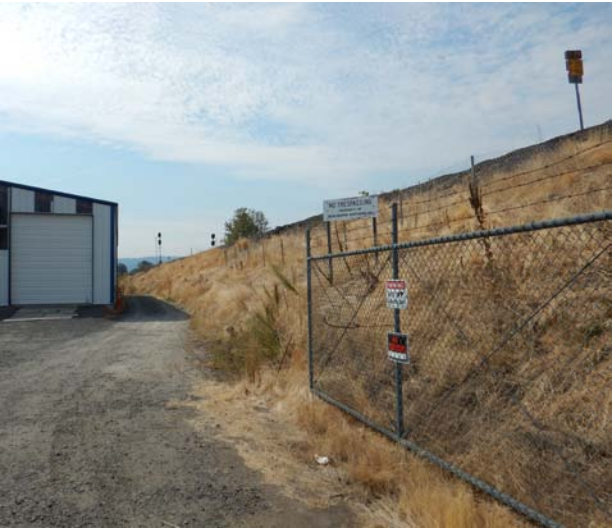
| <p>Photo No.19</p> | |

| <p>Description: On the landward side of the railroad embankment there are various private businesses. The middle to south landward toe of the railroad embankment is adjacent to the Heron Lakes Golf Club, a public course owned by Portland Parks and Recreation.</p> | |

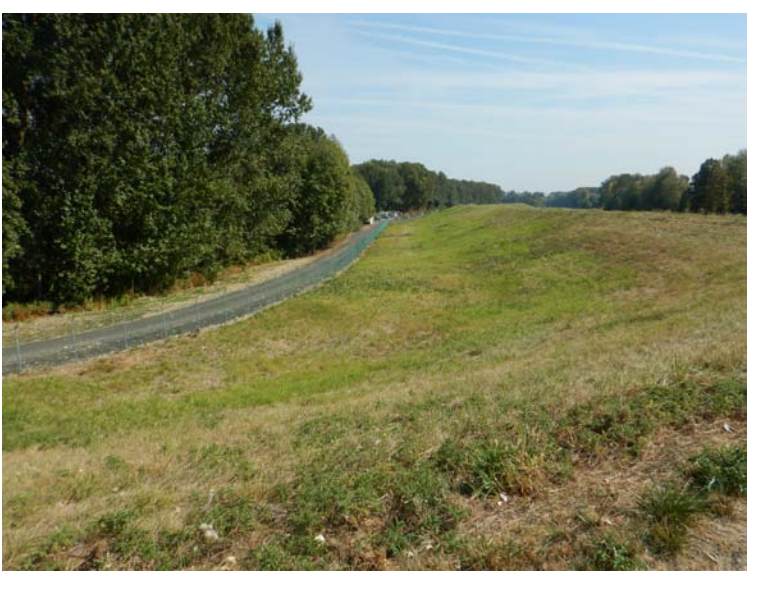
| Photo No. 23 | |

| <p>Description: The landward toe of the levee that runs along the upper Columbia Slough. The Portland International Raceway is located to the north of this levee section.</p> | |

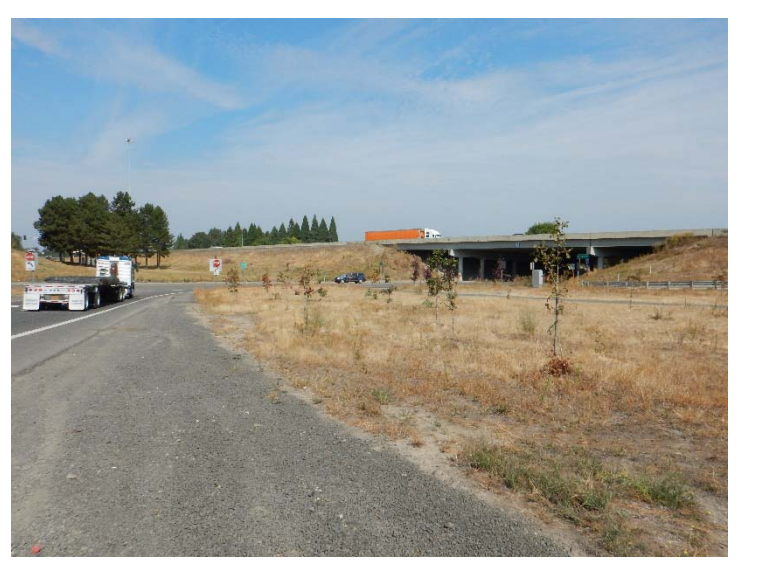
| Photo No. 24 | |

| <p>Description: The height and width of Interstate 5, the cross-levee between PEN 1 and 2, can be seen in this image.</p> | |

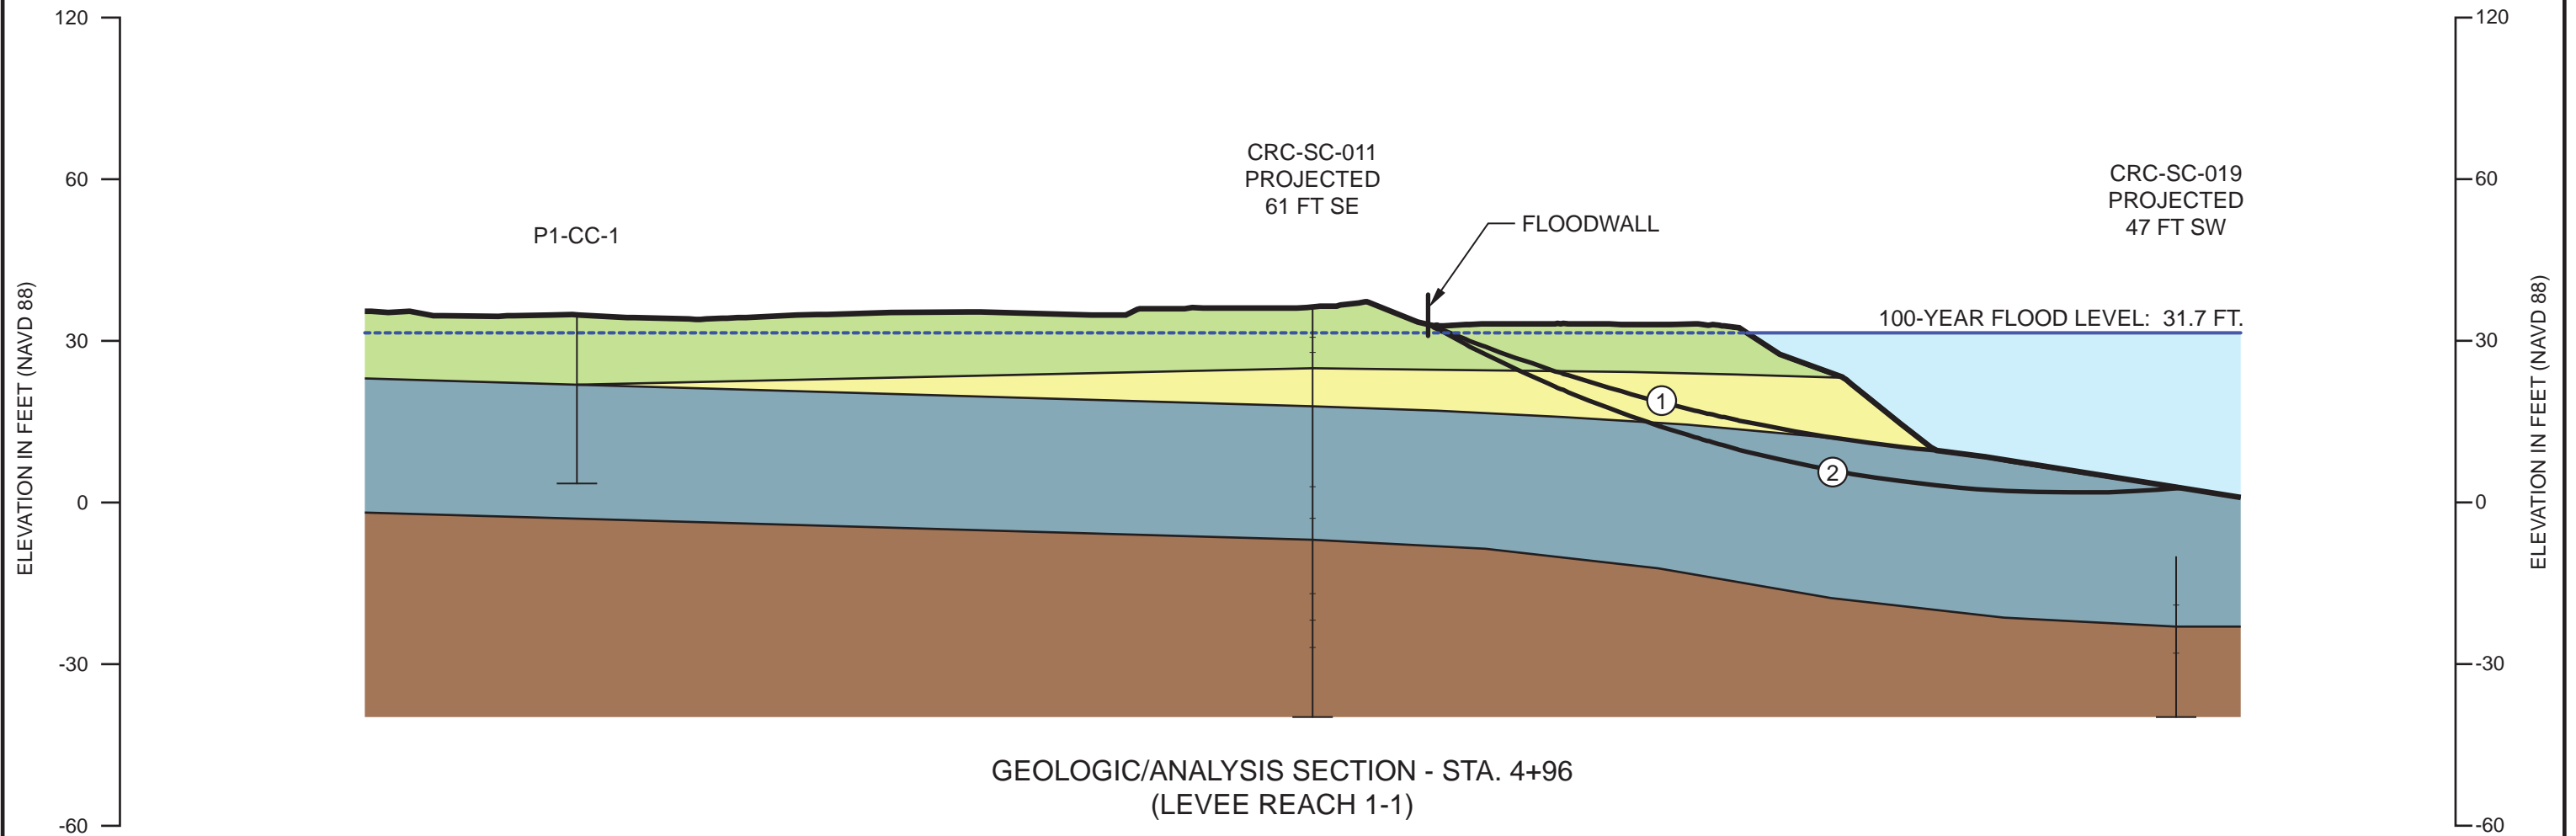
GEOLOGIC/ANALYSIS SECTION - STA. 4+96
(LEVEE REACH 1-1)

CALCULATED EXIT GRADIENT AT TOE OF LANDWARD SLOPE = 0.0**

**RECOMMENDED MAXIMUM EXIT GRADIENT = 0.5, USACE, EM 1110-2-1913

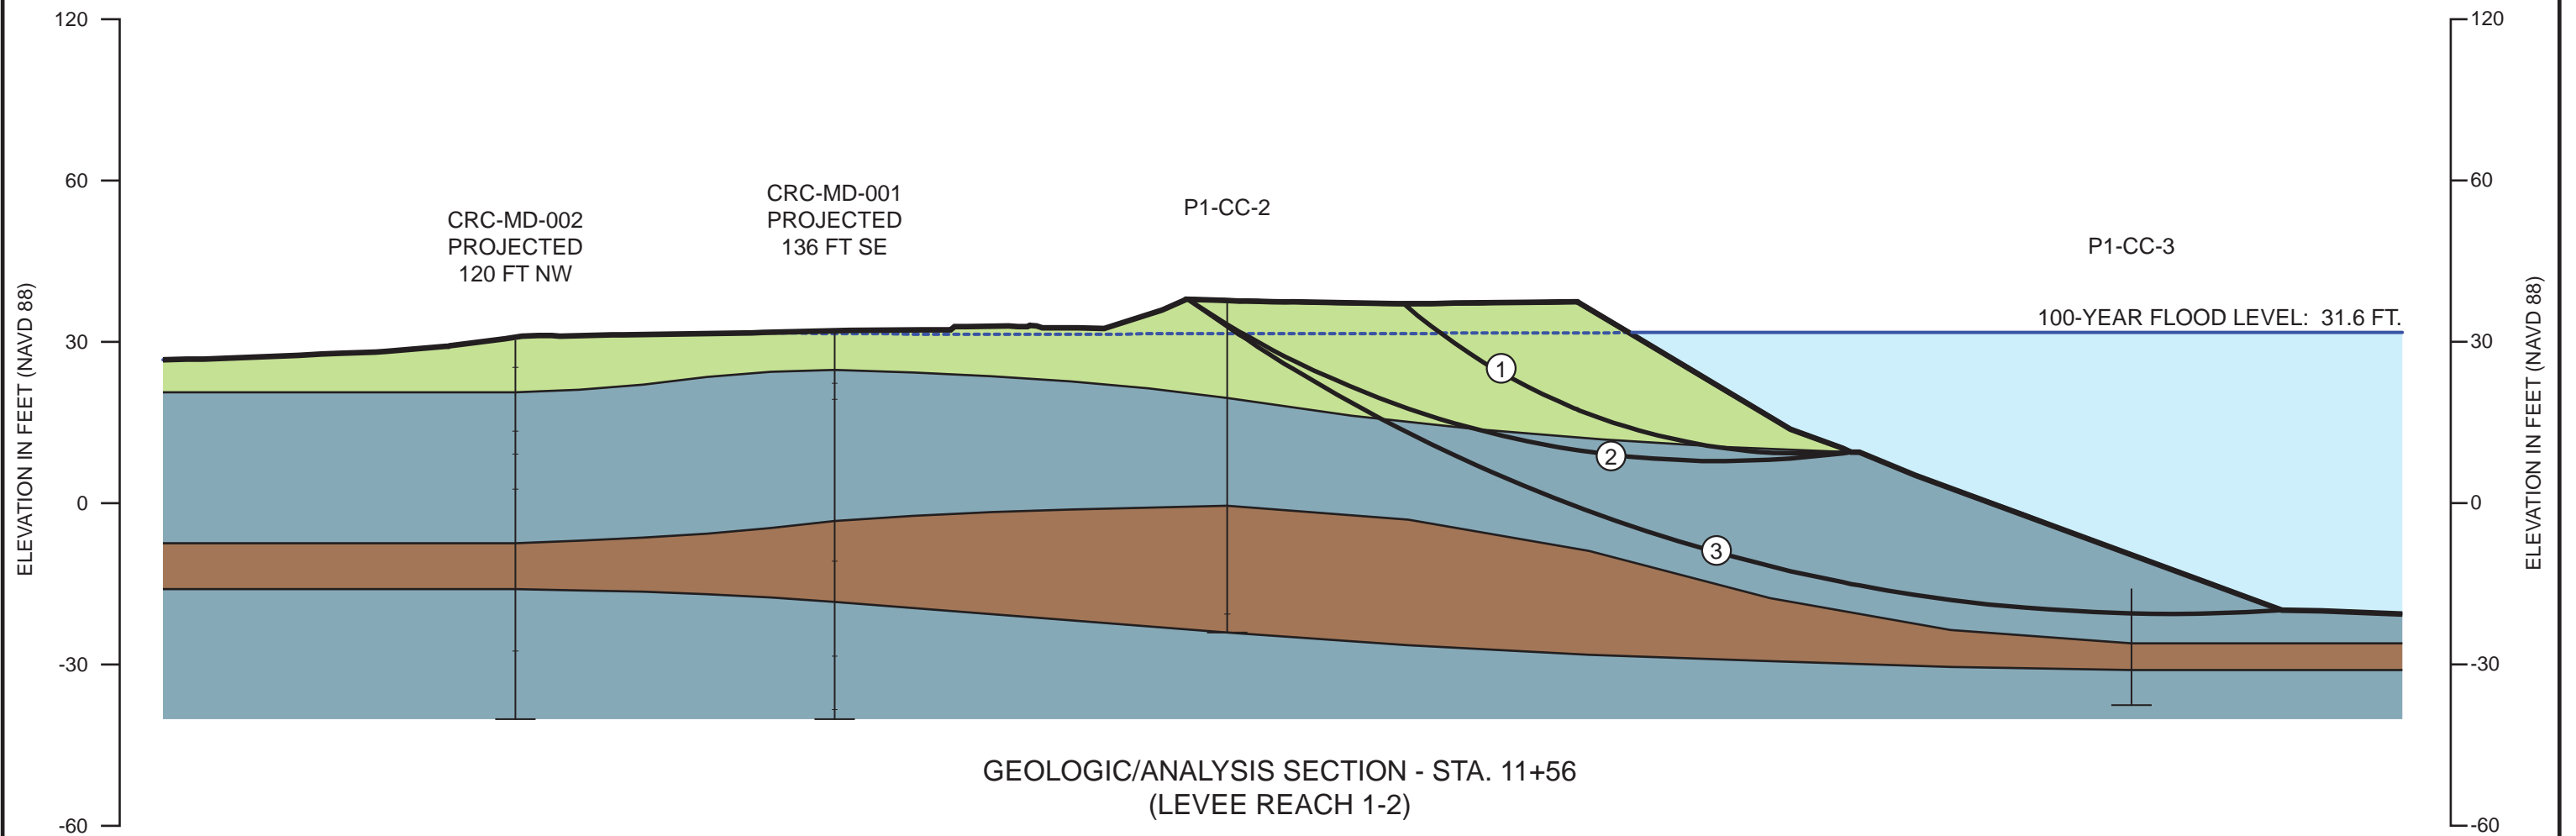
GEOLOGIC/ANALYSIS SECTION - STA. 11+56
(LEVEE REACH 1-2)

CALCULATED EXIT GRADIENT AT TOE OF LANDWARD SLOPE = 0.0**

**RECOMMENDED MAXIMUM EXIT GRADIENT = 0.5, USACE, EM 1110-2-1913

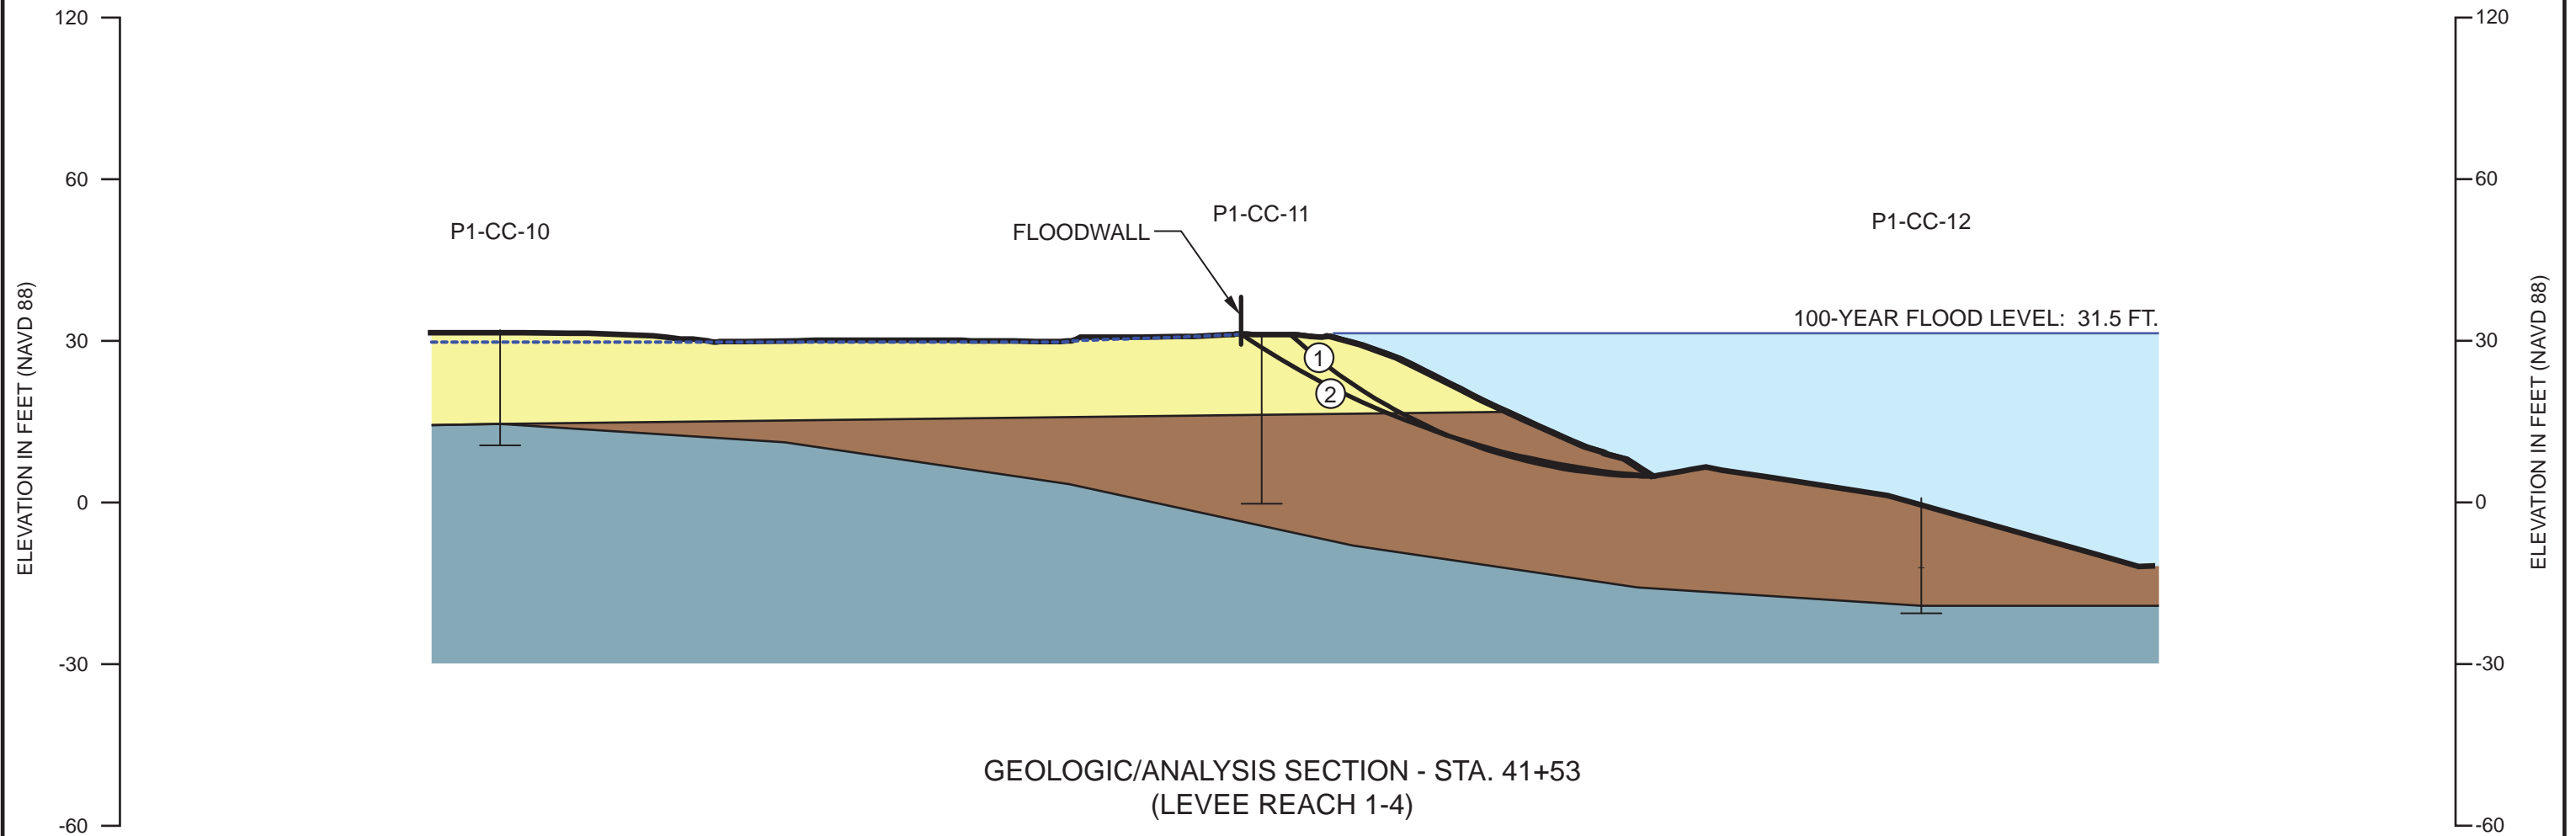
GEOLOGIC/ANALYSIS SECTION - STA. 41+53
(LEVEE REACH 1-4)

CALCULATED EXIT GRADIENT AT TOE OF LANDWARD SLOPE = 0.0**

**RECOMMENDED MAXIMUM EXIT GRADIENT = 0.5, USACE, EM 1110-2-1913

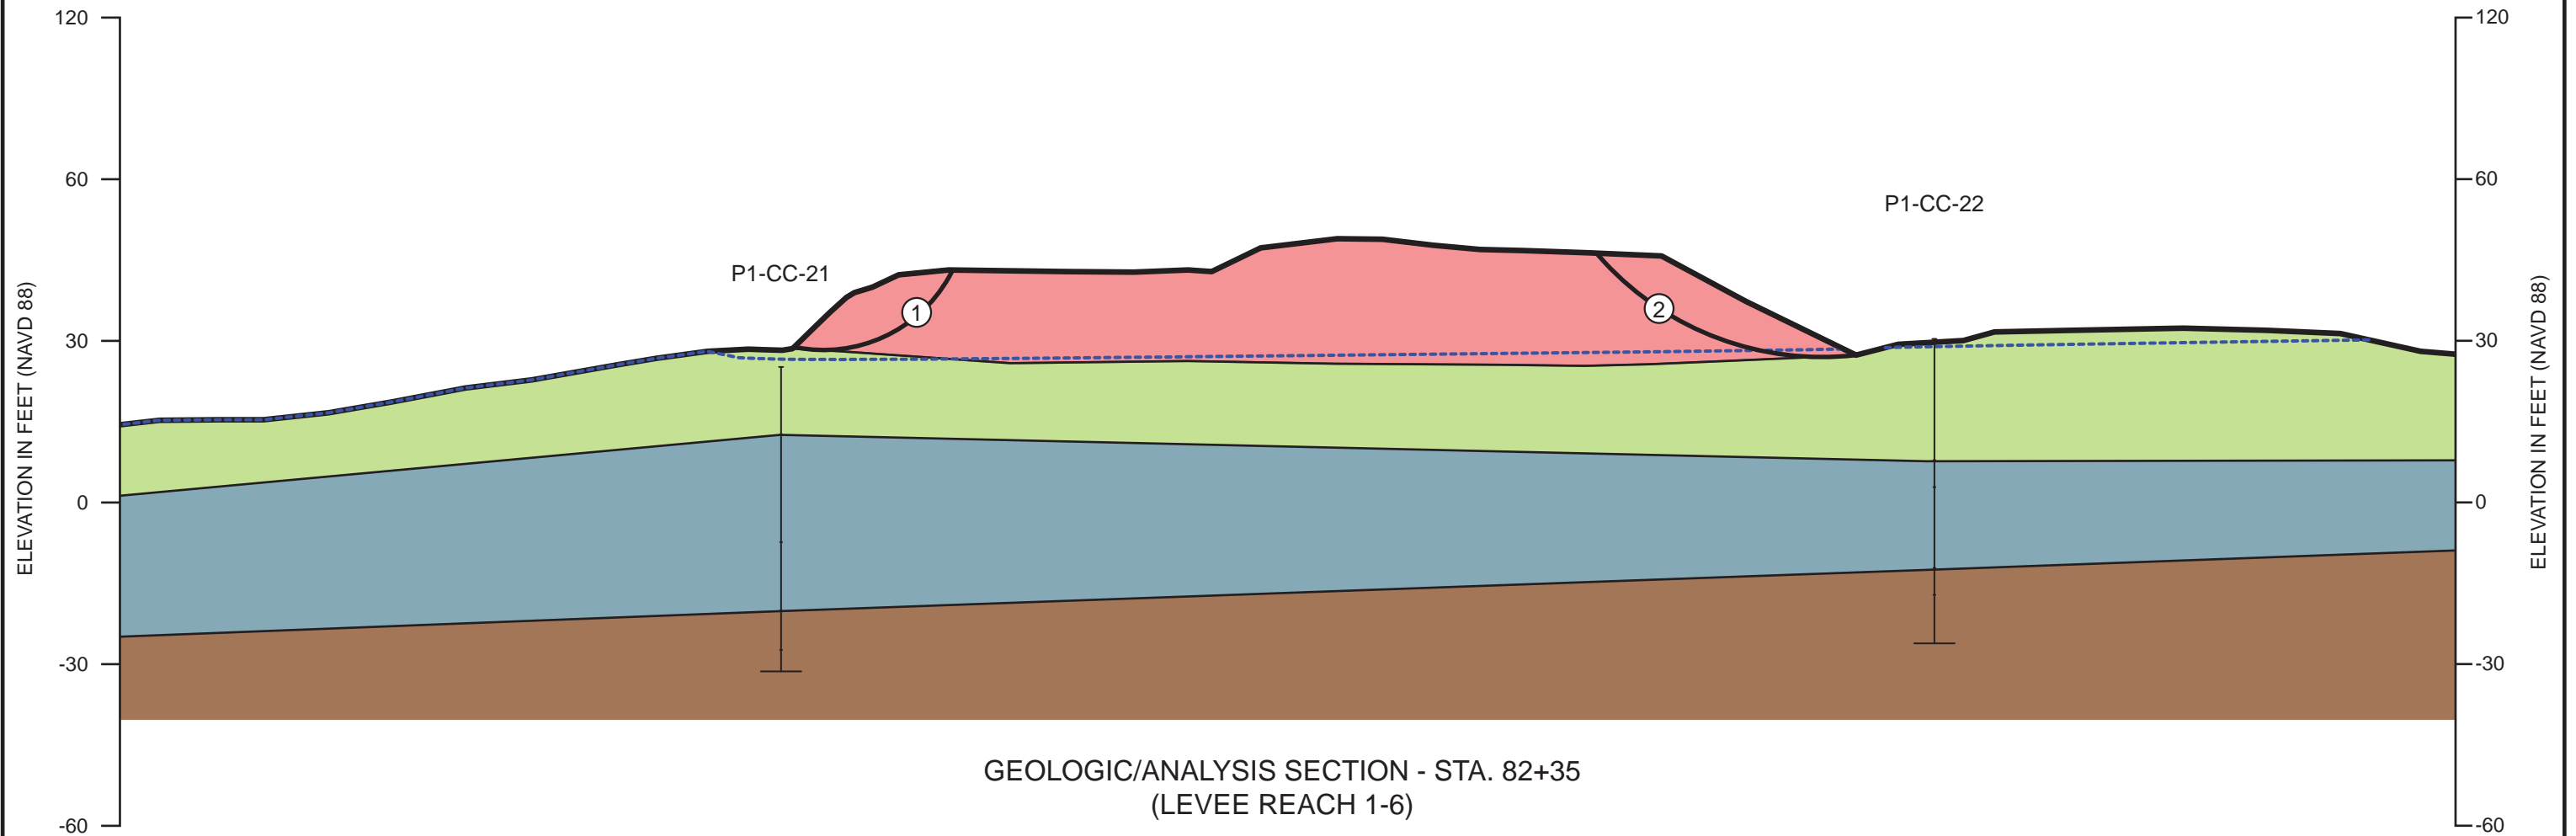
GEOLOGIC/ANALYSIS SECTION - STA. 82+35
(LEVEE REACH 1-6)

CALCULATED EXIT GRADIENT AT TOE OF LANDWARD SLOPE = 0.0**

**RECOMMENDED MAXIMUM EXIT GRADIENT = 0.5, USACE, EM 1110-2-1913

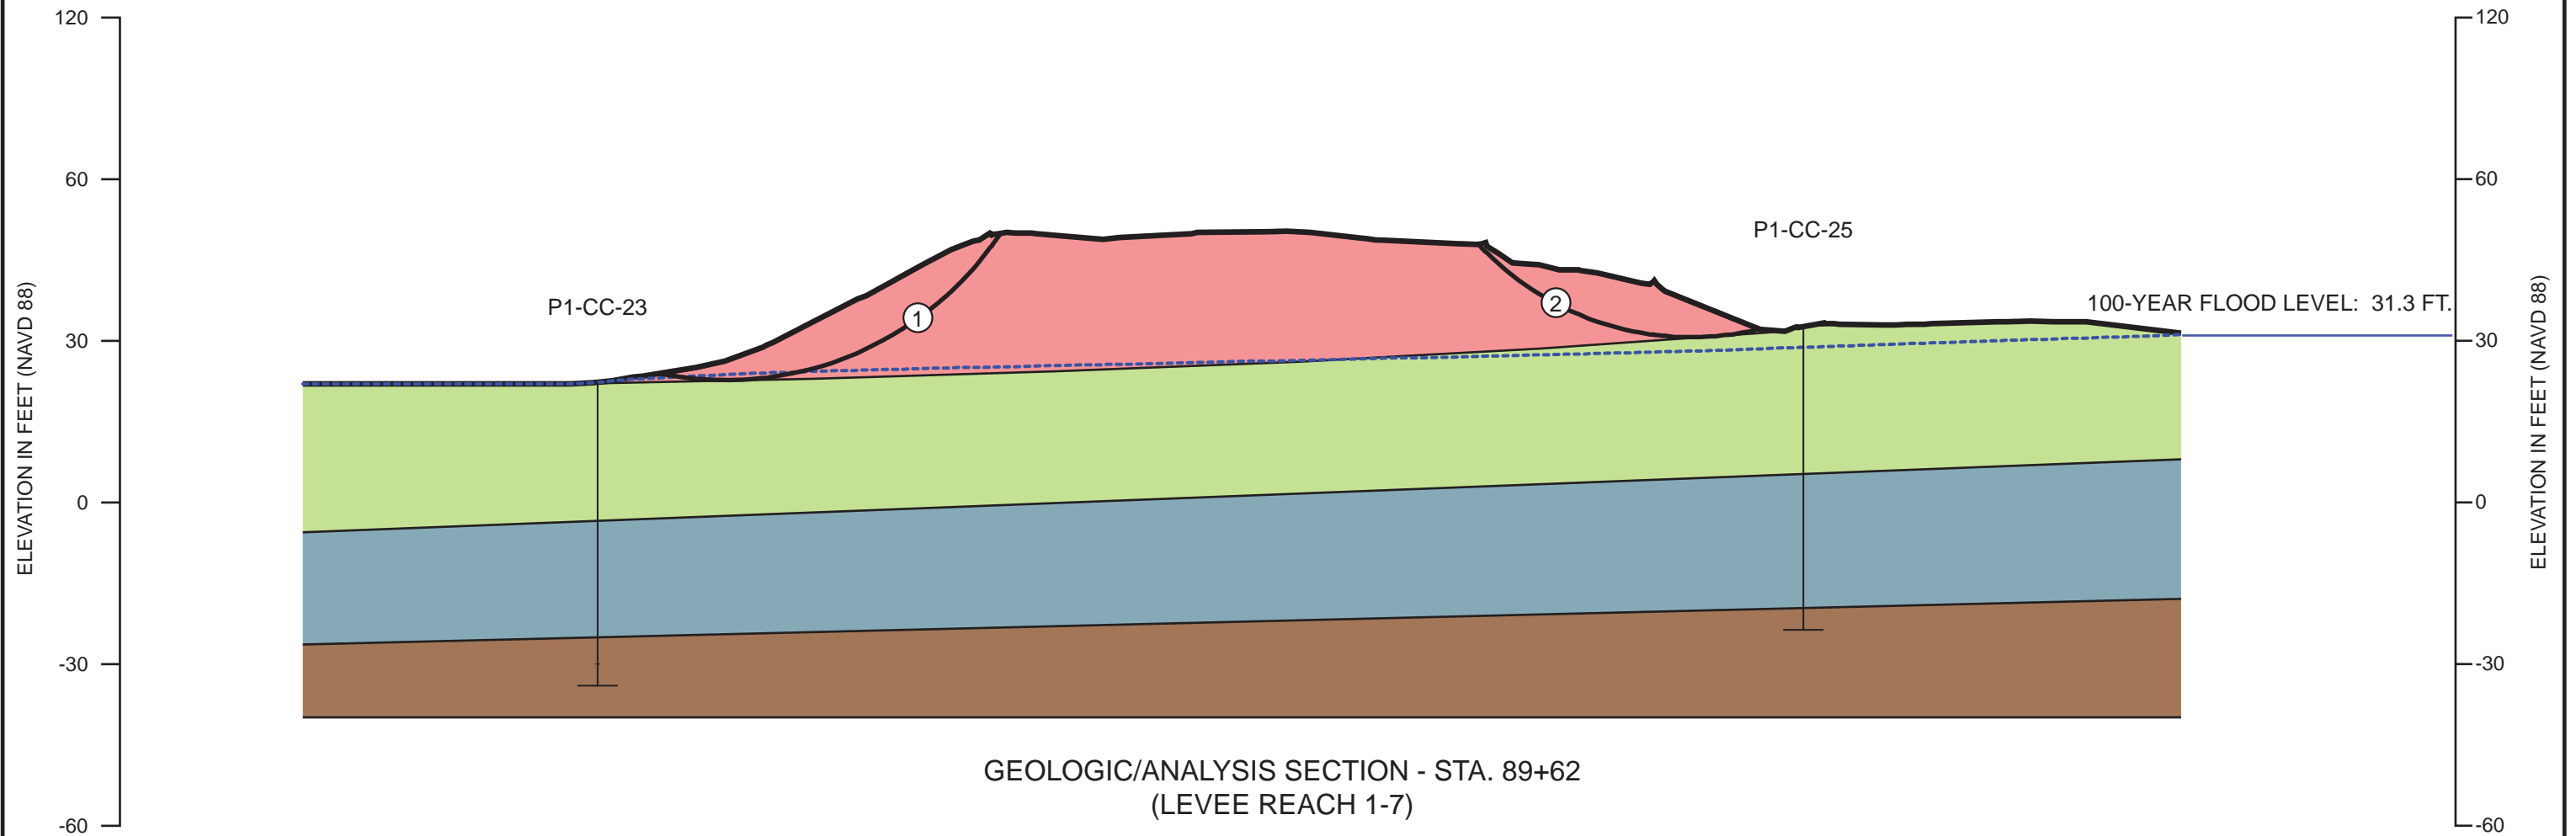
GEOLOGIC/ANALYSIS SECTION - STA. 89+62
(LEVEE REACH 1-7)

CALCULATED EXIT GRADIENT AT TOE OF LANDWARD SLOPE = 0.2**

**RECOMMENDED MAXIMUM EXIT GRADIENT = 0.5, USACE, EM 1110-2-1913

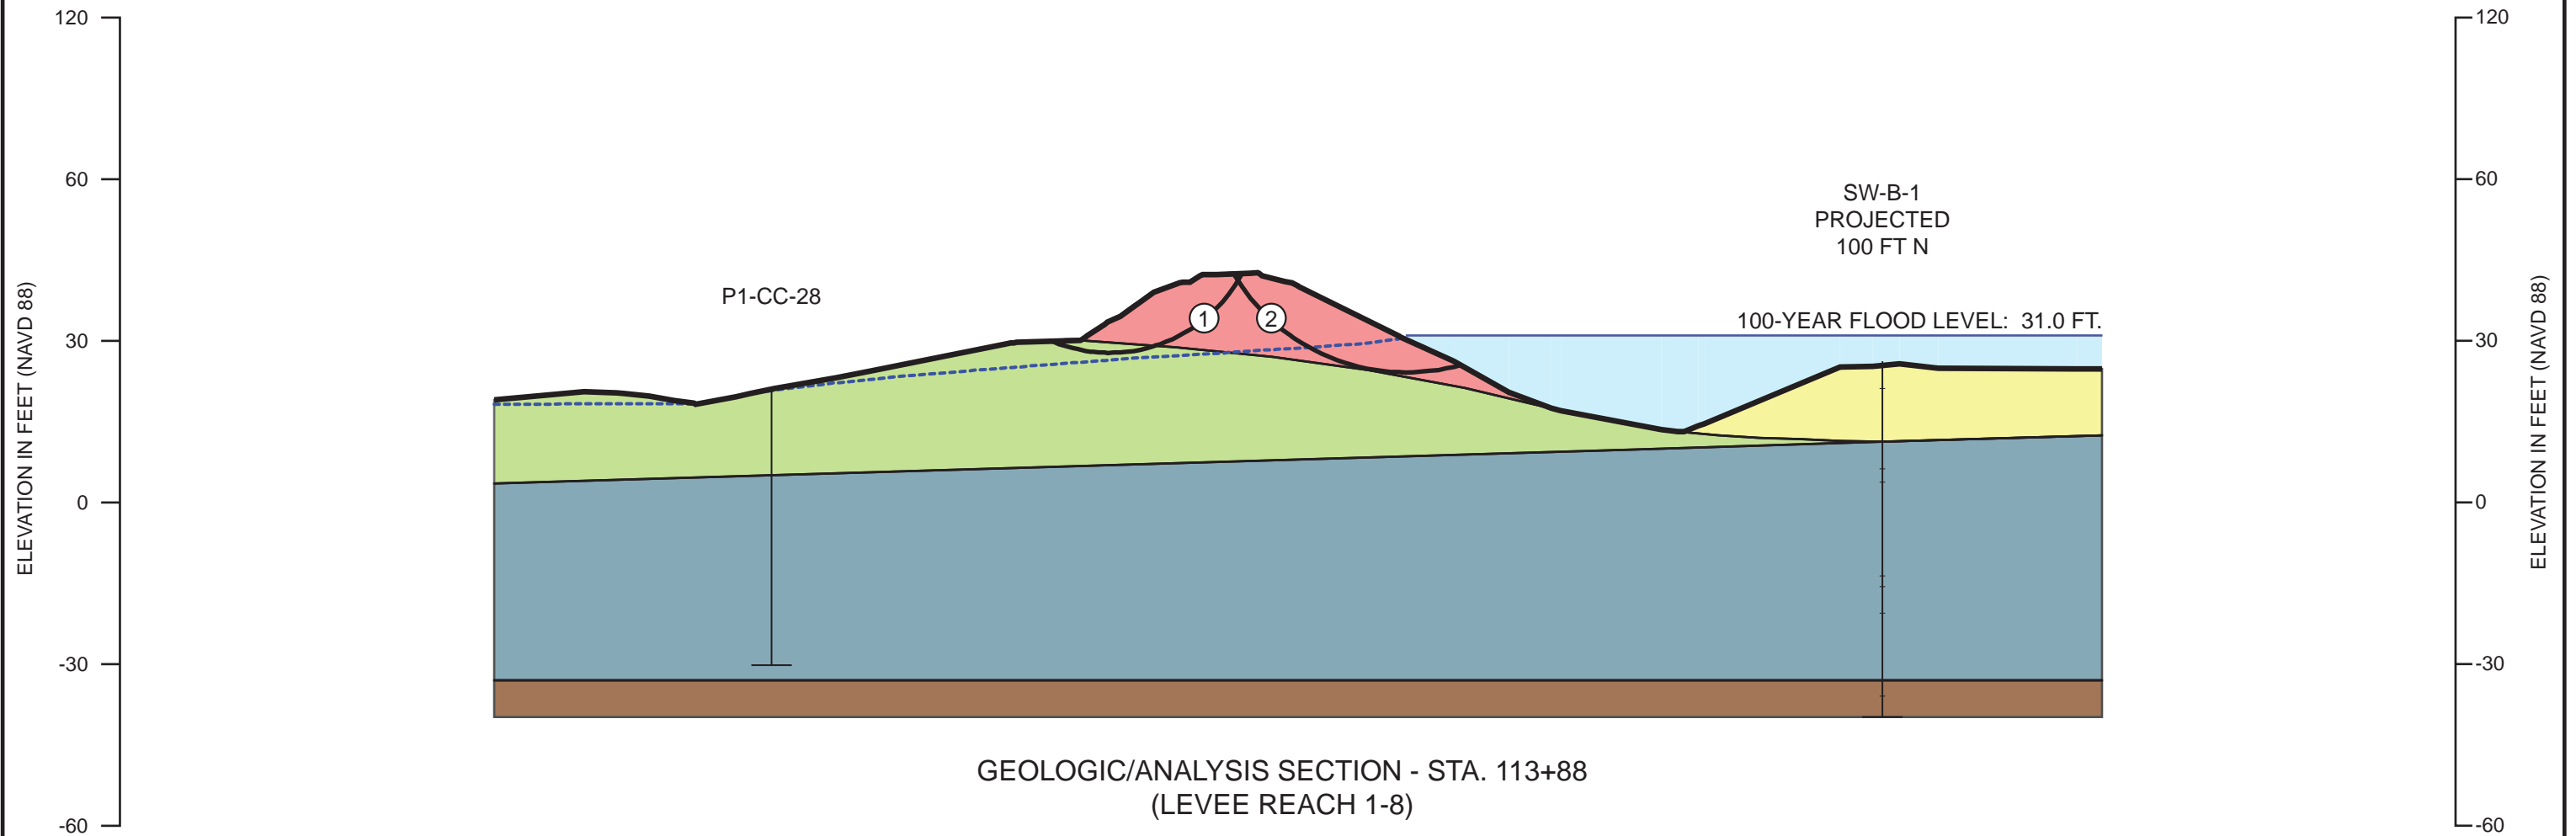
GEOLOGIC/ANALYSIS SECTION - STA. 113+88
(LEVEE REACH 1-8)

CALCULATED EXIT GRADIENT AT TOE OF LANDWARD SLOPE = 0.0**

**RECOMMENDED MAXIMUM EXIT GRADIENT = 0.5, USACE, EM 1110-2-1913
