Peninsula Drainage District No. 1 Levee Engineering Assessment Portland, Oregon

**PENINSULA DRAINAGE DISTRICT NO. 1
LEVEE ENGINEERING ASSESSMENT**

October 2, 2014

Cornforth Consultants, Inc
10250 SW Greenburg Road, Suite 111
Portland, Oregon 97223

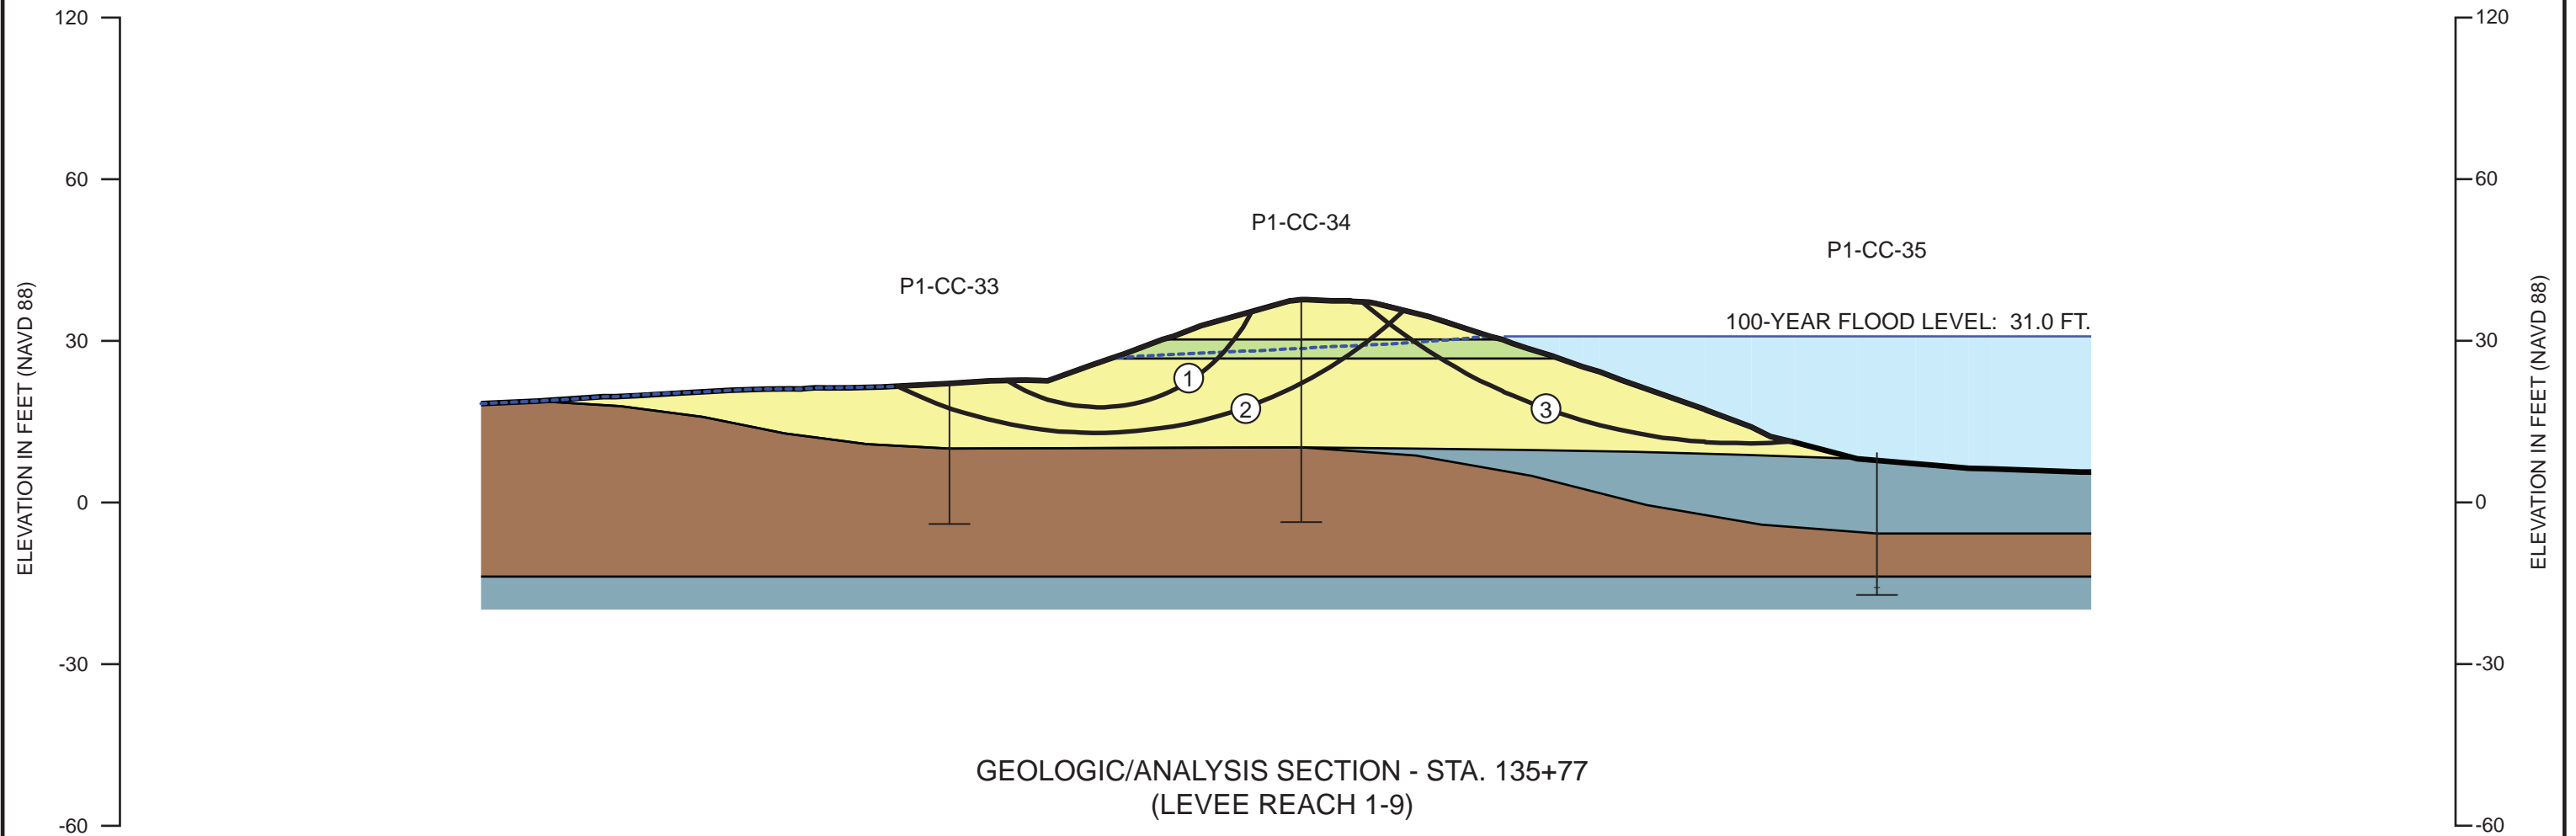
GEOLOGIC/ANALYSIS SECTION - STA. 135+77
(LEVEE REACH 1-9)

CALCULATED EXIT GRADIENT AT TOE OF LANDWARD SLOPE = 0.0**

**RECOMMENDED MAXIMUM EXIT GRADIENT = 0.5, USACE, EM 1110-2-1913

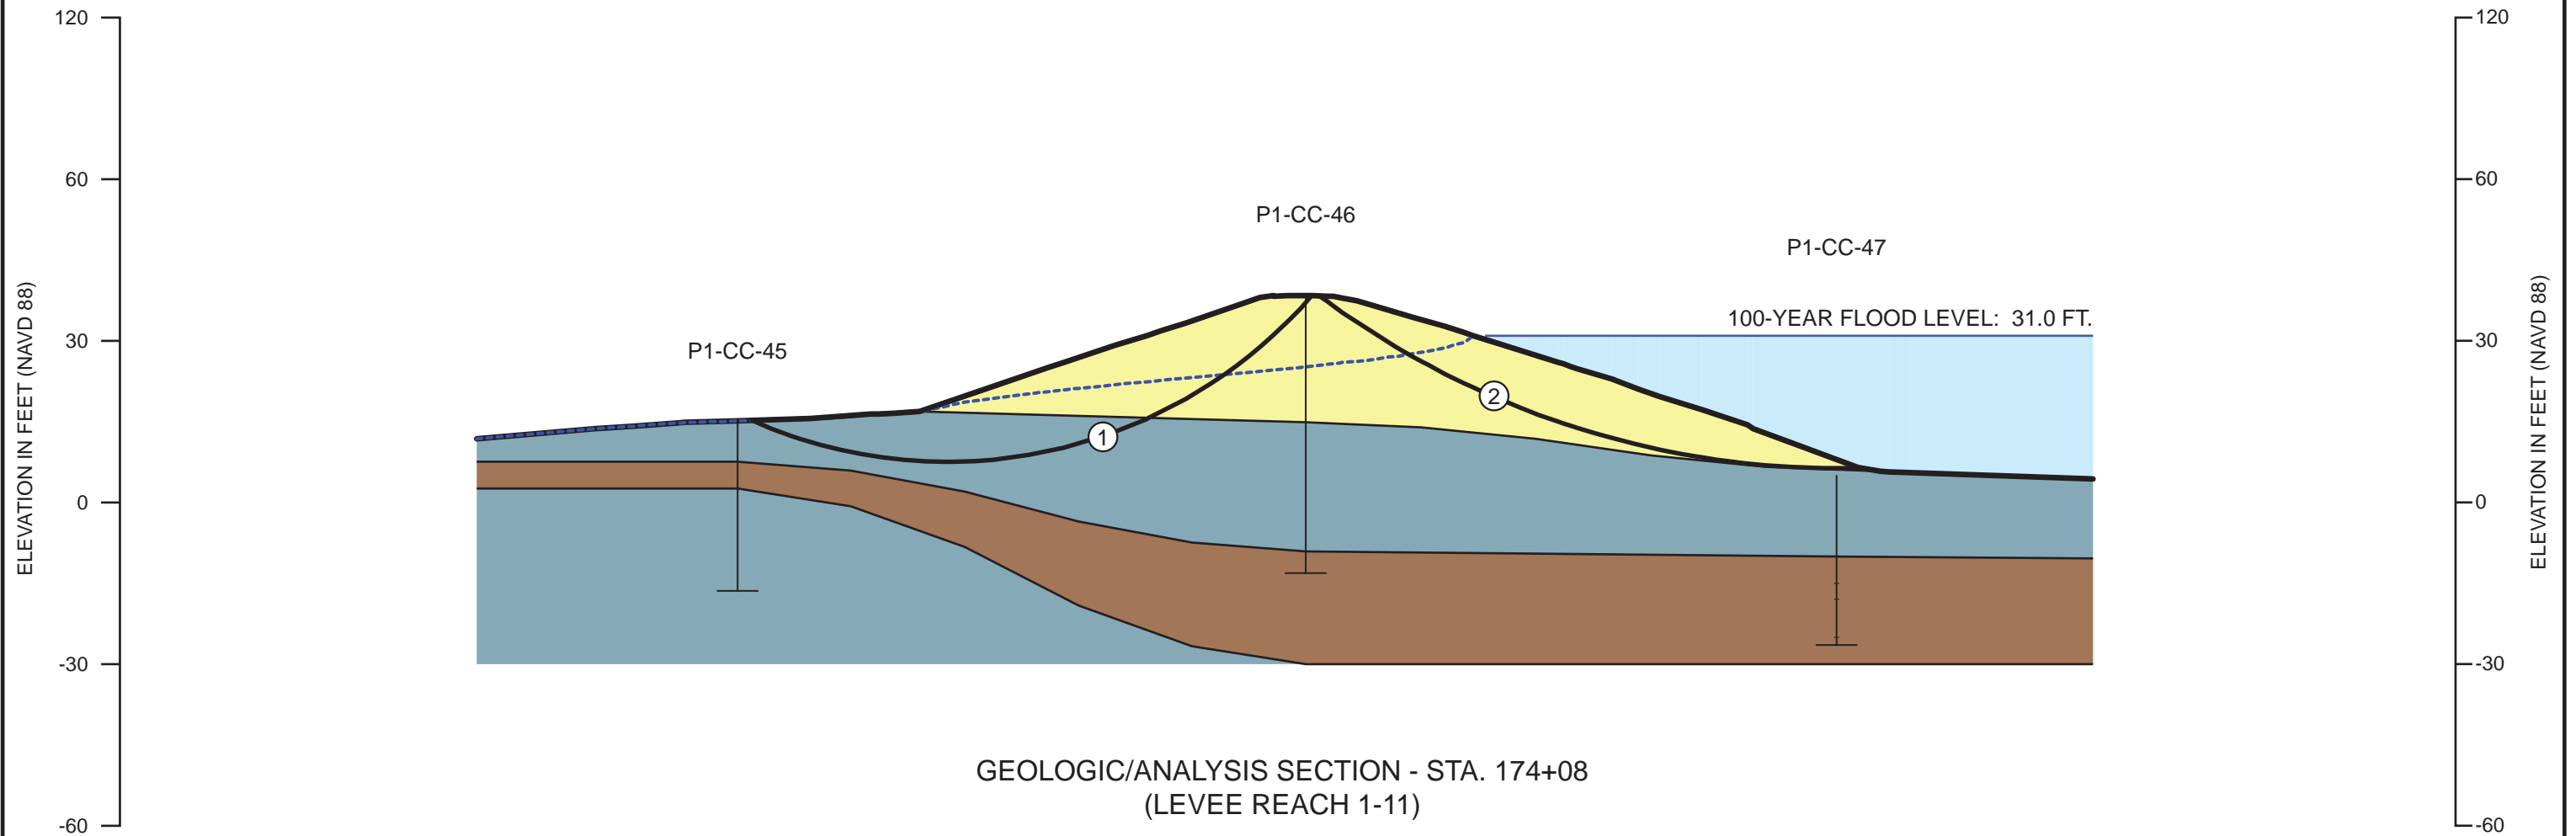
GEOLOGIC/ANALYSIS SECTION - STA. 174+08
(LEVEE REACH 1-11)

CALCULATED EXIT GRADIENT AT TOE OF LANDWARD SLOPE = 0.3**

**RECOMMENDED MAXIMUM EXIT GRADIENT = 0.5, USACE, EM 1110-2-1913

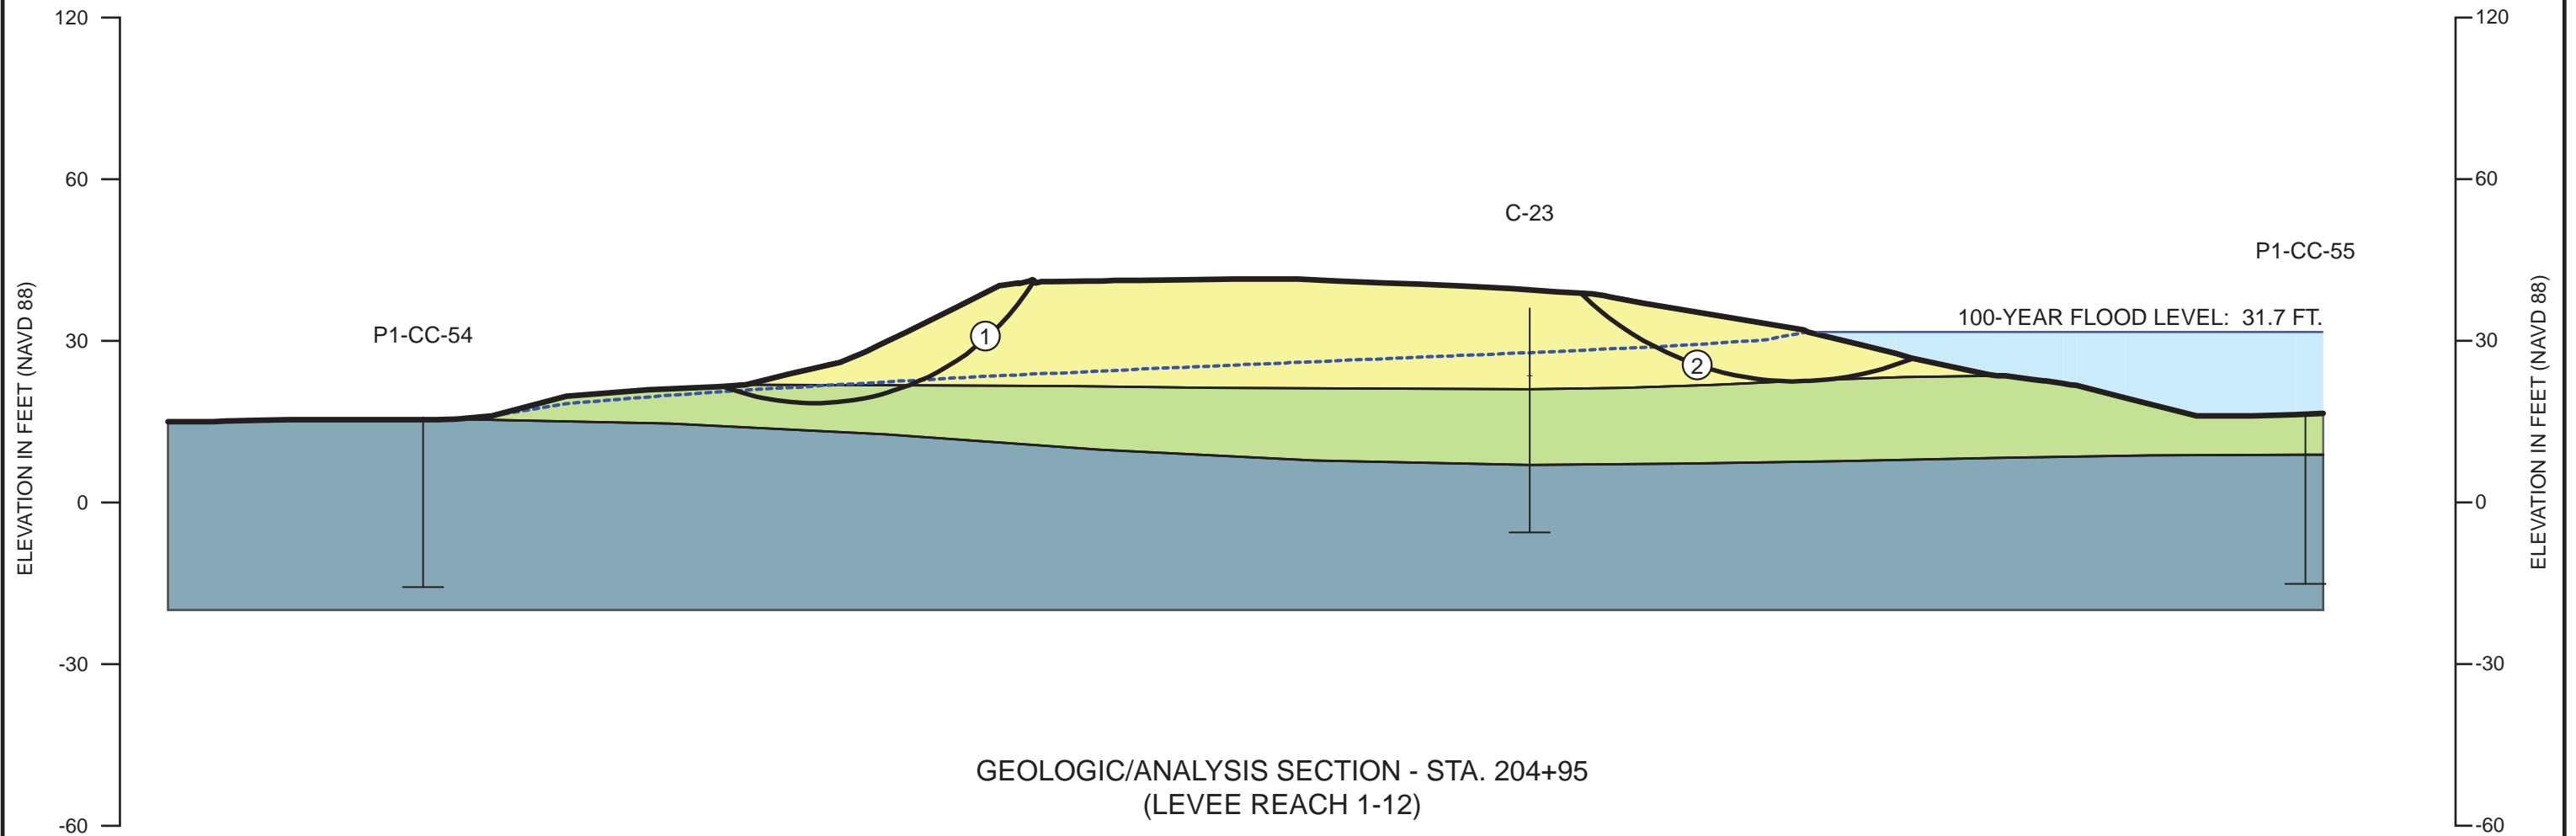
GEOLOGIC/ANALYSIS SECTION - STA. 204+95
(LEVEE REACH 1-12)

CALCULATED EXIT GRADIENT AT TOE OF LANDWARD SLOPE = 0.2**

**RECOMMENDED MAXIMUM EXIT GRADIENT = 0.5, USACE, EM 1110-2-1913

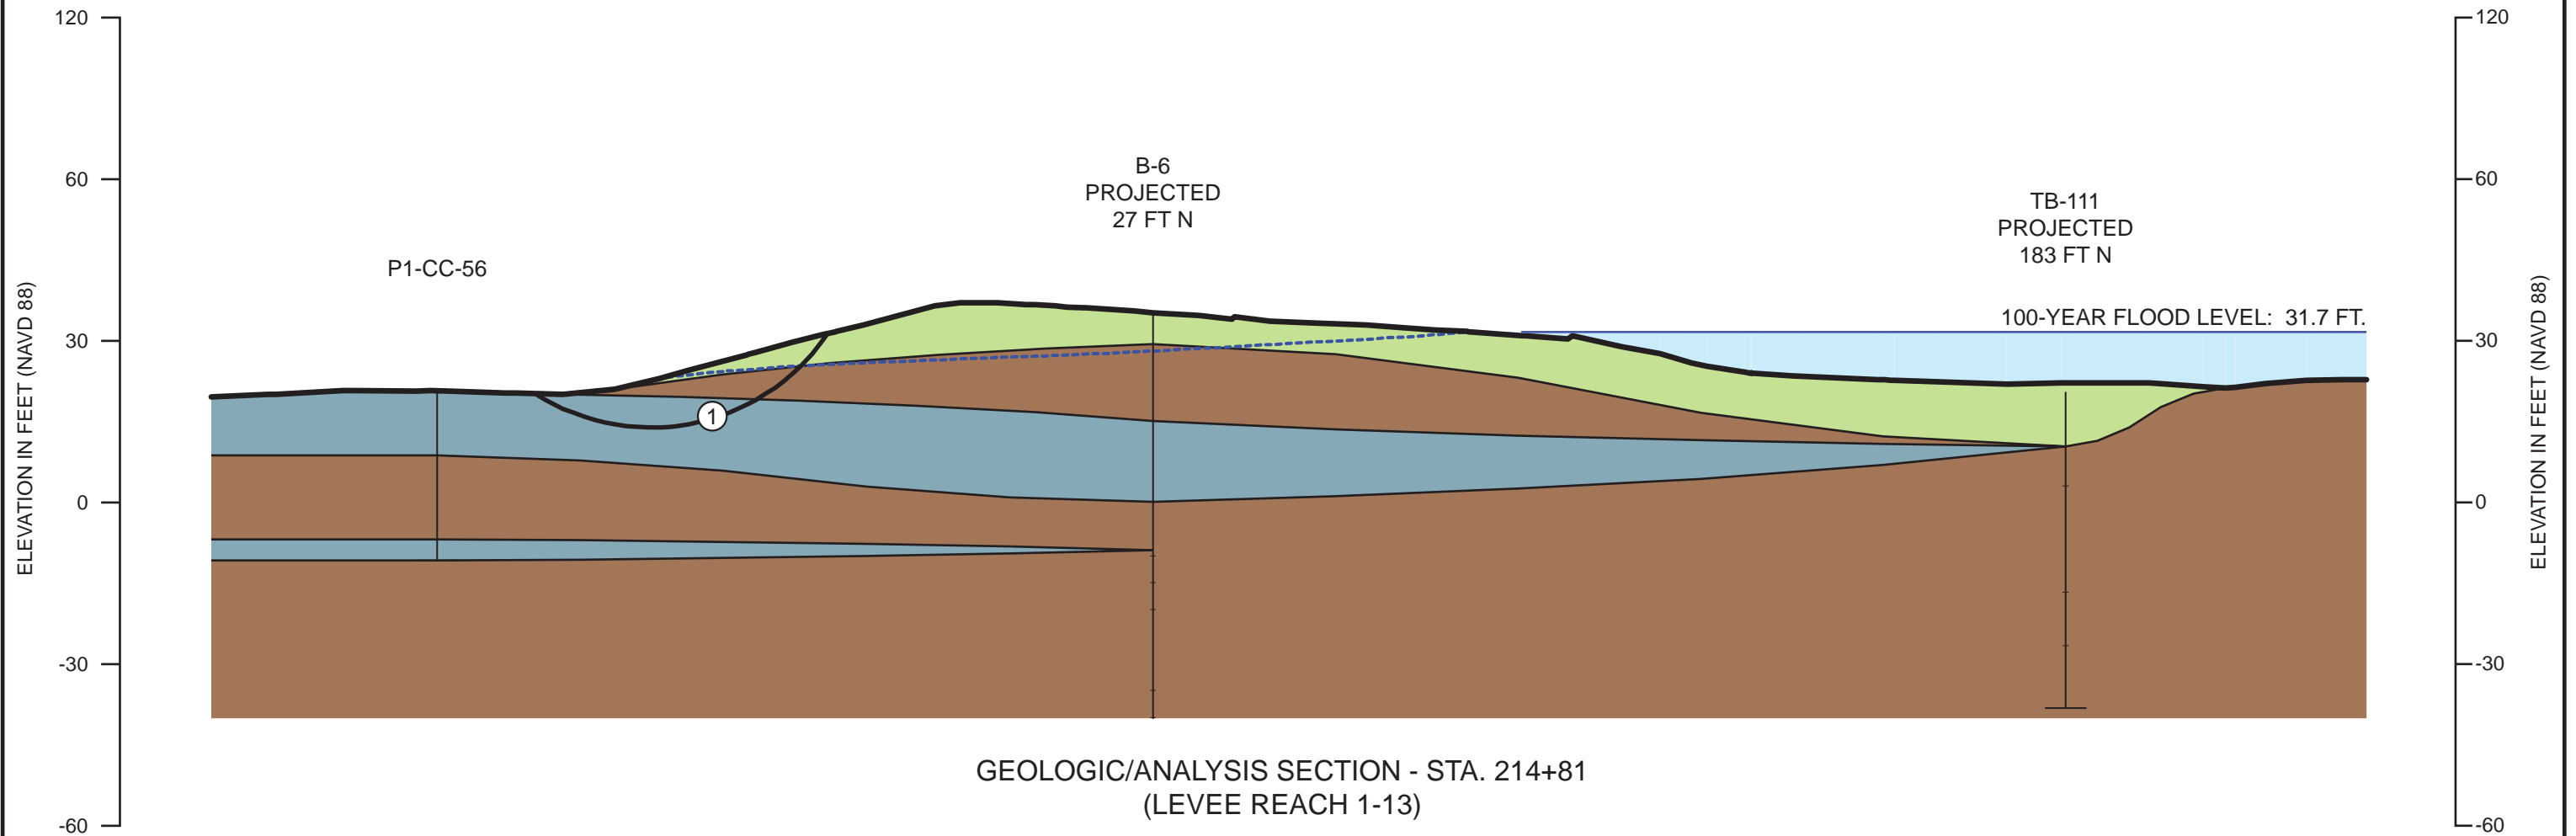
GEOLOGIC/ANALYSIS SECTION - STA. 214+81
(LEVEE REACH 1-13)

CALCULATED EXIT GRADIENT AT TOE OF LANDWARD SLOPE = 0.2**

**RECOMMENDED MAXIMUM EXIT GRADIENT = 0.5, USACE, EM 1110-2-1913

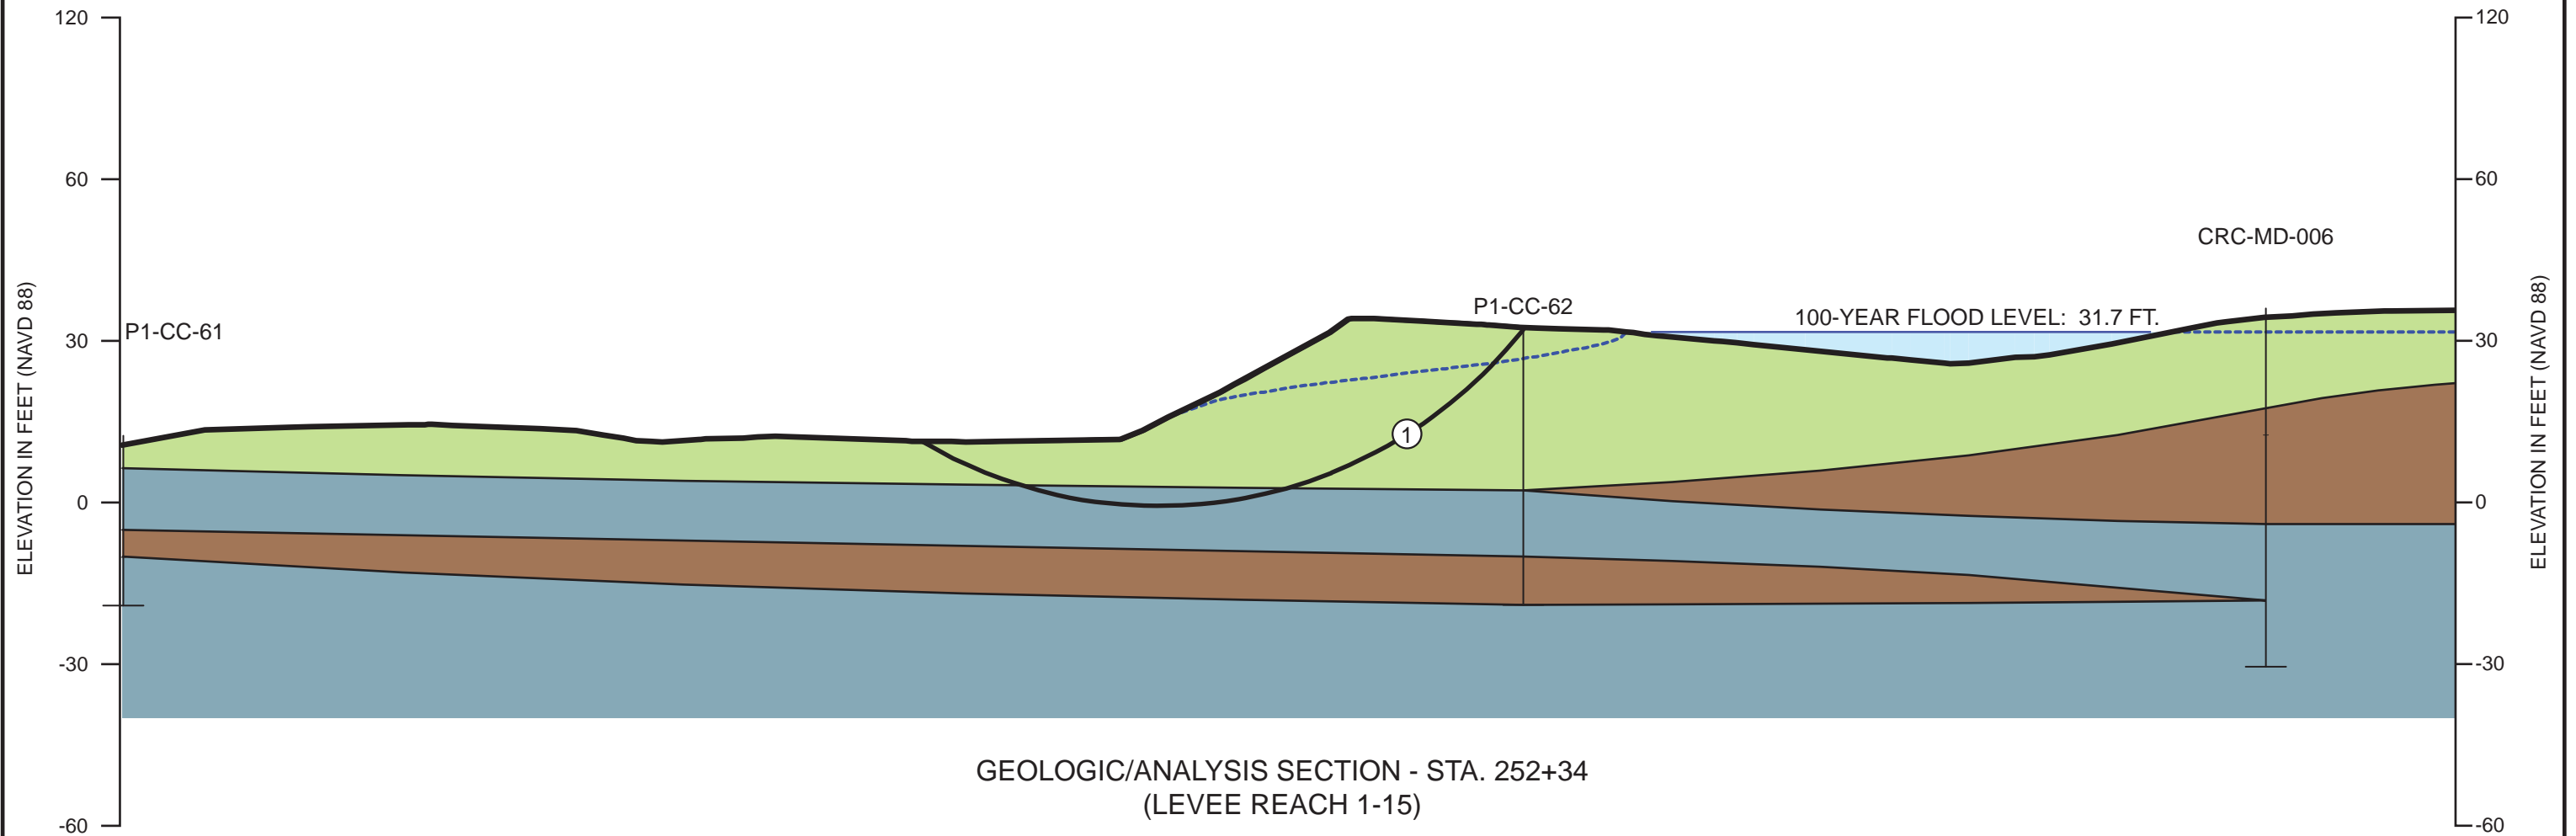
GEOLOGIC/ANALYSIS SECTION - STA. 252+34
(LEVEE REACH 1-15)

CALCULATED EXIT GRADIENT AT TOE OF LANDWARD SLOPE = 0.5**

**RECOMMENDED MAXIMUM EXIT GRADIENT = 0.5, USACE, EM 1110-2-1913

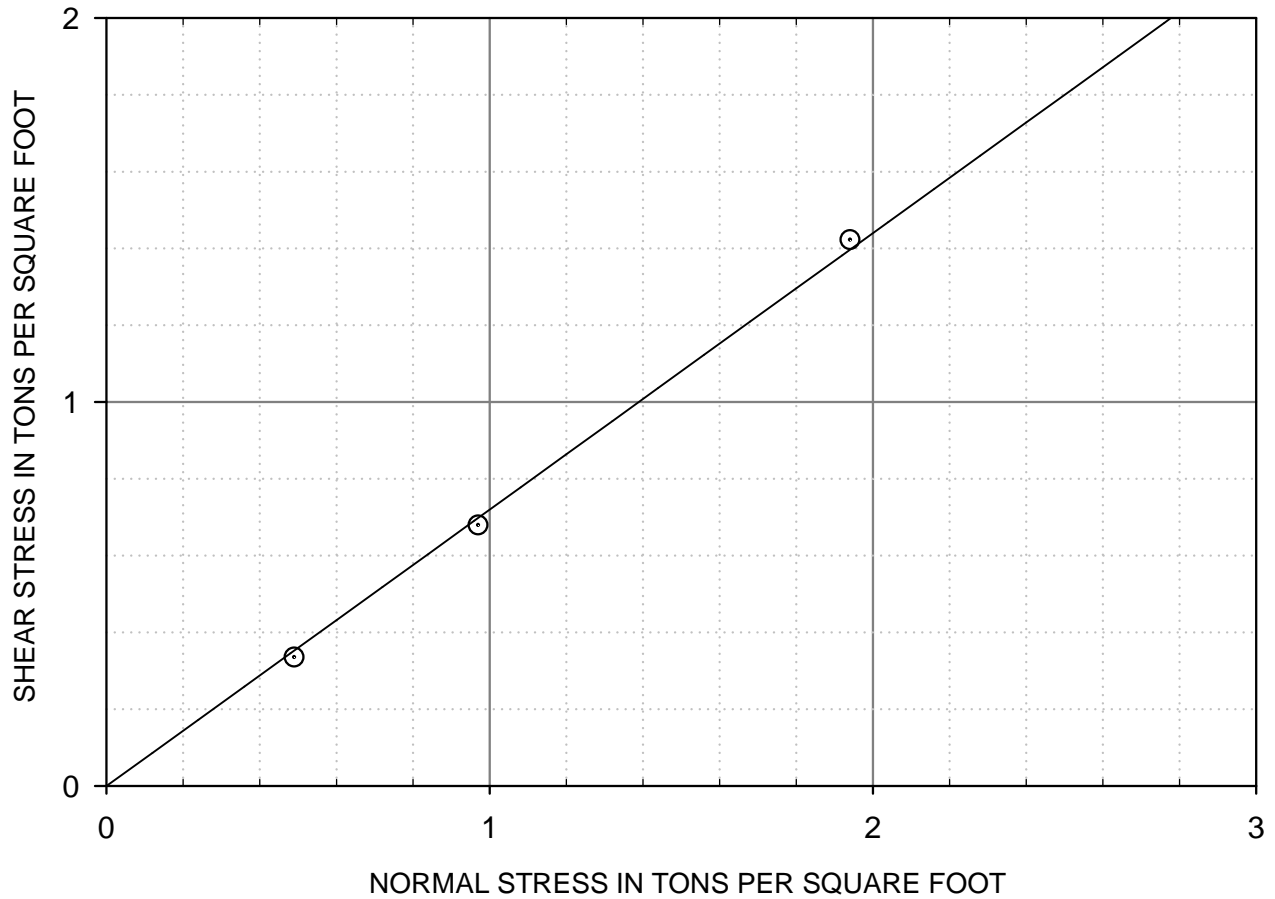
FIG. **C19**

Boring No. P1-CC-11 Sample No. S-3 Depth of Sample 14 to 14.3 ft.

Soil Description: VERY LOOSE, brown, silty FINE SAND; numerous mica, moist (FILL)
