**Subject: Final Submittal, Willamette Falls Locks Engineering Study
Large Scale Capital Costs**

Name of Project: Willamette Falls Locks Engineering Study
INCA Job No.: 07-013

Willamette Falls Lock Engineering Study
Large Scale Capital Costs
Final Submittal

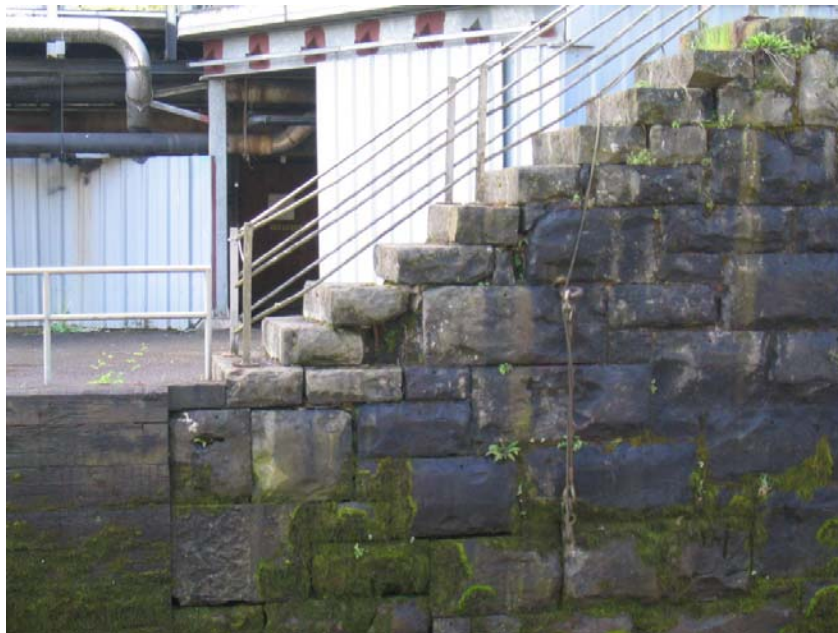
Photo 3-17 **Riverside Wall - Chamber 3**

One of the signature features of the Willamette Falls Locks is the ashlar masonry gate monoliths and chamber walls. The masonry, made from locally quarried stones, was placed without mortar. In a number of places, the surface stones have become displaced. We did not note any locations where two adjacent stones have become displaced, an indication of imminent failure. All missing stones appeared to be individual occurrences. A portion of these instances are shown below.
