Willamette Falls Canal and Locks

Independent Condition Assessment and Recommendations for Recommissioning

Prepared for:
Willamette Falls Locks Commission (WFLC)

October 10th 2018

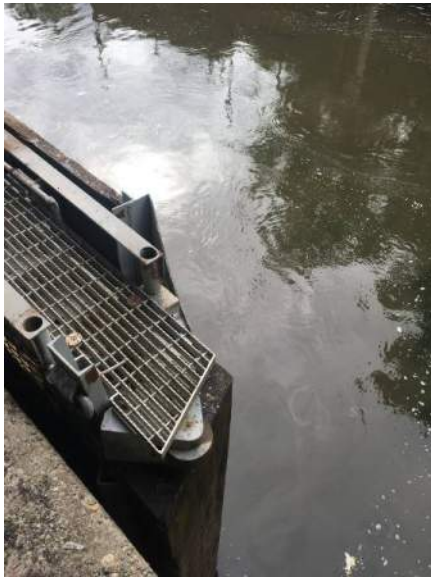
anchorage that utilizes short anchor rods installed in keyed slots in the lock wall. See Photo #3 for the roller arrangement, Photo #4 for the quoin block and Photo #6 for the gudgeon anchorage.

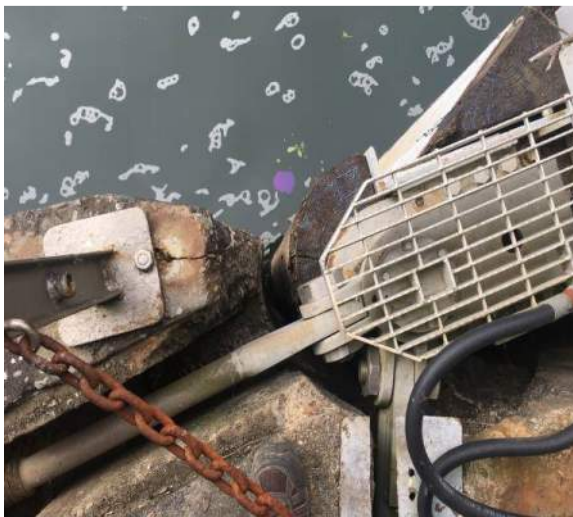
The gate's gudgeon anchorage system functioned as designed. With the gate closed, each gate leaf was firmly seated between the miter and quoin blocks and the gudgeon anchors appeared to be unloaded. As soon as the gates started to open, a gap opened between the quoin post and the quoin block, transferring the gate's dead weight to the gudgeon anchor bars. (See Photo #5 and #6 for typical condition.)

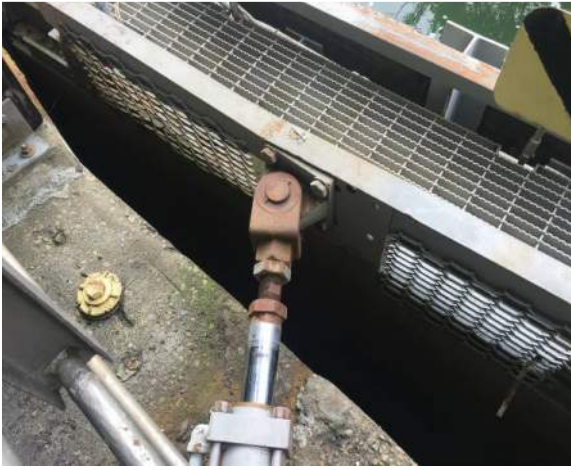
Photo #7

The gate hydraulic operating cylinders appear to be National Fluid Power Association (NFPA) standard tie rod type industrial cylinders. The cylinders are connected to the gate via standard clevis and a short threaded rod with lock nuts. This arrangement allows the length of the cylinder to be adjusted to fine tune the location of the gate in the open position. Based on the cylinder's paint system and the use of threaded piping for the rod and blind end fluid connection, these cylinders were likely installed prior to 1970. Although some surface rust is apparent on the rod end connections and cylinder bodies, the cylinders are in relatively good condition and should provide reliable service if the system is put back in operation. That being said, these cylinders are well past the typical service life that would be expected and should be replaced or fully refurbished in the near future. This situation will be exacerbated by the current "care-taker" status of the facility, which dramatically limits the number of gate operations (cylinder extend/retract cycles) seen by each cylinder. (See Photos #7 and #8 for typical cylinder condition.)

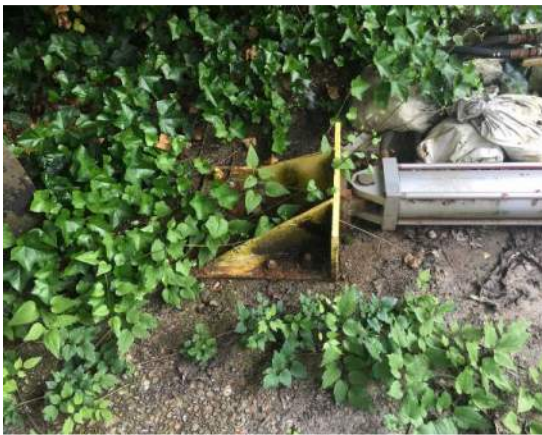
Photo #9

On the lock wall, the miter gate cylinders are attached to steel brackets installed directly onto native stone. The steel brackets appear to be in good condition, solid and well anchored. (See Photo #9)

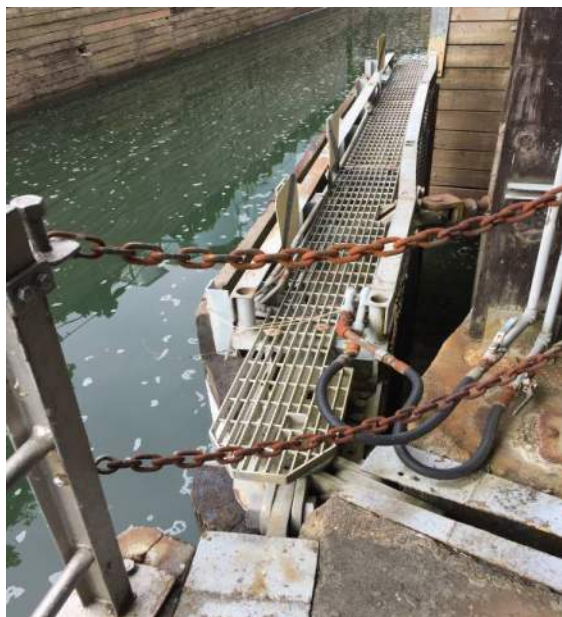
Photo #12

This lock was created by cutting into the native rock, with the side walls comprised of timber facing in front of the native rock. This lock is bound by Miter Gate 1 on the downstream side and Miter Gate 2 on the upstream side. Gate 1 is kept in an open position, and Gate 2 is kept in a closed position. Total design lift on this lock is 20.5 feet. See photo #1 for an overall view of Lock 1 and photo #2 for Miter Gate 1 in the closed position. See photos #12 & #13 for close ups of Gate 1 in the open and closed positions.

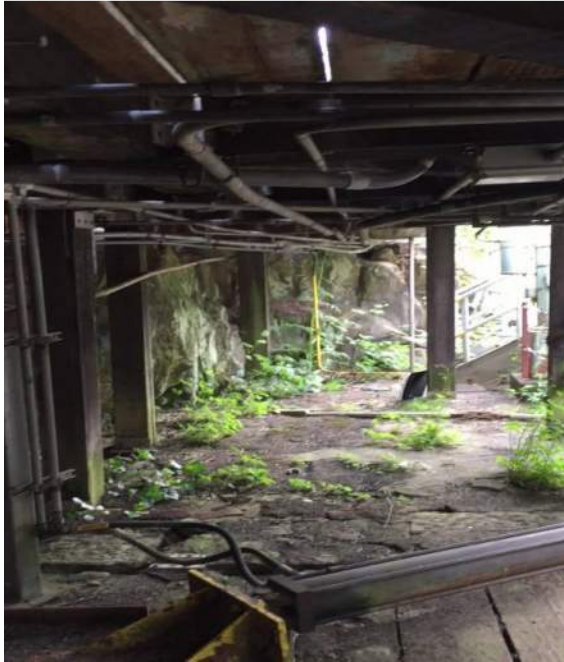
Photo #14

Generally the anchor rods parallel to the lock chamber appear to be anchored to the lock wall and are readily accessible. The Corps has noted concern about the condition of the anchor rods used by the lateral gudgeon bars. Large portions of these anchor rods are not visible and cannot be visually assessed. To address this concern, two options may be undertaken. One would be to excavate around the anchor, where there is access, to the point at which the anchor is embedded in concrete (and should be corrosion free within the grout surrounding the anchor); or Two would be to perform a tension pull test on the anchor to verify its capacity. A third potential option would be to abandon the anchor completely and provide a new drilled in anchor with a known capacity. Note that access to the gudgeon anchors on the Corps side of the lock is difficult due to an existing framework of utilities supported by a timber boardwalk. See Photo #14.
