Peninsula Drainage District No. 2

Levee Engineering Assessment

**PENINSULA DRAINAGE DISTRICT NO. 2
LEVEE ENGINEERING ASSESSMENT**

October 2, 2014

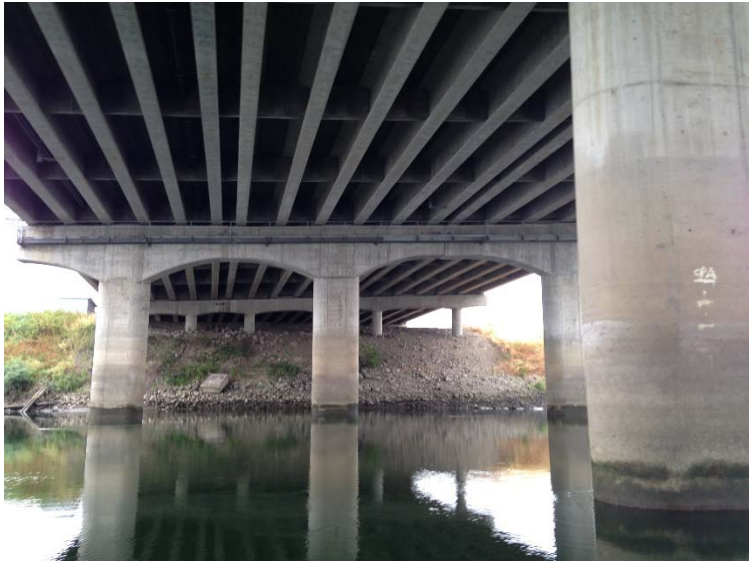
Photo No. 1

Photo Date: 9/18/2014	
Orientation: South	
<p>Description: Interstate 5 functions as the cross-levee between PEN 1 and 2. There is a flood wall on the landward side of the levee adjacent to the Oregon Slough at this location.</p>

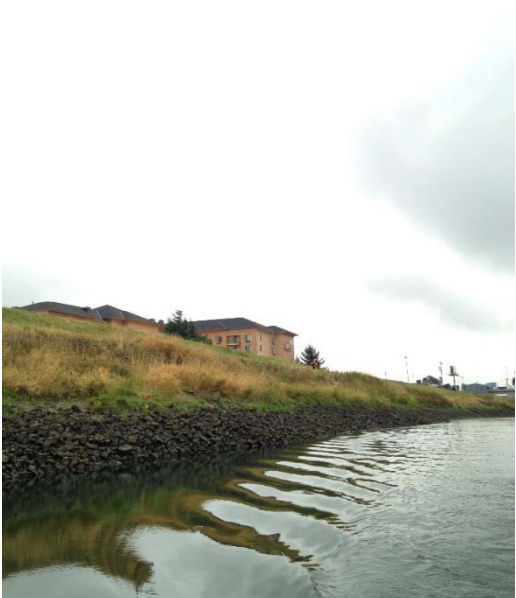
<p>Photo No. 3</p>

<p>Photo Date: 9/16/2014</p>	
<p>Orientation: West</p>	
<p>Description: The north side of PEN 2 levee protects the district from the high water in the Oregon Slough on the Columbia River. This section of levee has rip rap on the waterward toe.</p>

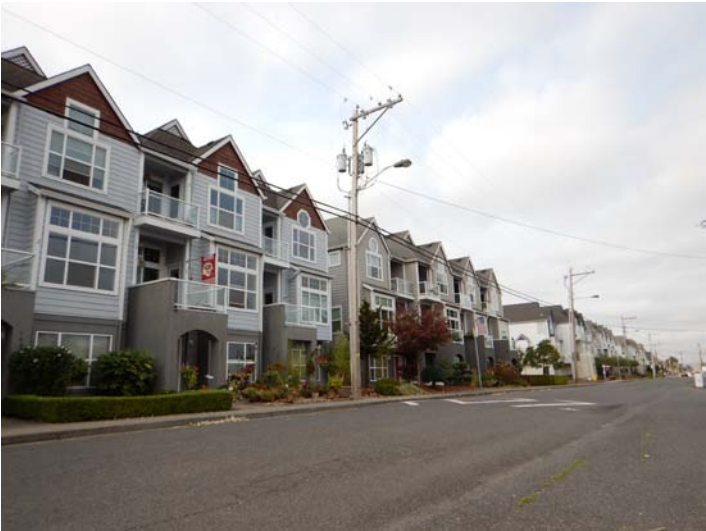
<p>Photo No. 4</p>

<p>Photo Date: 9/16/2014</p>	
<p>Orientation: Southwest</p>	
<p>Description: Townhouses are located on the south side of Bridgeton Road. The levee centerline is located along Bridgeton Road. There is a large amount of overbuild over the USACE design section of the levee. There are also multiple utilities within the levee right-of-way.</p>

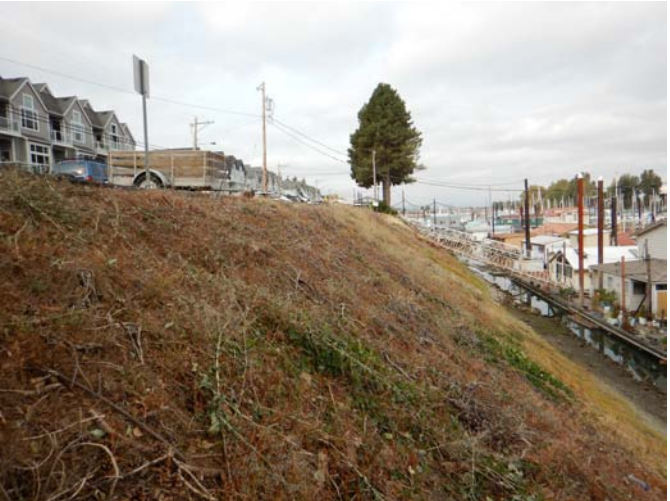
Photo No. 5

Photo Date: 9/16/2014	
Orientation: West	
Description: The levee has steep slopes along Bridgeton Road. Vegetation is managed manually once a year along.

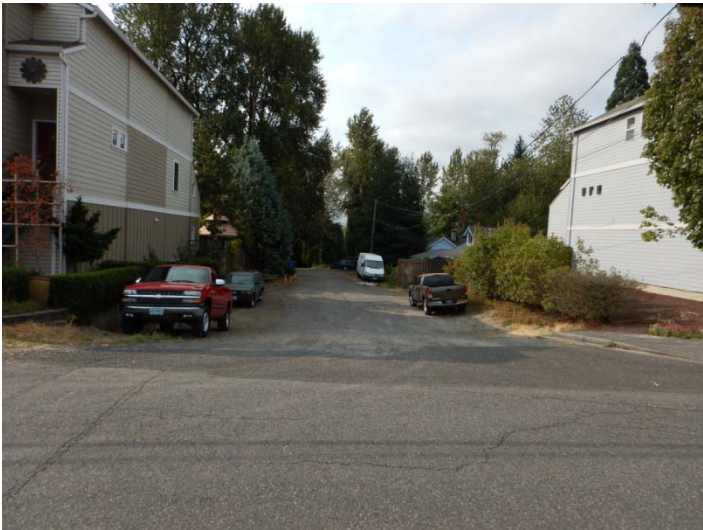
Photo No. 7

Photo Date: 9/16/2014	
Orientation: South	
Description: This image shows that the levee does not have a steep slope on the landward side along Bridgeton Road.

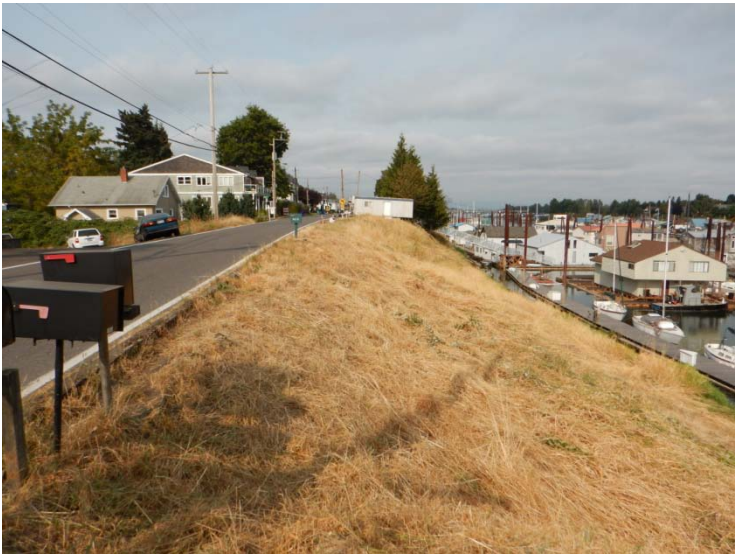
Photo No. 8

Photo Date: 9/16/2014	
Orientation: West	
Description: The waterward side of the levee along Bridgeton Road.

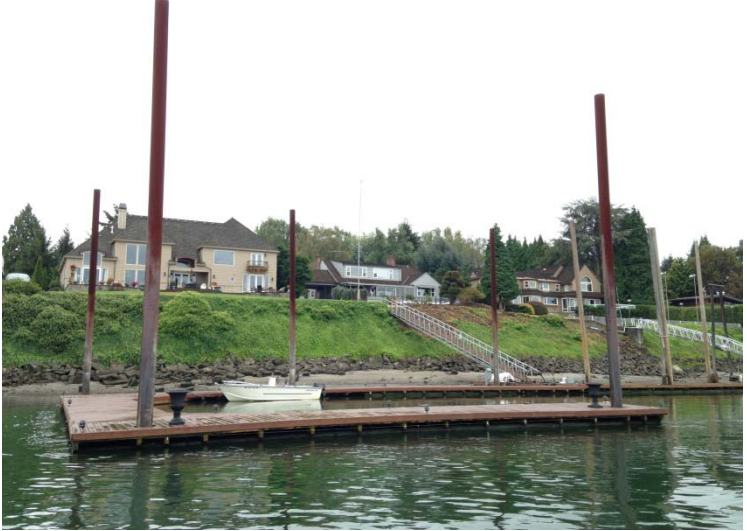
Photo No. 12

Photo Date: 9/18/2014	
Orientation: South	
Description: There are large residences located to the north of Marine Drive. The levee centerline runs along many of these properties. The levee does not have a standard levee prism along this location as it ties into level ground along Marine Drive, and there is no slope on the landward toe.

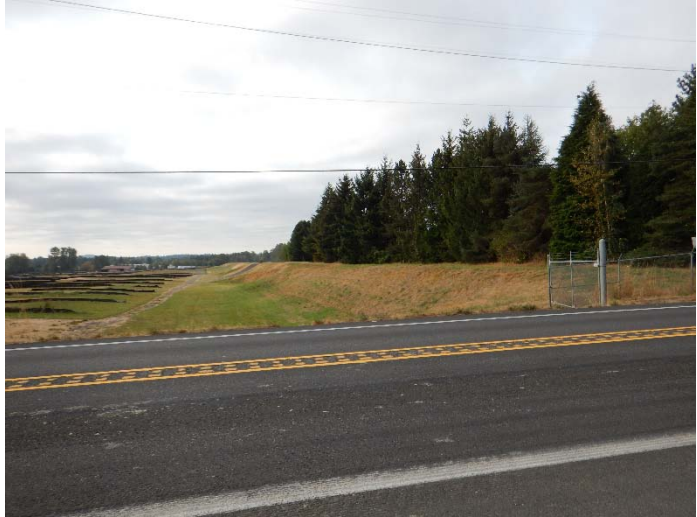
<p>Photo No. 16</p>

<p>Photo Date: 9/16/2014</p>	
<p>Orientation: South</p>	
<p>Description: The Peninsula Slough Drainage Canal separates PEN 2 and MCDD. The levee along the east side of the canal is the cross-levee between PEN 2 and MCDD. This image shows the beginning of the cross-levee prior to the beginning of the canal.</p>

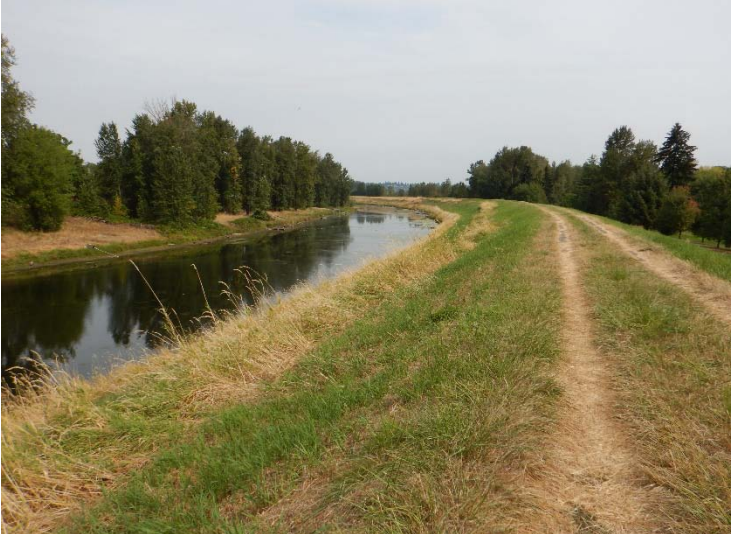
<p>Photo No. 20</p>

<p>Photo Date: 9/16/2014</p>	
<p>Orientation: North</p>	
<p>Description: The Peninsula Slough Drainage Canal and the cross-levee between PEN 2 and MCDD. The canal is not hydraulically connected to the Columbia River or the upper Columbia Slough. Water enters the canal as rainfall or groundwater.</p>

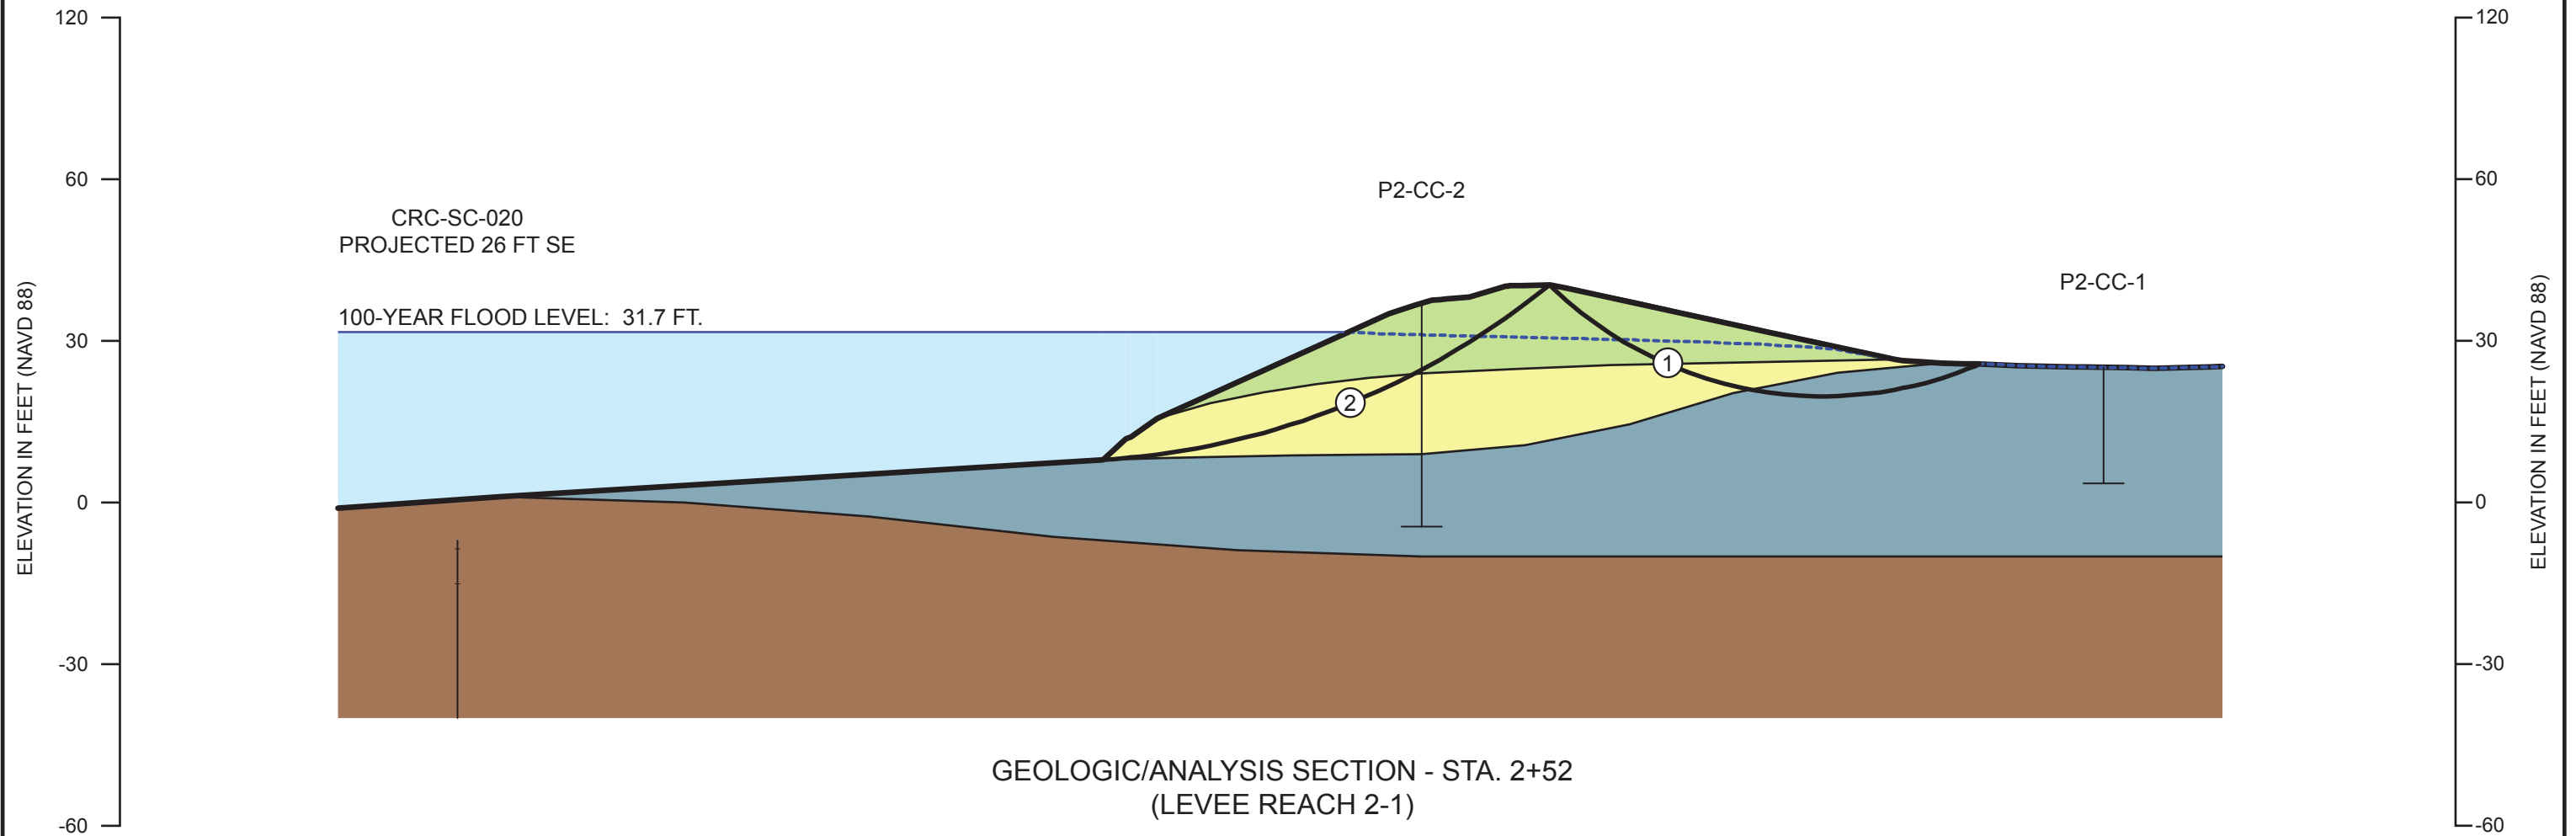
CALCULATED EXIT GRADIENT AT TOE OF LANDWARD
SLOPE = 0.1**

**RECOMMENDED MAXIMUM EXIT GRADIENT = 0.5, USACE,
EM 1110-2-1913

**GEOLOGIC/ANALYSIS
CROSS SECTION**
PENINSULA 2 LEVEE ASSESSMENT
PORTLAND, OREGON

The stability and seepage analyses were performed on geologic cross-sections through the levee embankment, which were developed using: (i) the topographic information of the site collected by Gibbs & Olson; (ii) bathymetry data acquired by MCDD for the adjacent waterways (Oregon Slough and Columbia Slough); and (iii) the subsurface information obtained from Cornforth Consultants' field investigation program. Analyses were performed on representative cross-sections for all of the reaches except for Reach 2-6, which is flat ground with no embankment. Two separate analyses were performed for Reach 2-9, which included a section across the dam embankment that separates the Columbia Slough from the Peninsula Drainage Canal, and another representative cross-section through the levee at Station 186+67 (see Fig. 2C). Cross-sections for the analyzed levee reaches are presented on Figures 7 through 21.

Results of Stability Analyses. The results of the slope stability analyses are summarized on Table 13 below and also on Figures 7 through 21. The calculated FS from each levee reach was compared against the minimum value recommended by USACE in EM 1110-2-1913 (USACE, 2000); which requires FS greater than 1.4 for static, steady-state seepage conditions. This threshold FS value was met for all the levee reaches except for Levee Reaches 2-7 and 2-8.

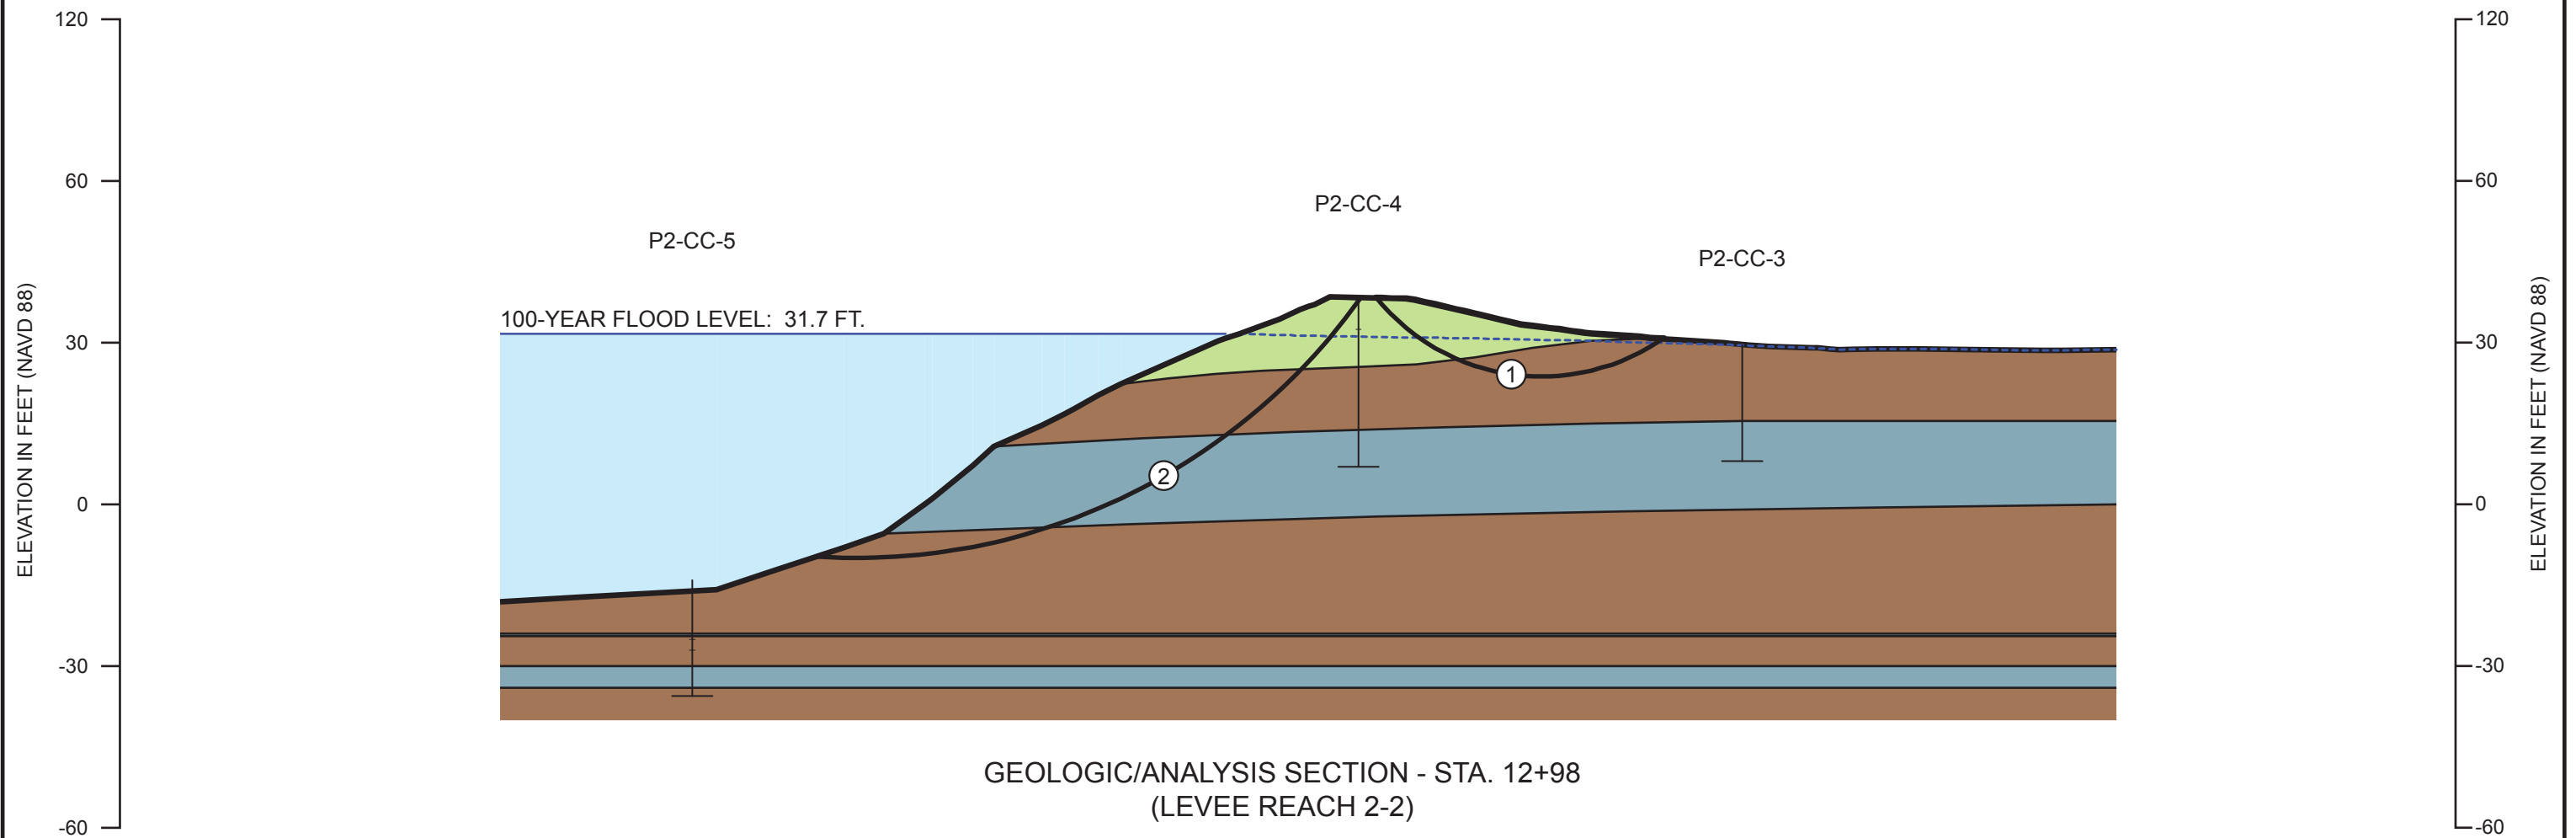
CALCULATED EXIT GRADIENT AT TOE OF LANDWARD
SLOPE = 0.0**

**RECOMMENDED MAXIMUM EXIT GRADIENT = 0.5, USACE,
EM 1110-2-1913

GEOLOGIC/ANALYSIS SECTION - STA. 12+98
(LEVEE REACH 2-2)

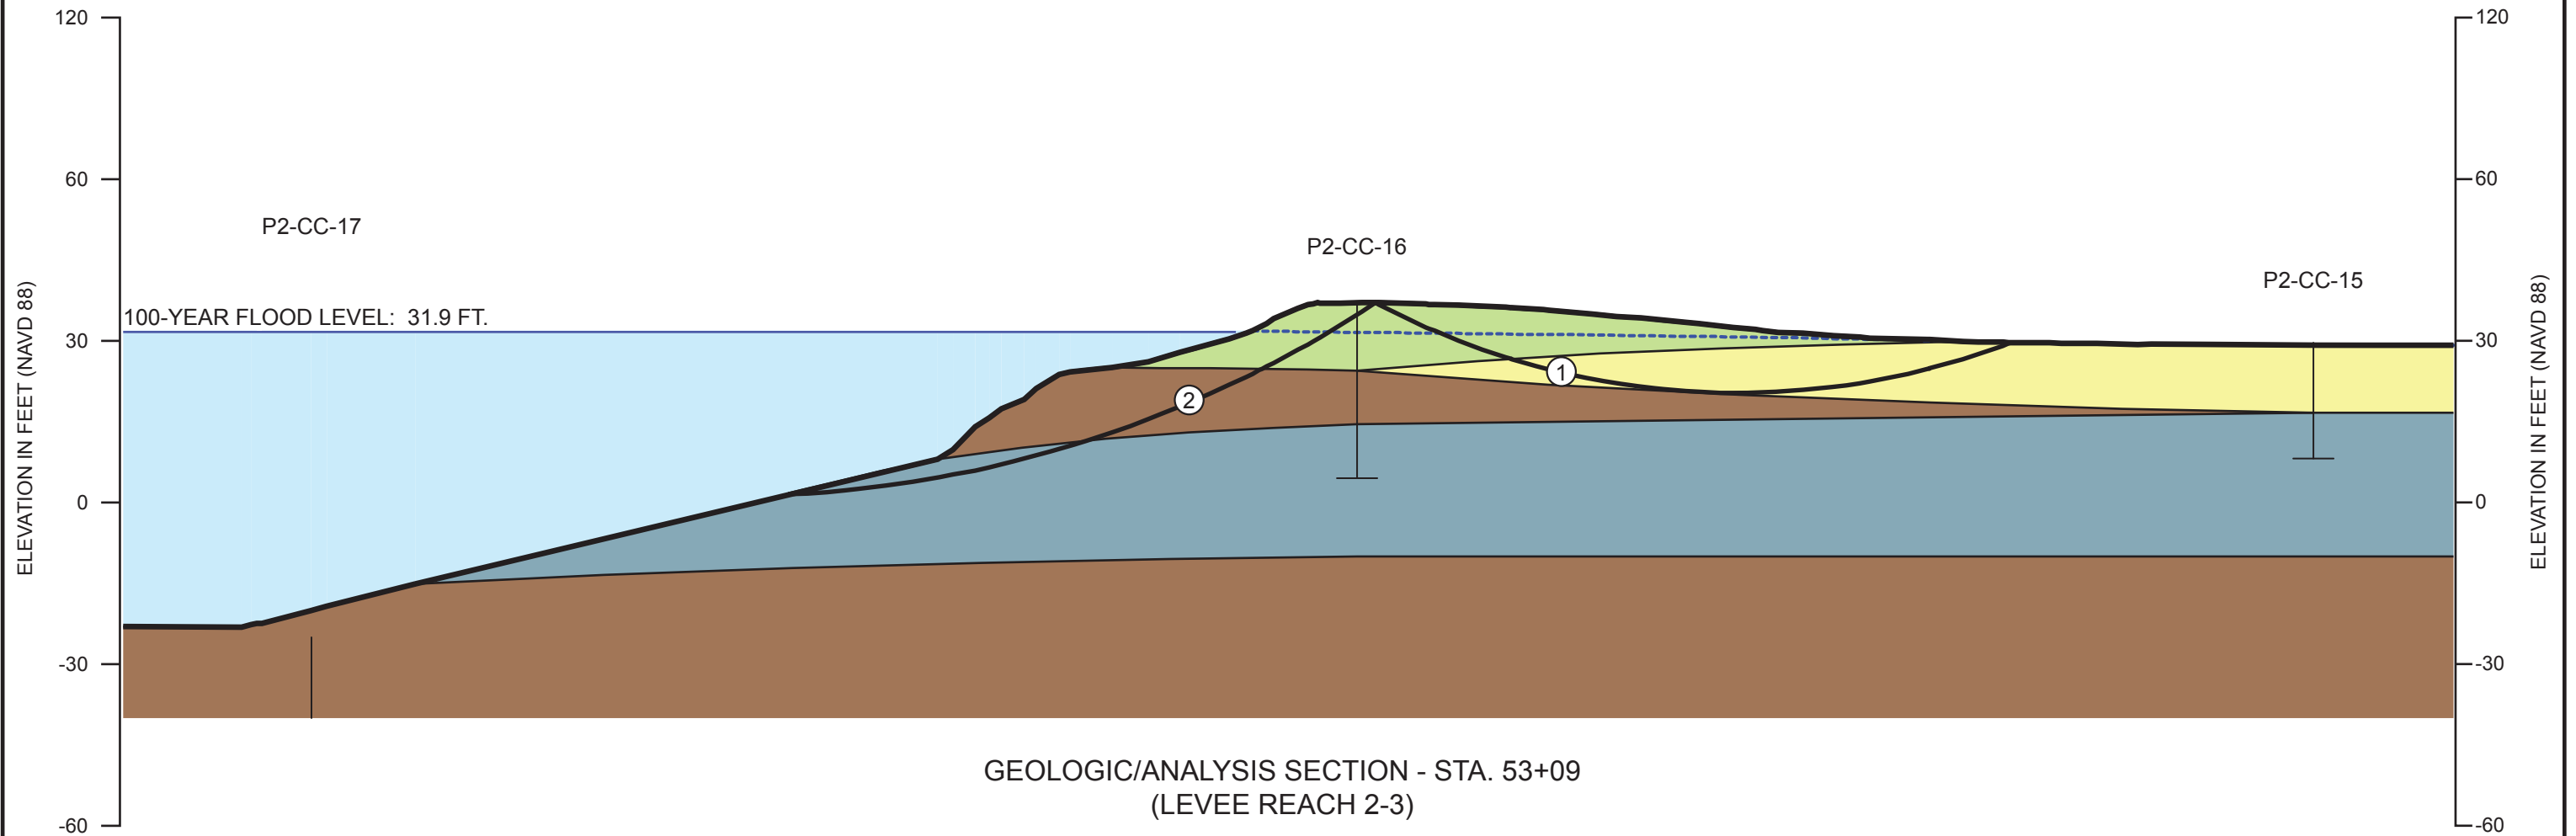
CALCULATED EXIT GRADIENT AT TOE OF LANDWARD
SLOPE = 0.0**

**RECOMMENDED MAXIMUM EXIT GRADIENT = 0.5, USACE,
EM 1110-2-1913

**GEOLOGIC/ANALYSIS
CROSS SECTION**
PENINSULA 2 LEVEE ASSESSMENT
PORTLAND, OREGON

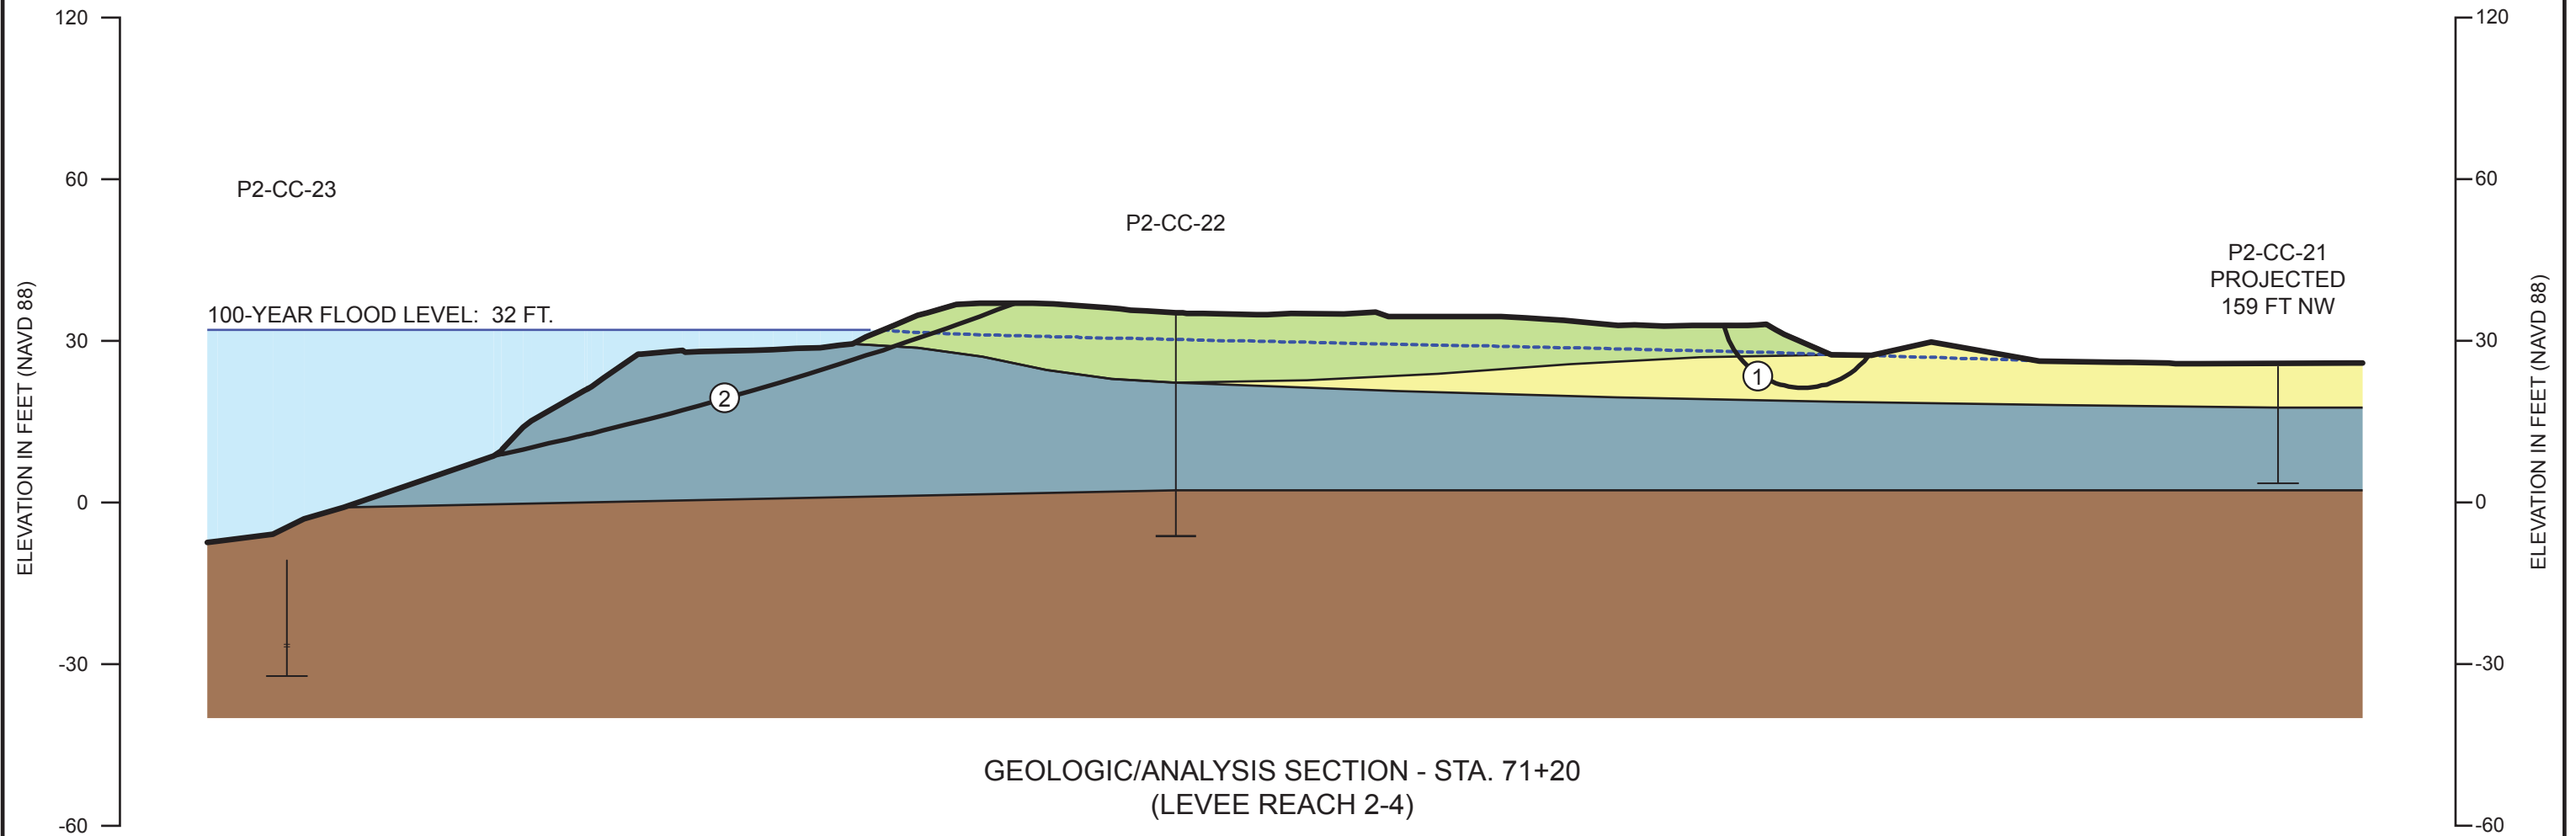
OCT 2014
 PROJ. 2320
 FIG. 10

CALCULATED EXIT GRADIENT AT TOE OF LANDWARD
SLOPE = 0.0**

**RECOMMENDED MAXIMUM EXIT GRADIENT = 0.5, USACE,
EM 1110-2-1913

GEOLOGIC/ANALYSIS SECTION - STA. 71+20
(LEVEE REACH 2-4)

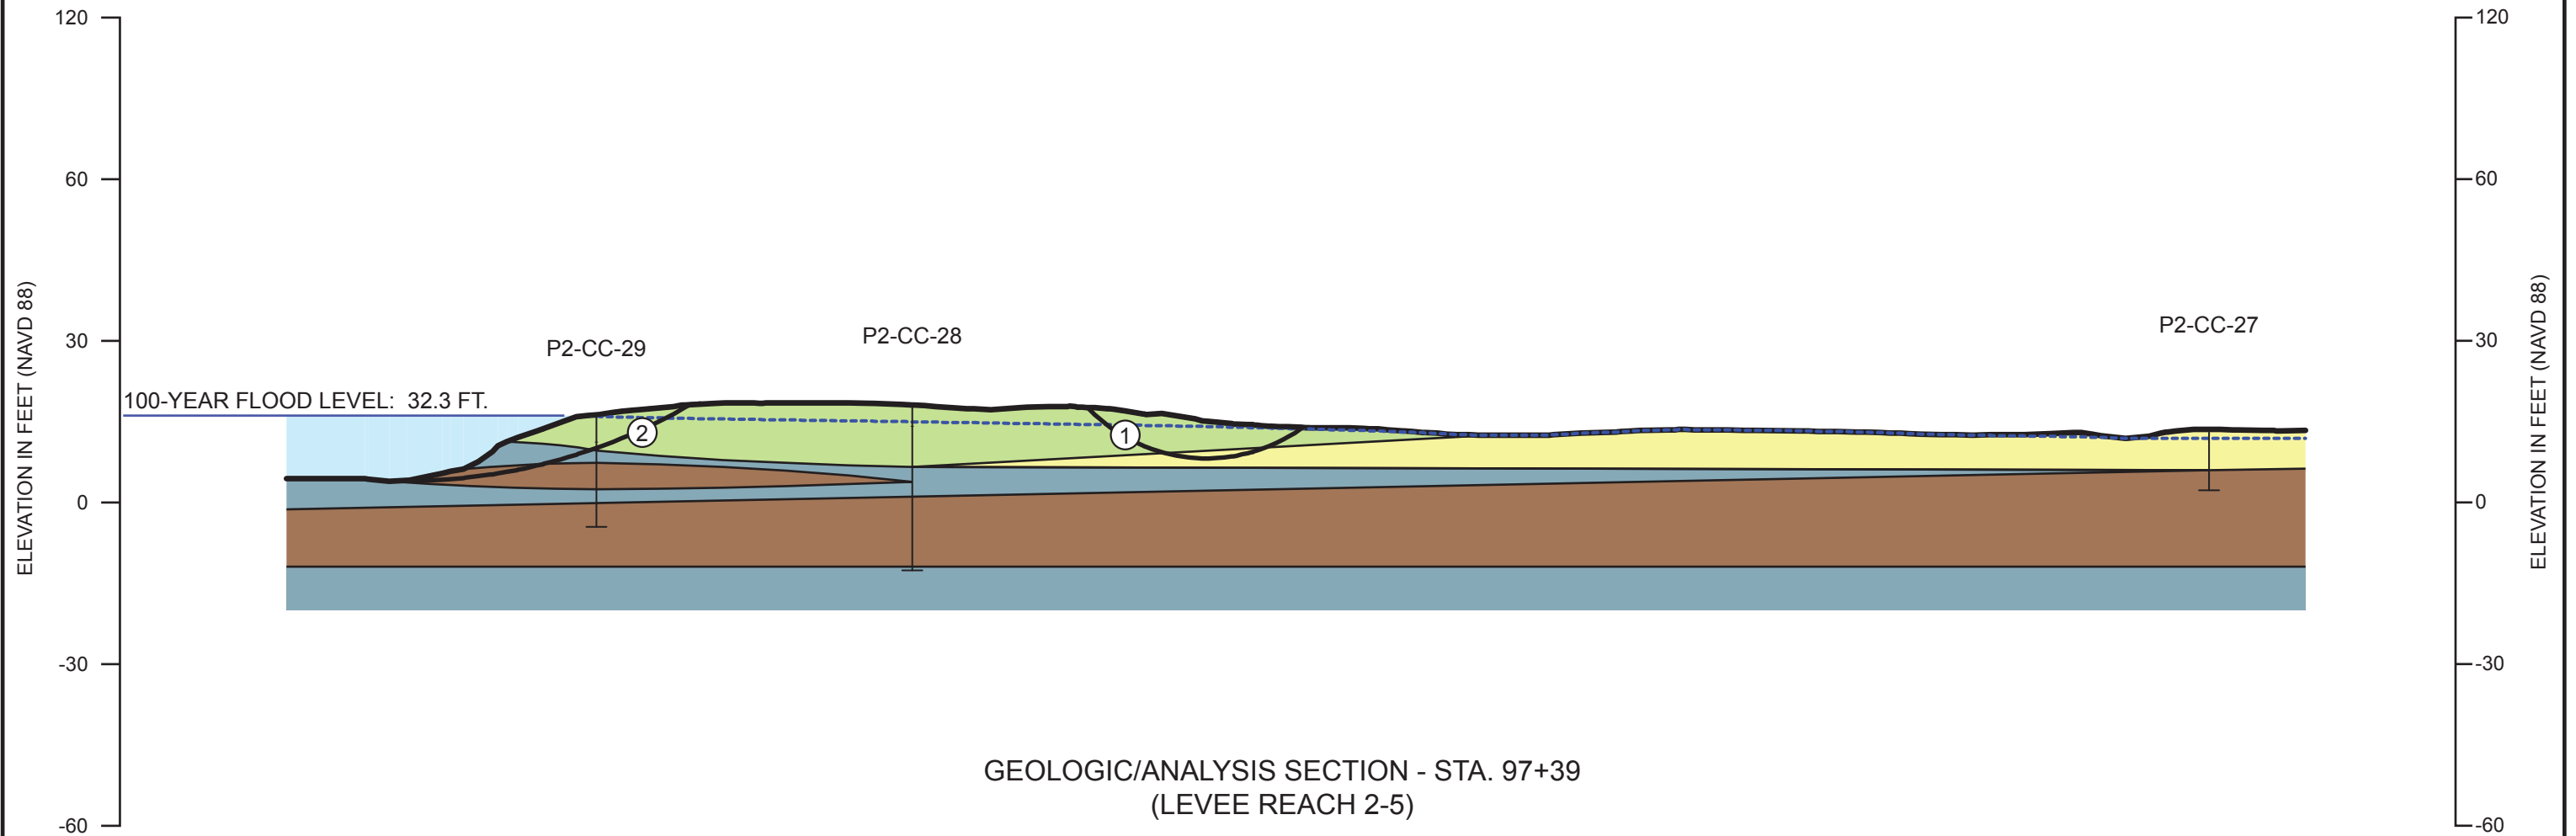
OCT 2014
PROJ. 2320
FIG. 11

CALCULATED EXIT GRADIENT AT TOE OF LANDWARD
SLOPE = 0.1**

**RECOMMENDED MAXIMUM EXIT GRADIENT = 0.5, USACE,
EM 1110-2-1913

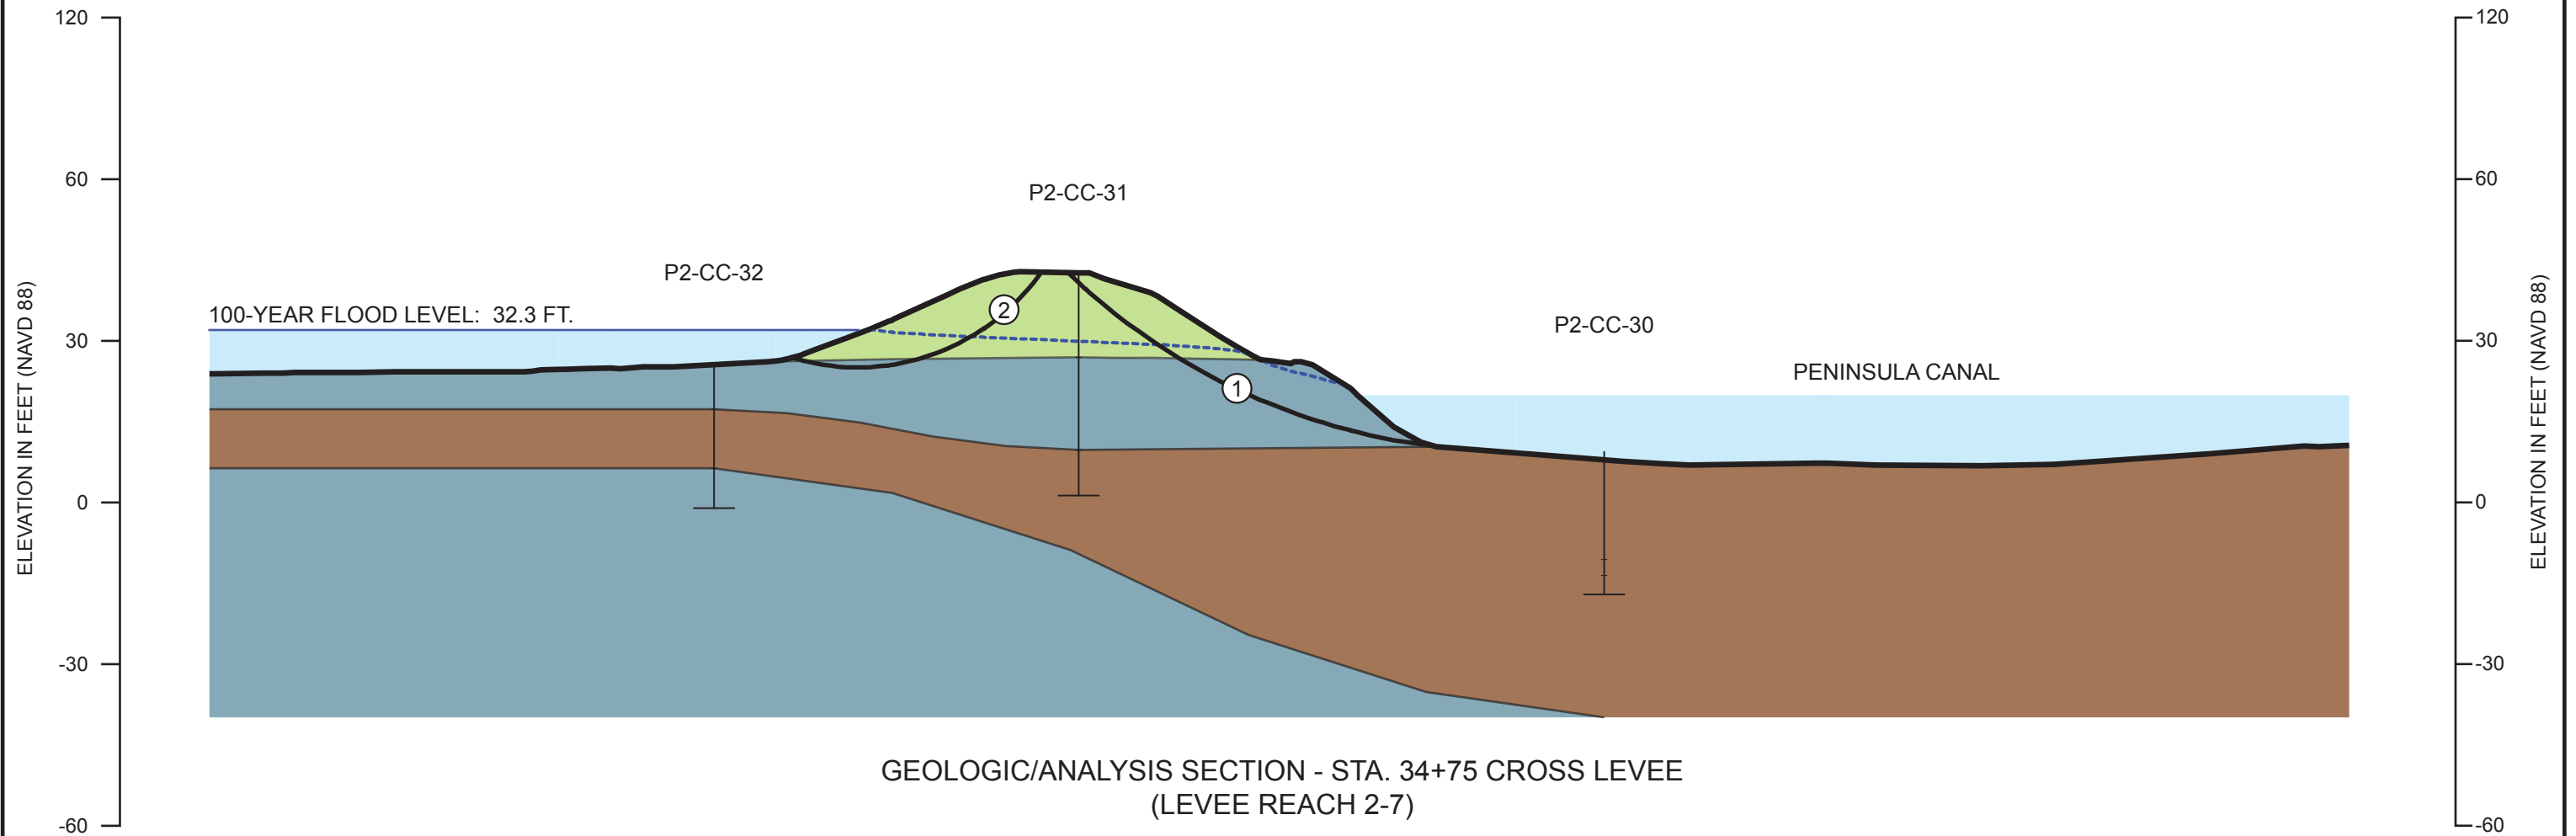
OCT 2014
 PROJ. 2320
 FIG. 12

CALCULATED EXIT GRADIENT AT TOE OF LANDWARD SLOPE = 0.1**

**RECOMMENDED MAXIMUM EXIT GRADIENT = 0.5, USACE, EM 1110-2-1913

GEOLOGIC/ANALYSIS SECTION - STA. 34+75 CROSS LEVEE (LEVEE REACH 2-7)

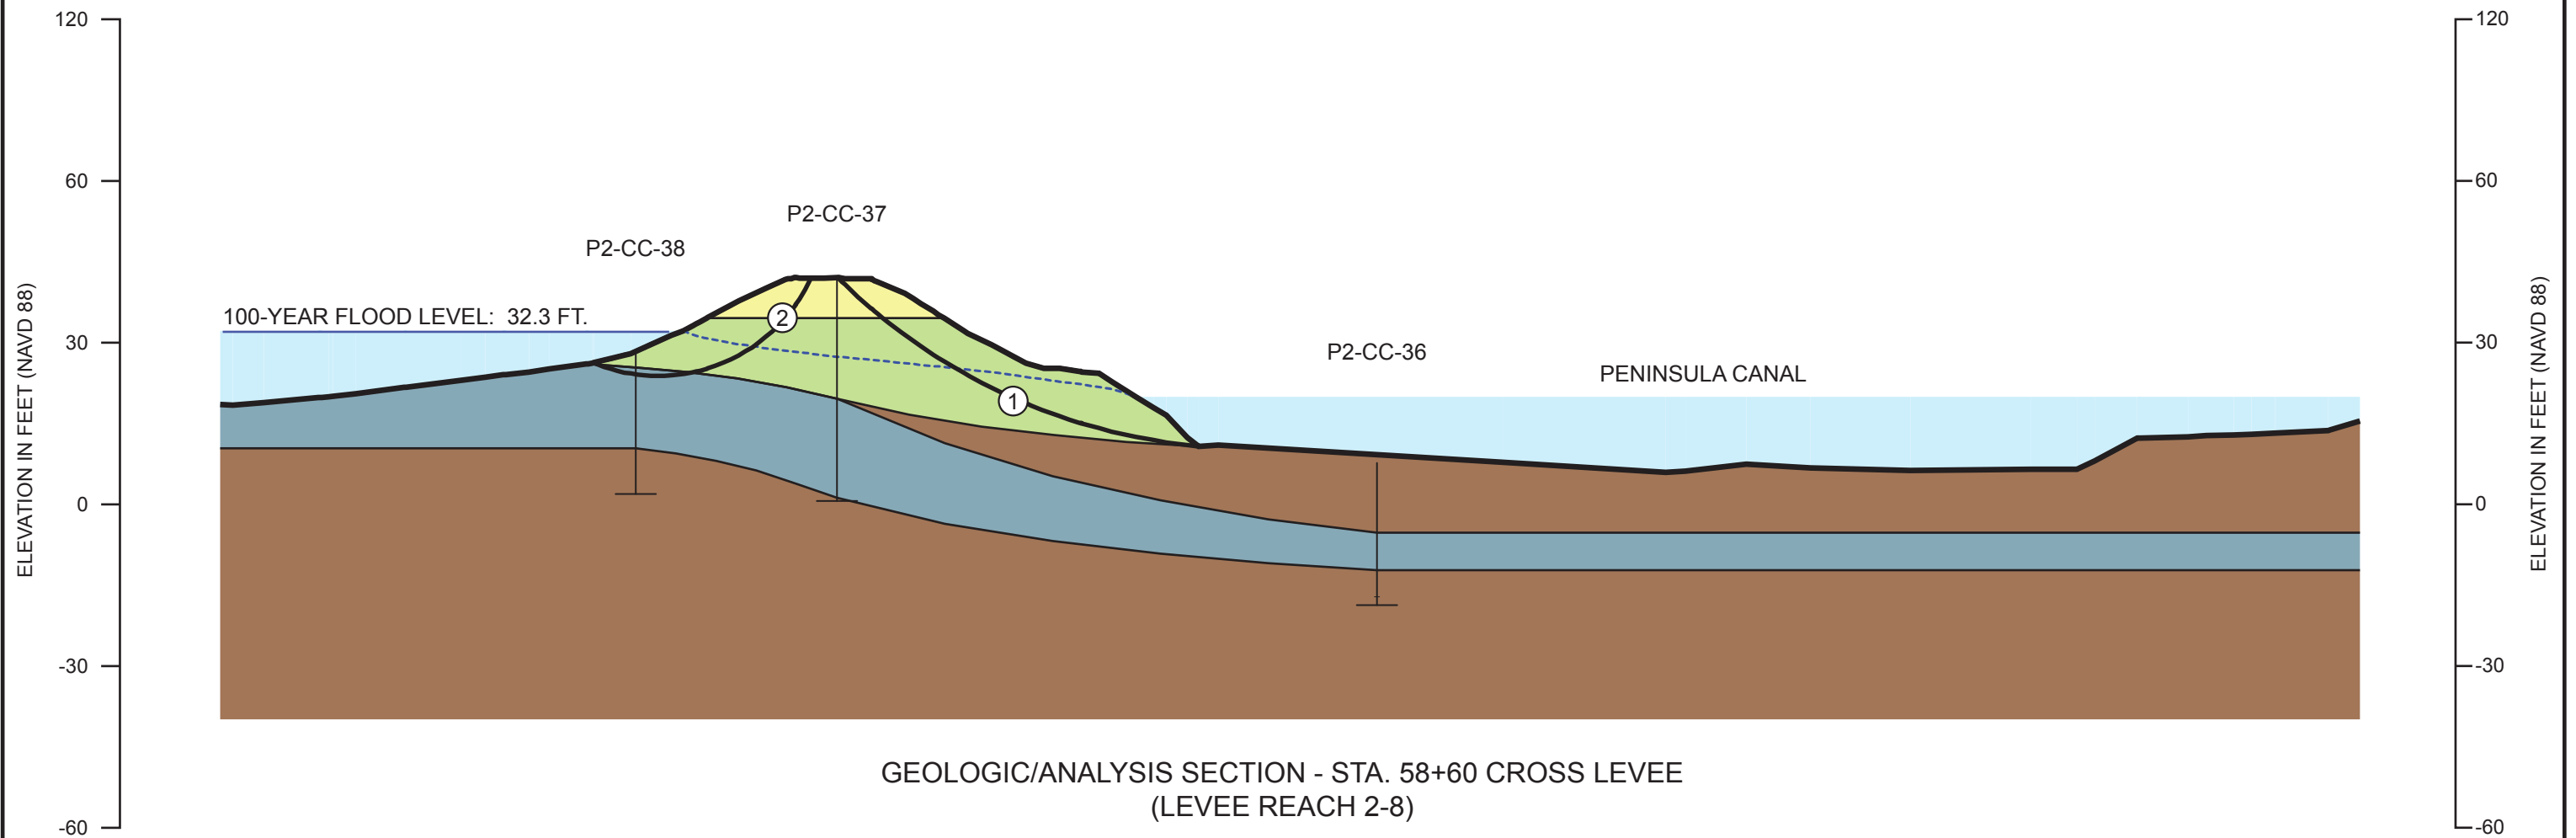
OCT 2014
PROJ. 2320
FIG. 13

CALCULATED EXIT GRADIENT AT TOE OF LANDWARD
SLOPE = 0.1**

**RECOMMENDED MAXIMUM EXIT GRADIENT = 0.5, USACE,
EM 1110-2-1913

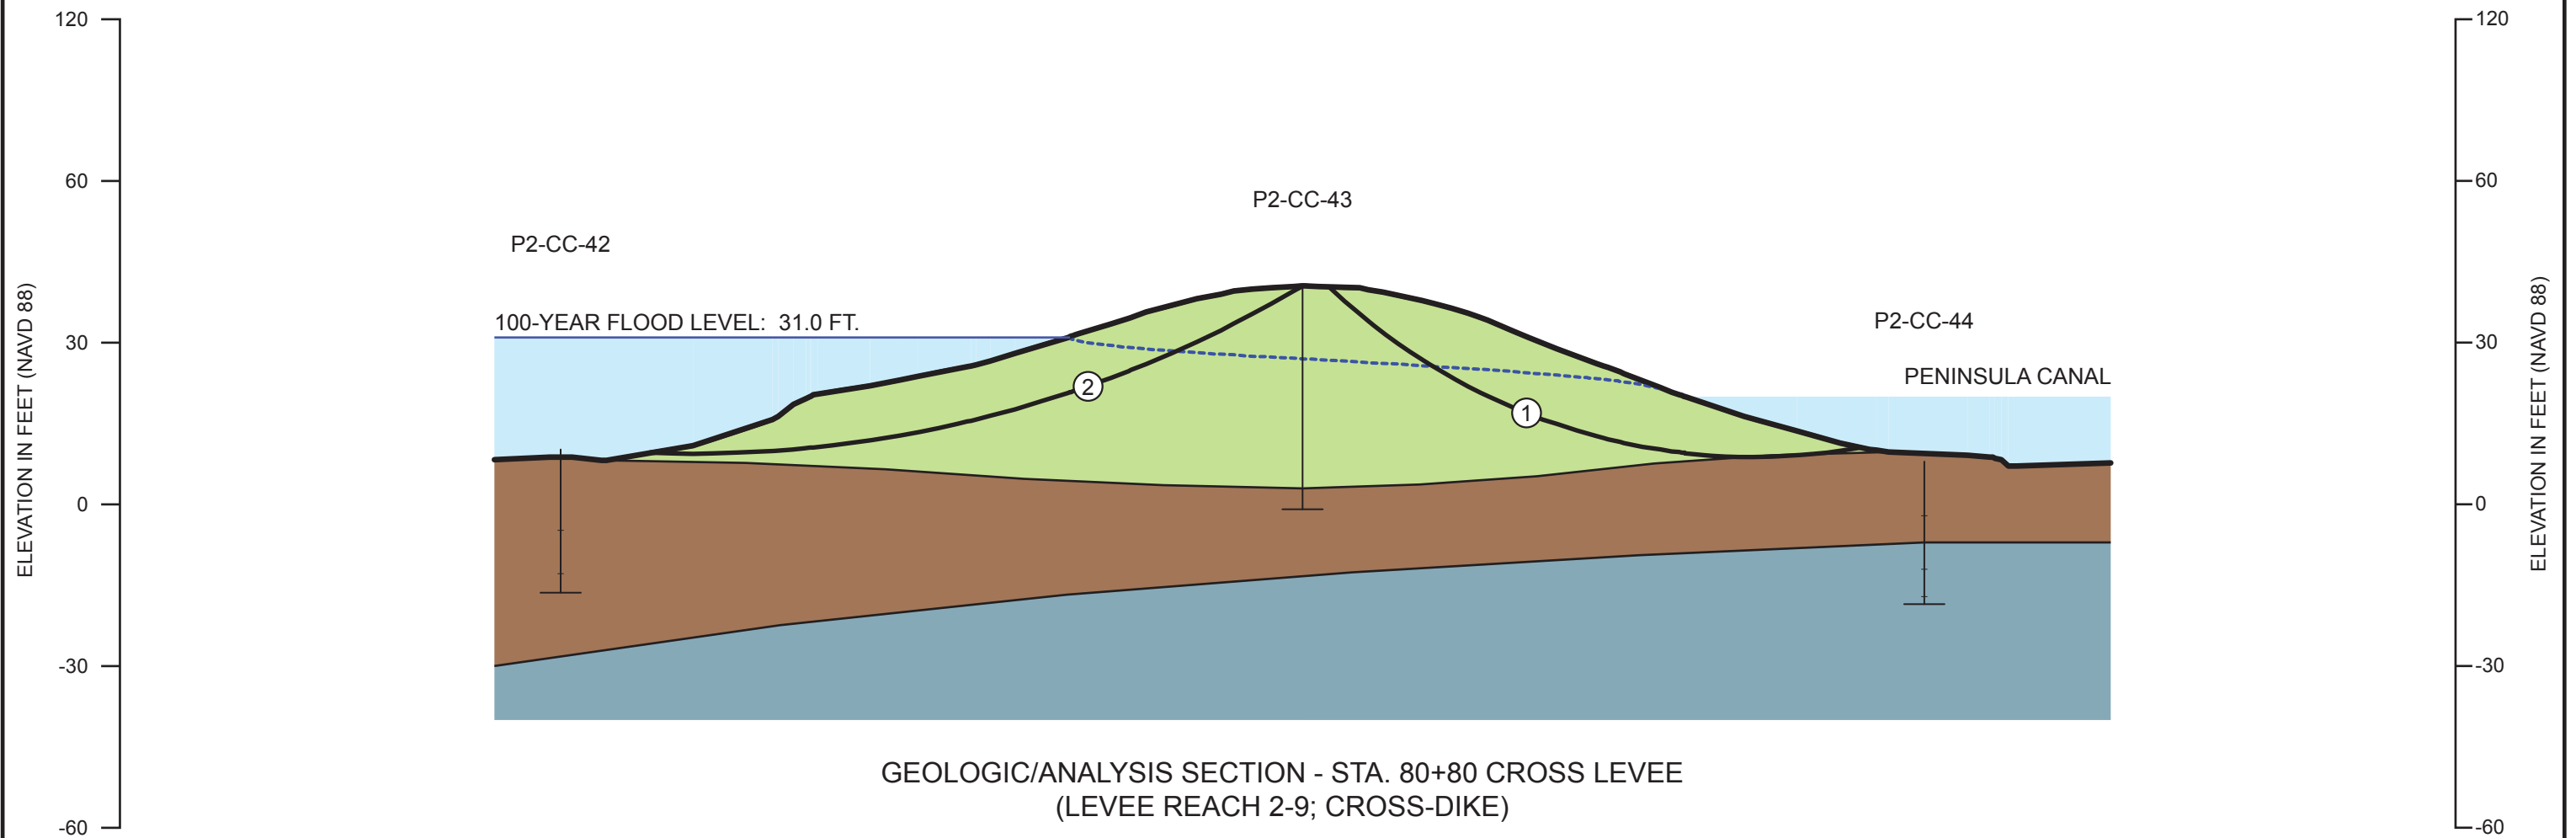
CALCULATED EXIT GRADIENT AT TOE OF LANDWARD
SLOPE = 0.2**

**RECOMMENDED MAXIMUM EXIT GRADIENT = 0.5, USACE,
EM 1110-2-1913
