Peninsula Drainage District No. 2

Levee Engineering Assessment

**PENINSULA DRAINAGE DISTRICT NO. 2
LEVEE ENGINEERING ASSESSMENT**

October 2, 2014

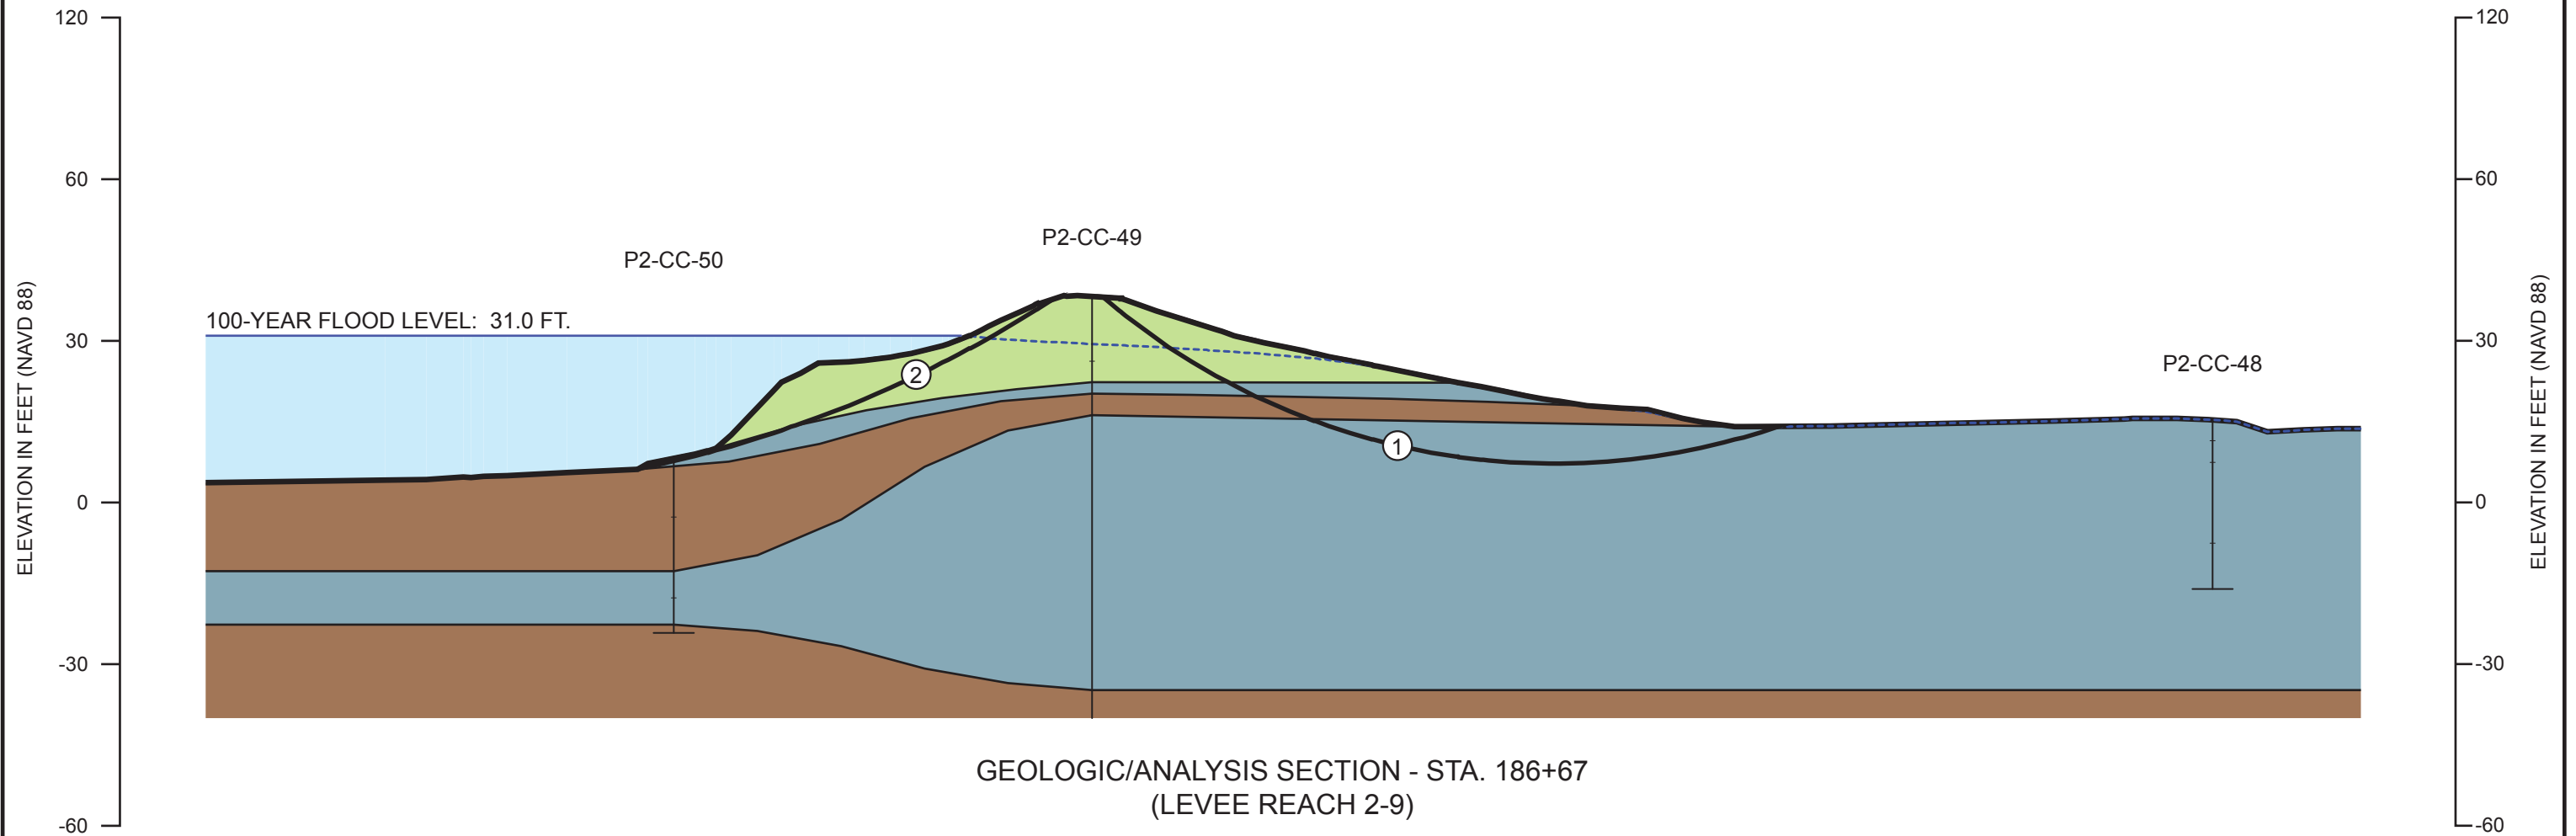
GEOLOGIC/ANALYSIS SECTION - STA. 186+67
(LEVEE REACH 2-9)

CALCULATED EXIT GRADIENT AT TOE OF LANDWARD SLOPE = 0.3**

**RECOMMENDED MAXIMUM EXIT GRADIENT = 0.5, USACE, EM 1110-2-1913

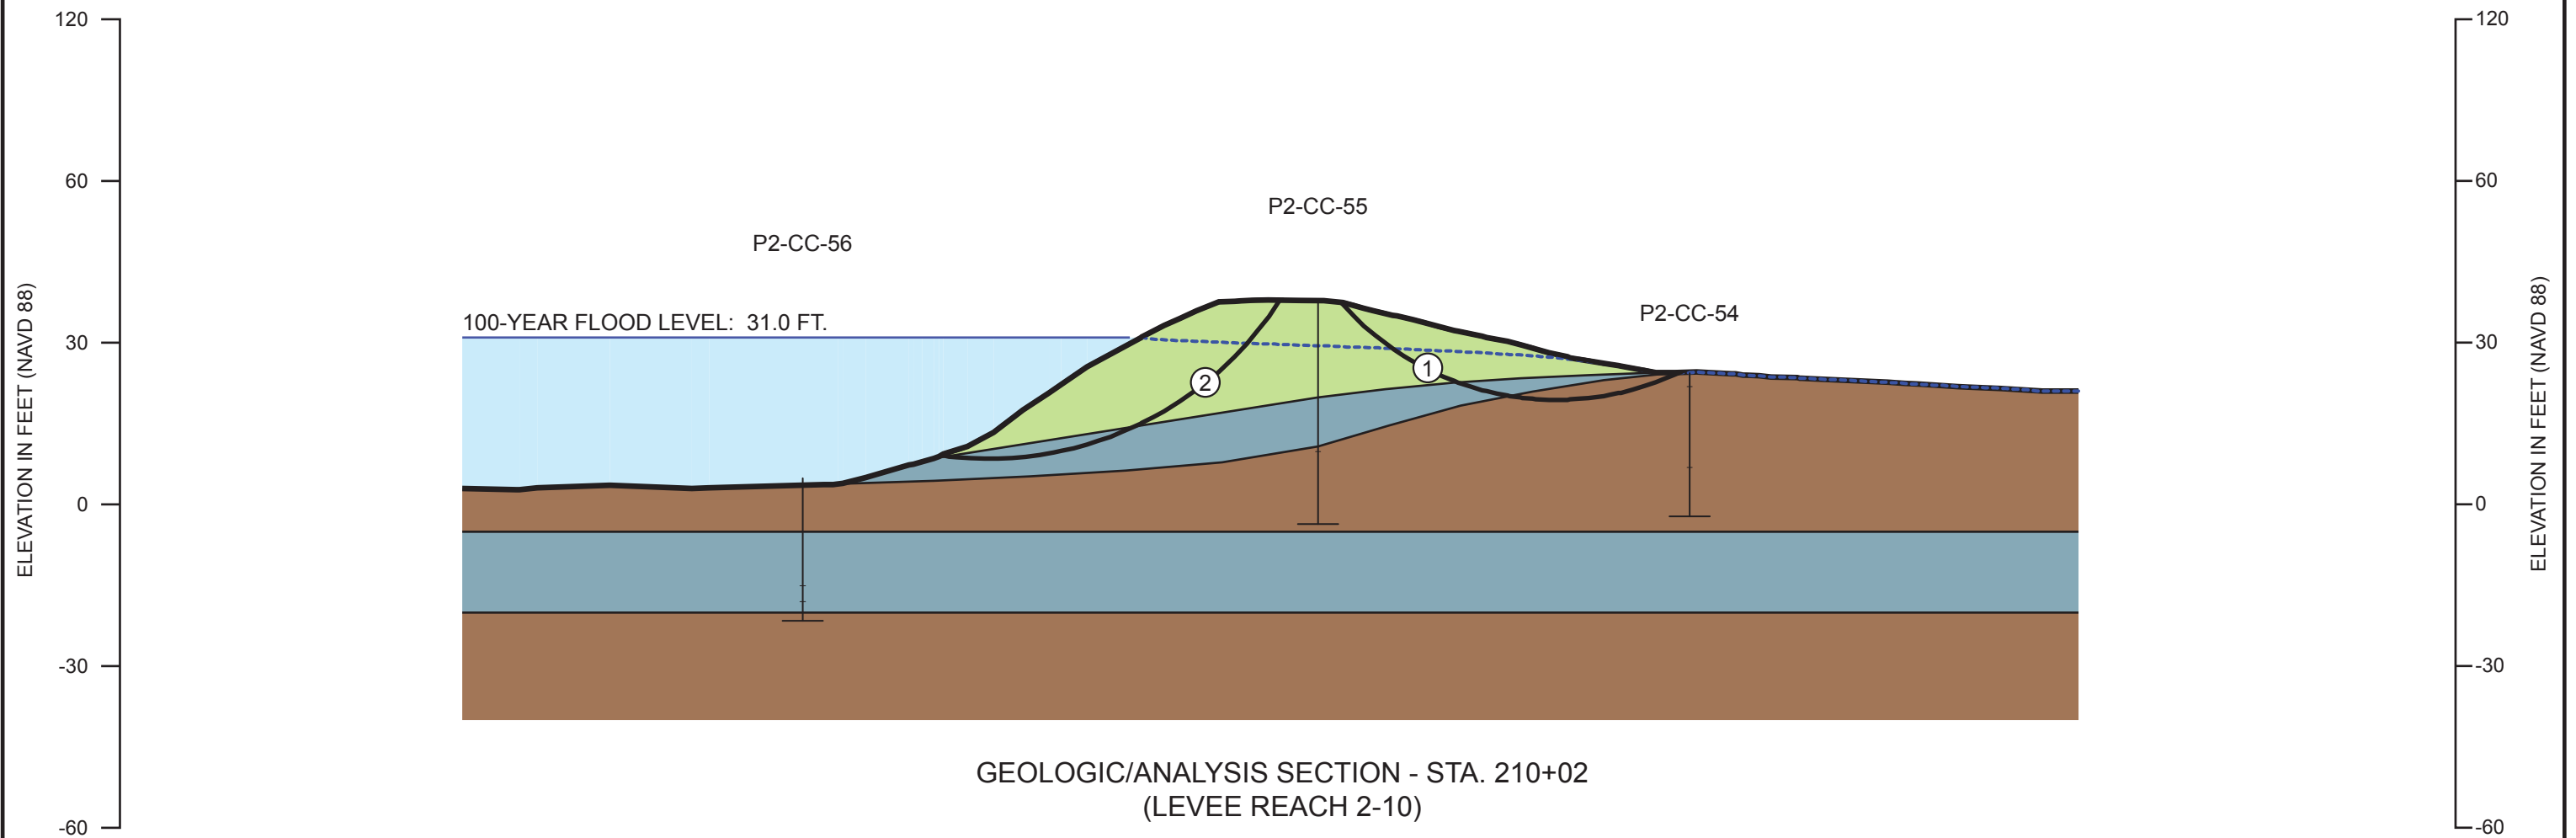
CALCULATED EXIT GRADIENT AT TOE OF LANDWARD
SLOPE = 0.1**

**RECOMMENDED MAXIMUM EXIT GRADIENT = 0.5, USACE,
EM 1110-2-1913

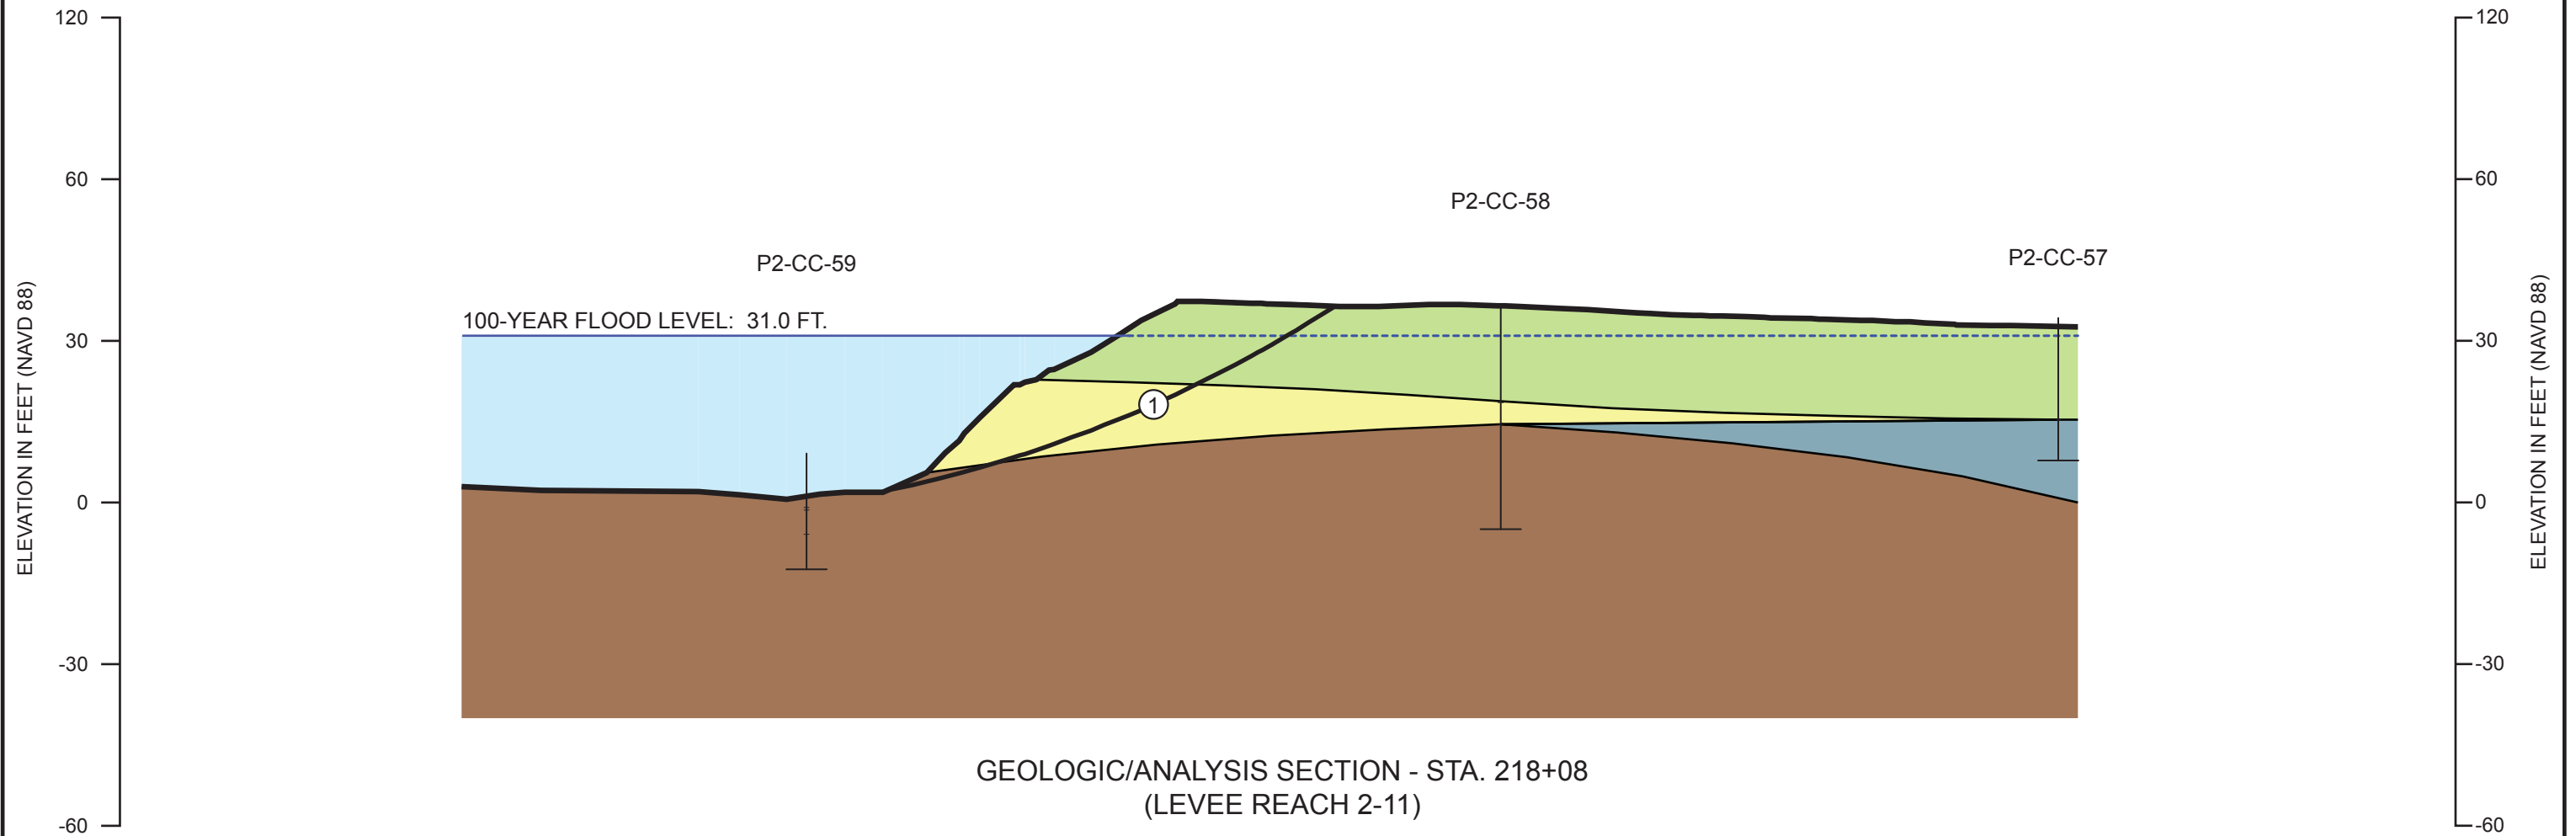
GEOLOGIC/ANALYSIS SECTION - STA. 218+08
(LEVEE REACH 2-11)

CALCULATED EXIT GRADIENT AT TOE OF LANDWARD SLOPE = 0.0**

**RECOMMENDED MAXIMUM EXIT GRADIENT = 0.5, USACE, EM 1110-2-1913

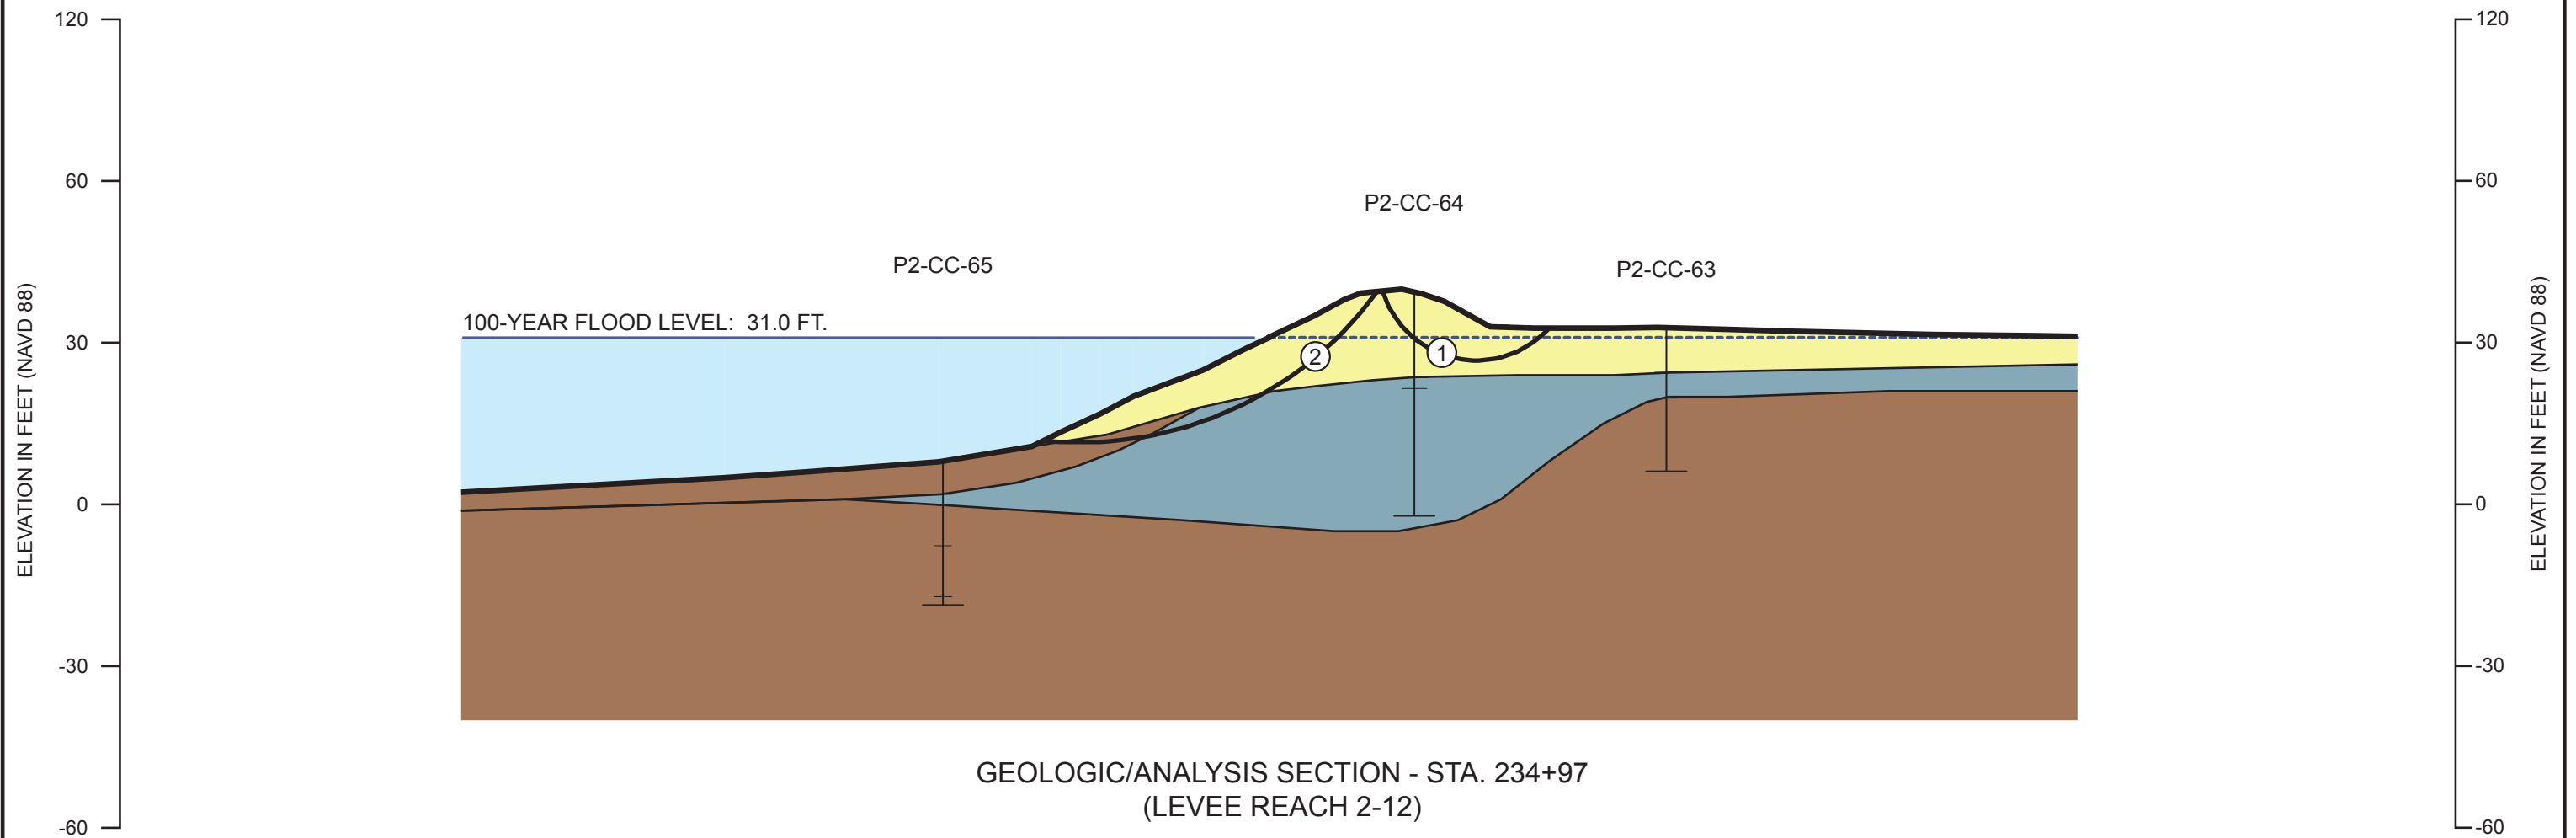
GEOLOGIC/ANALYSIS SECTION - STA. 234+97
(LEVEE REACH 2-12)

CALCULATED EXIT GRADIENT AT TOE OF LANDWARD
SLOPE = 0.0**

**RECOMMENDED MAXIMUM EXIT GRADIENT = 0.5, USACE,
EM 1110-2-1913

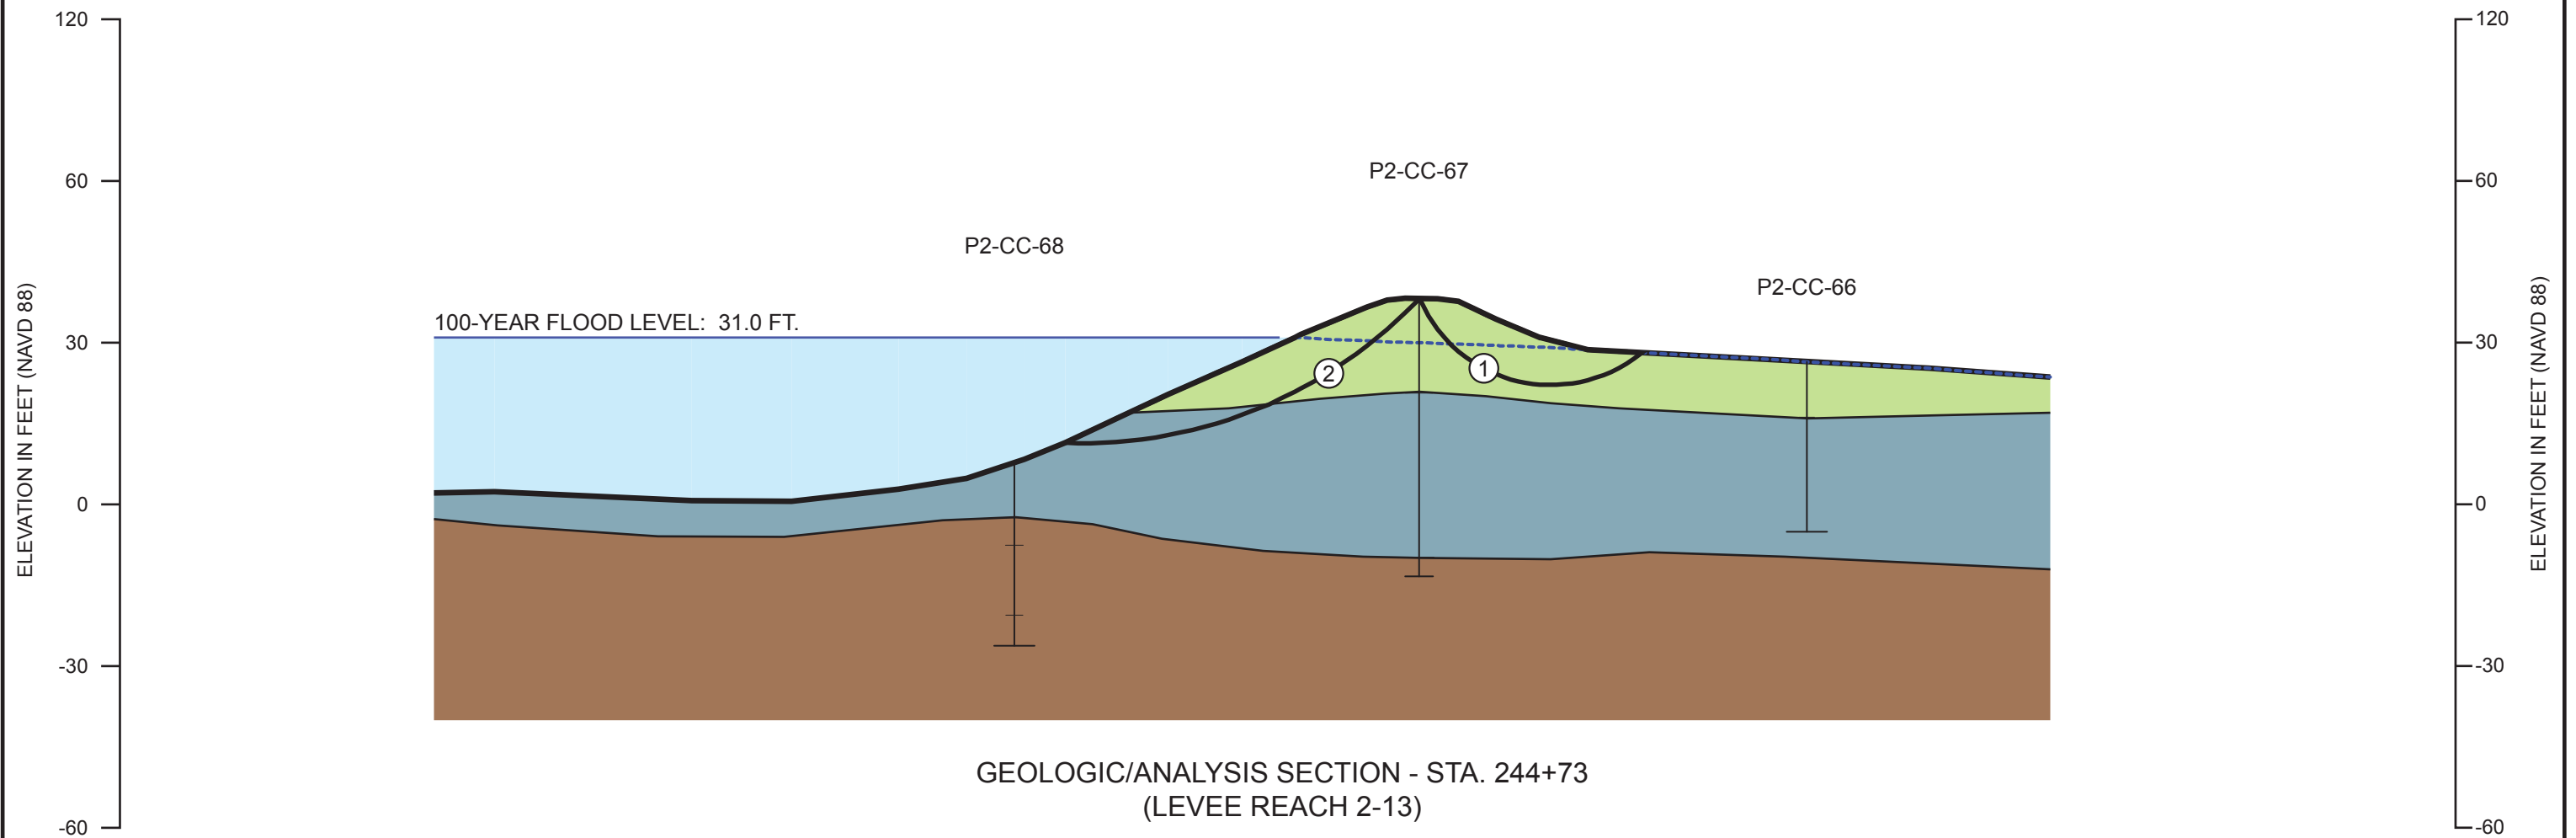
GEOLOGIC/ANALYSIS SECTION - STA. 244+73
(LEVEE REACH 2-13)

CALCULATED EXIT GRADIENT AT TOE OF LANDWARD
SLOPE = 0.0**

**RECOMMENDED MAXIMUM EXIT GRADIENT = 0.5, USACE,
EM 1110-2-1913

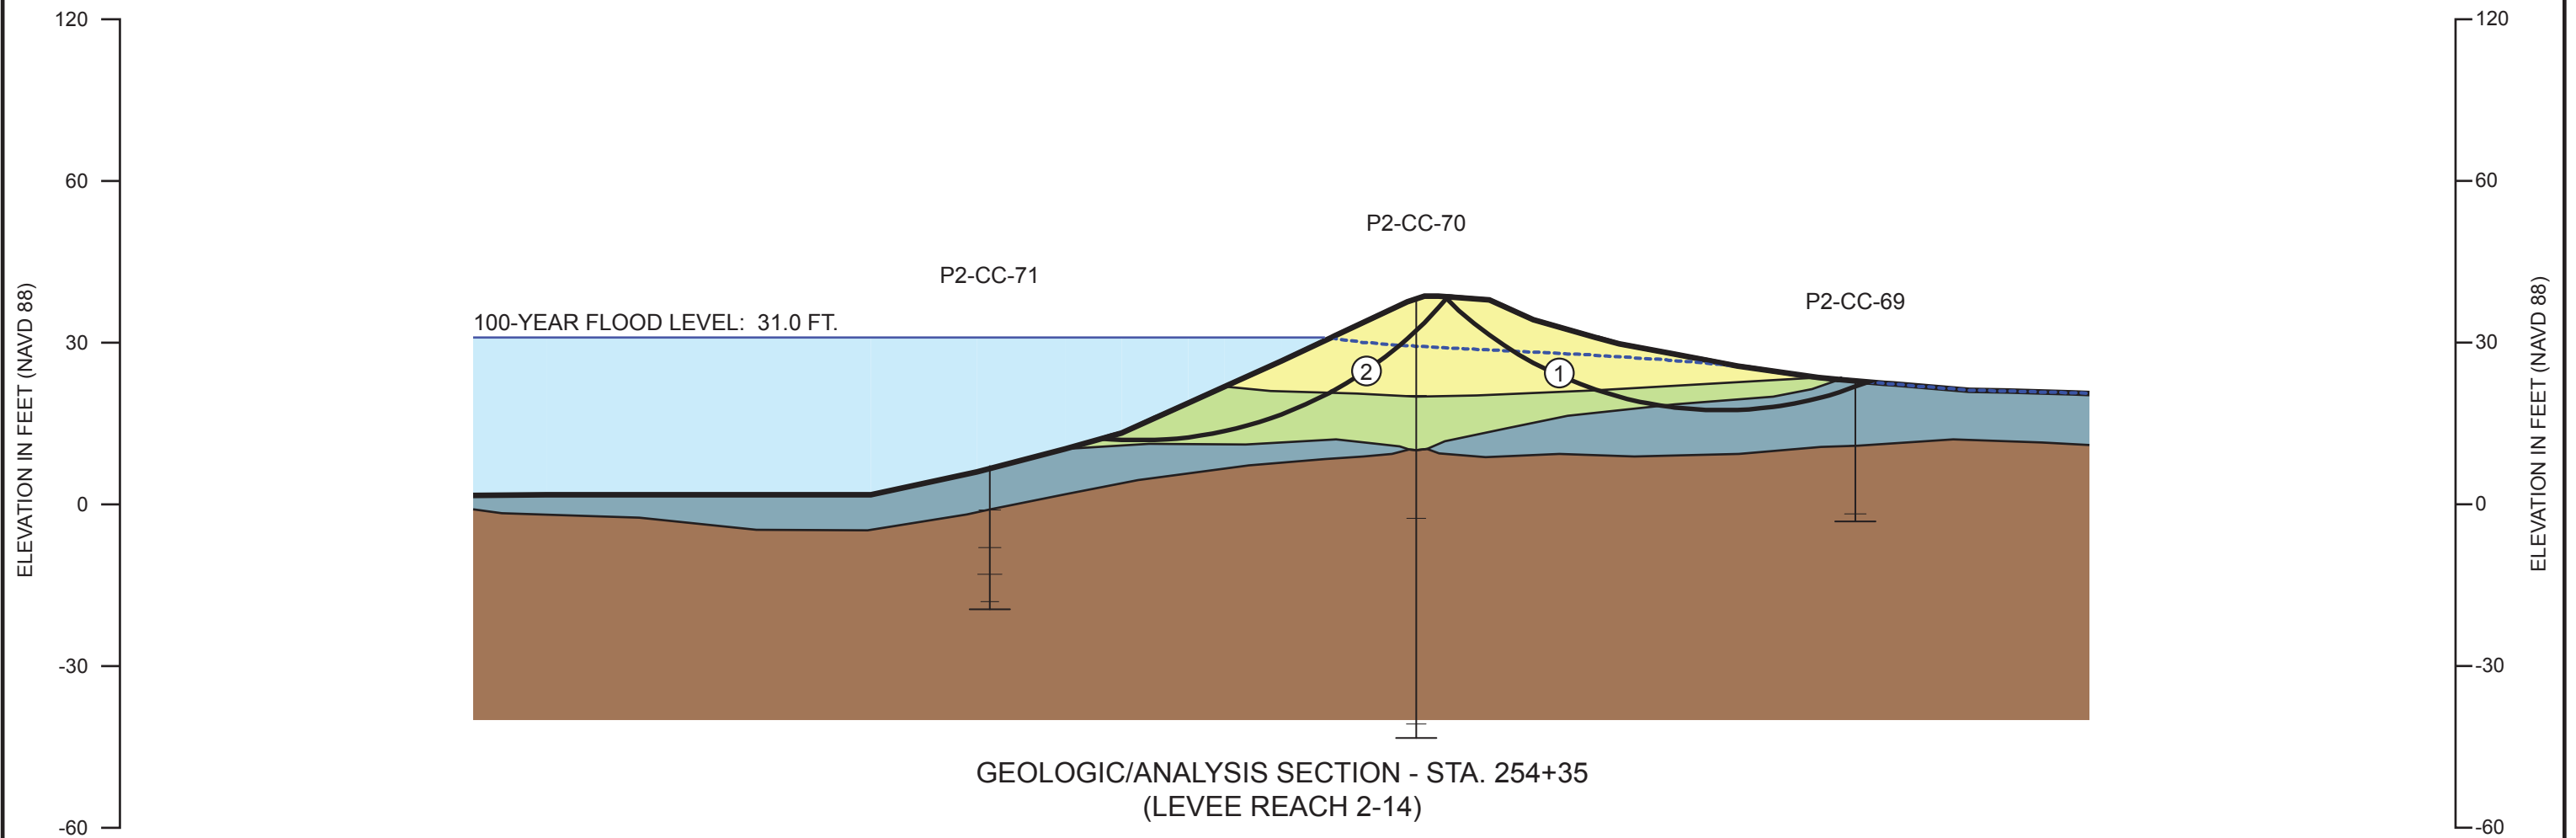
CALCULATED EXIT GRADIENT AT TOE OF LANDWARD
SLOPE = 0.1**

**RECOMMENDED MAXIMUM EXIT GRADIENT = 0.5, USACE,
EM 1110-2-1913

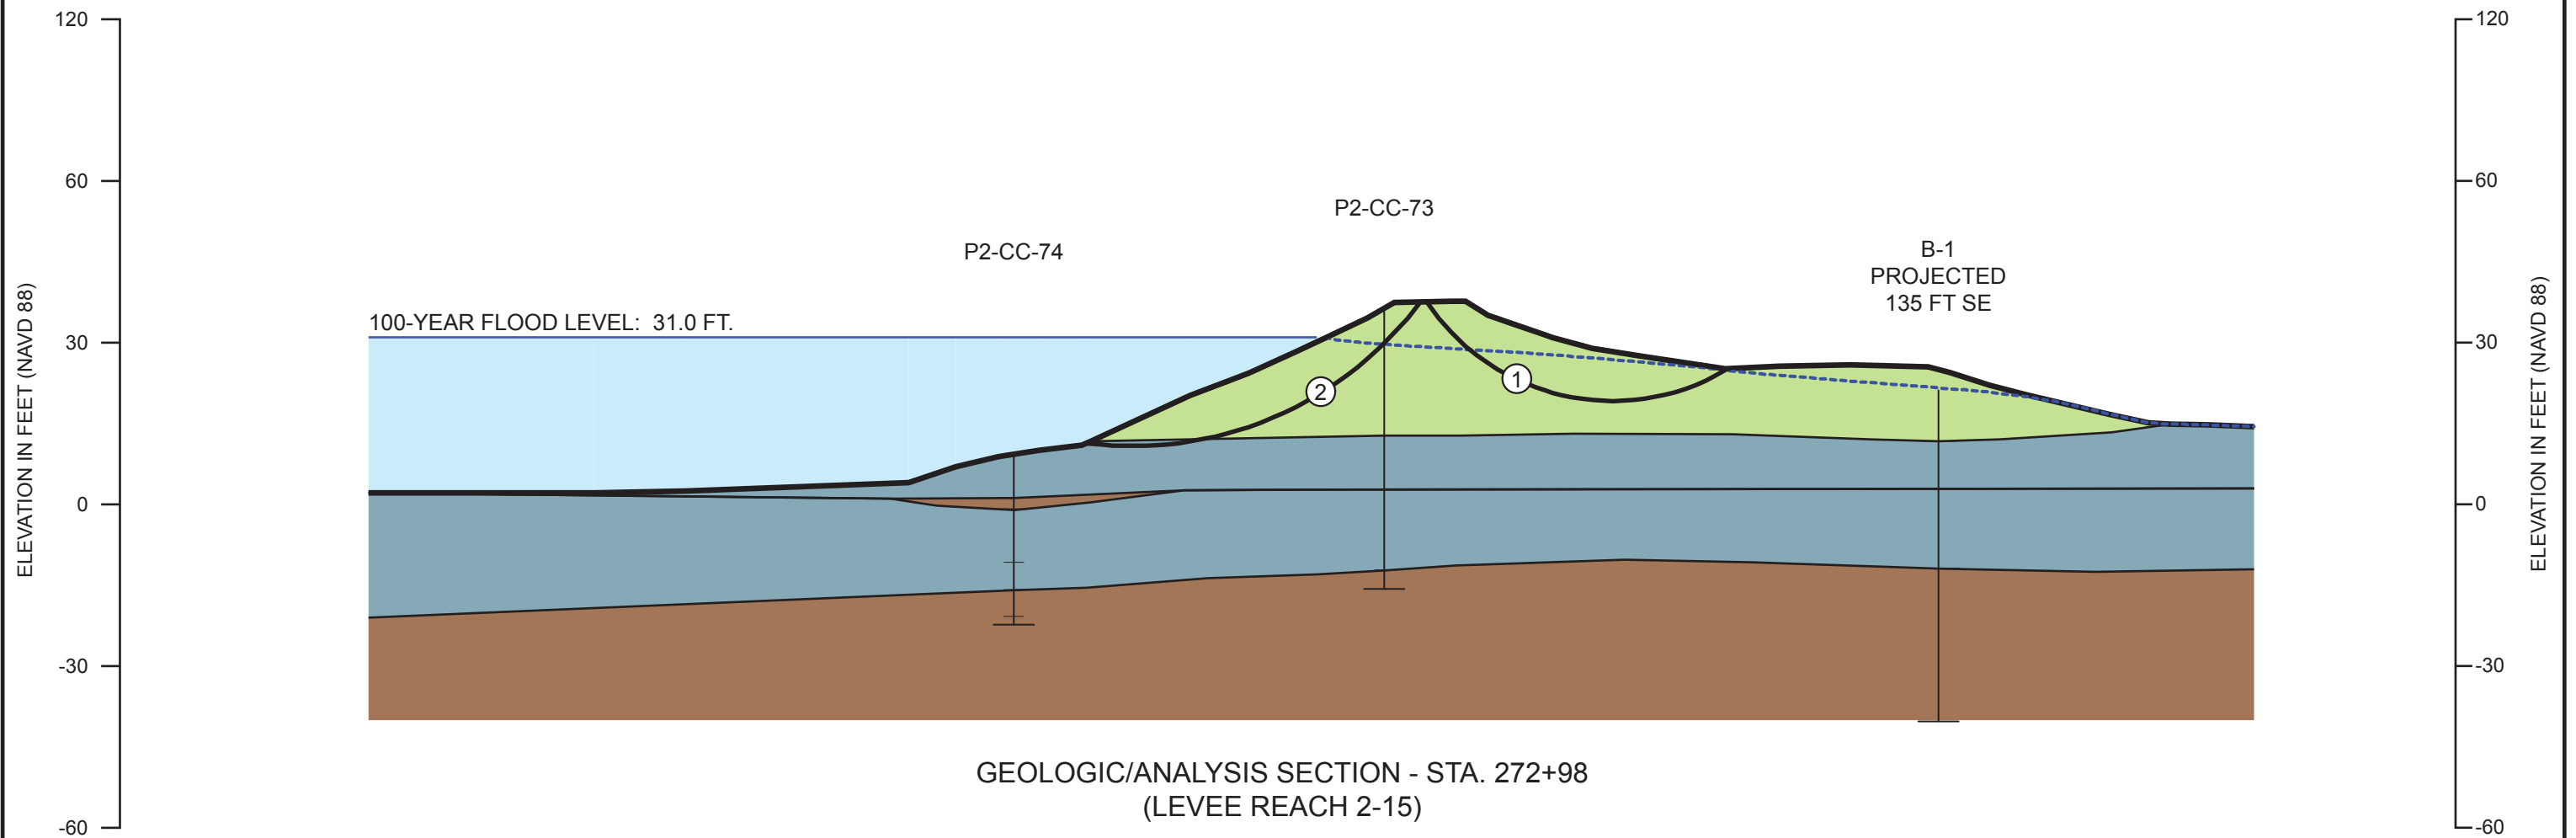
CALCULATED EXIT GRADIENT AT TOE OF LANDWARD
SLOPE = 0.2**

**RECOMMENDED MAXIMUM EXIT GRADIENT = 0.5, USACE,
EM 1110-2-1913

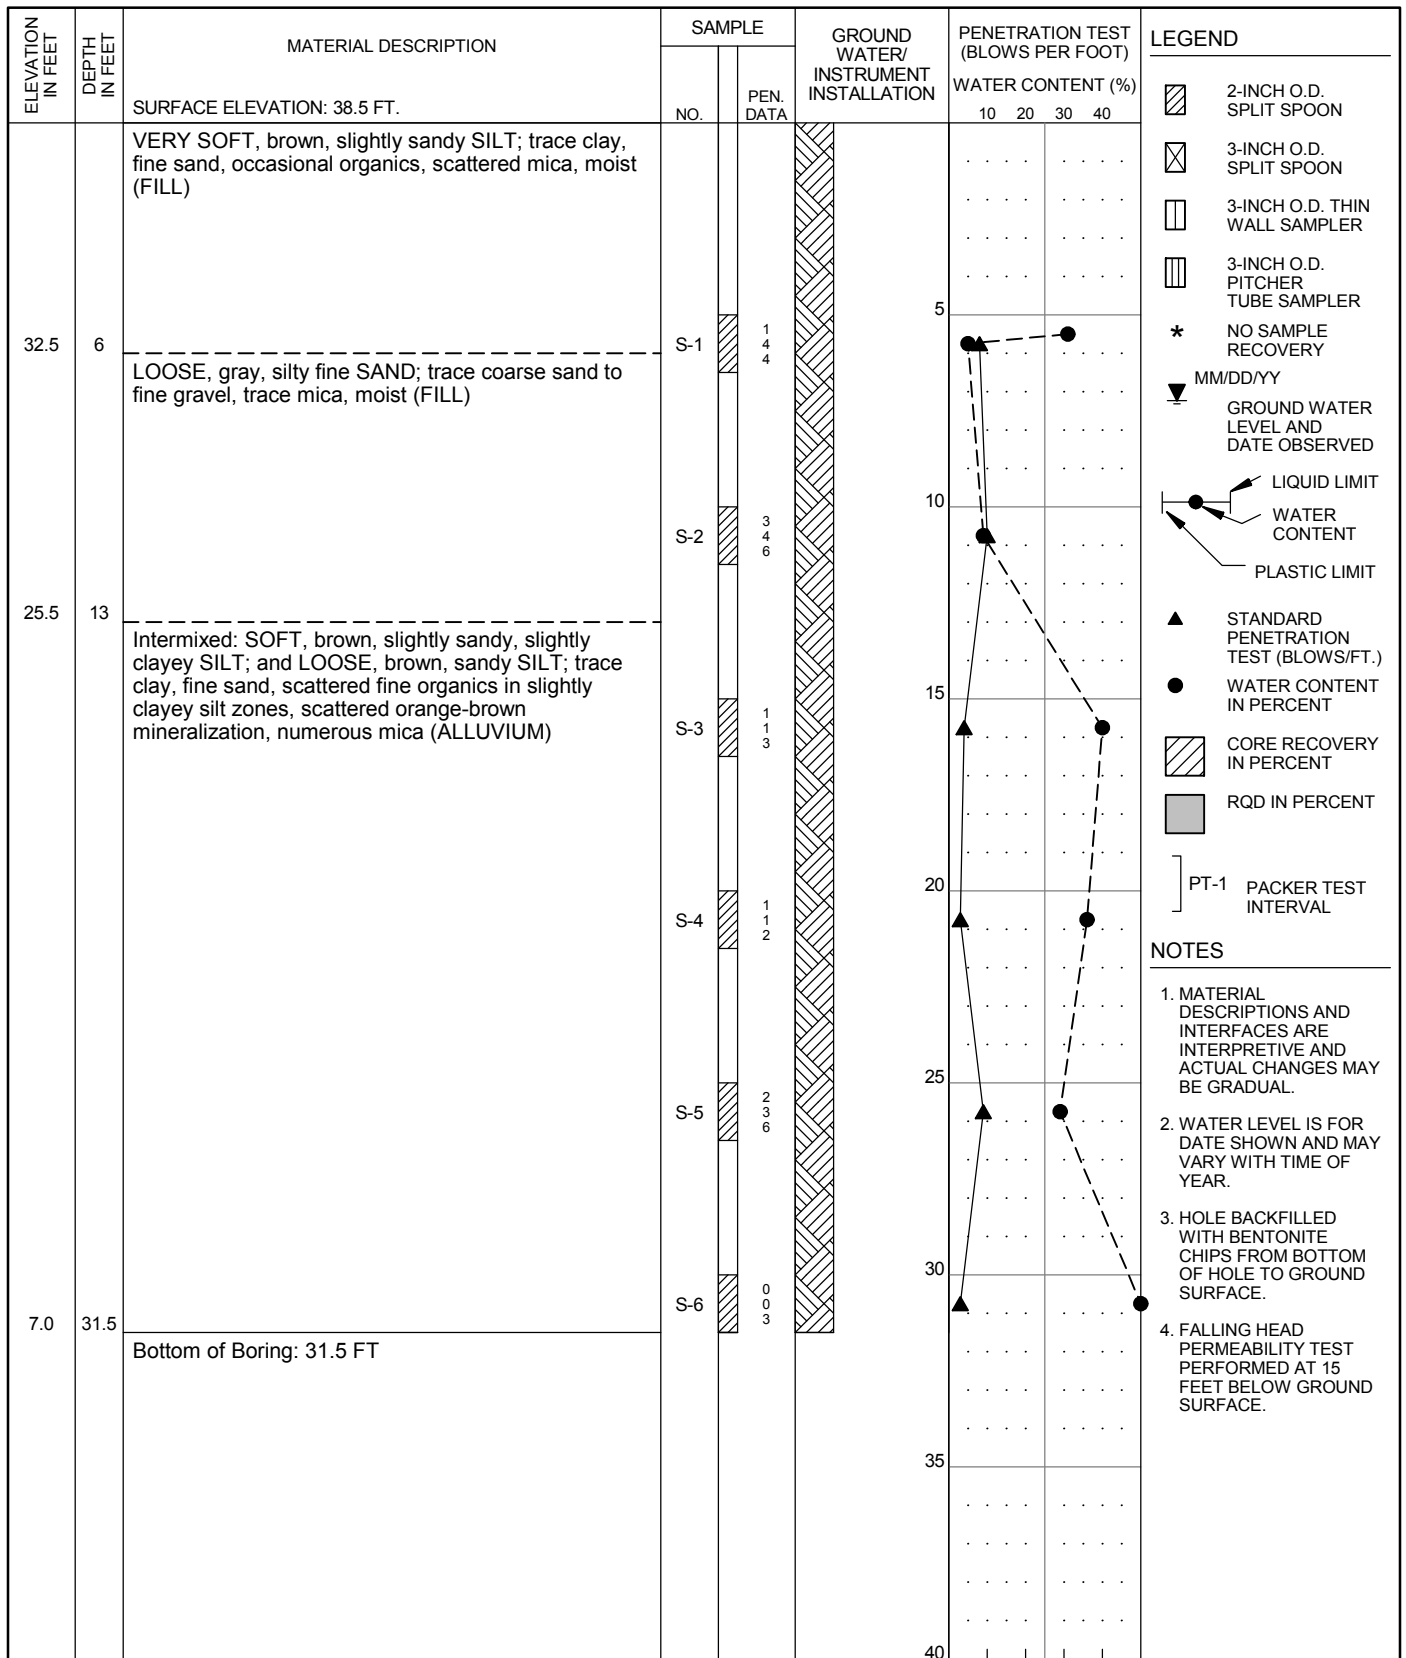
HAMMER ASSEMBLY: AUTO TRIP SPT SAMPLER: NO LINER - RECESSED ID RECOVERY/RQD (%)

DRILL ROD USED: NWJ BOREHOLE DIAM.: 8 1/4"

DRILLER: WESTERN STATES DATE START: 4/10/2014 FINISH: 4/10/2014 DRILLING TECHNIQUE: HOLLOW STEM AUGER	 10250 S.W. Greenburg Road, Suite 111 Portland, Oregon 97223 Phone 503-452-1100 Fax 503-452-1528	SUMMARY BORING LOG P2-CC-4 PENINSULA DISTRICT 2 LEVEE PORTLAND, OR	SEP 2014
			PROJ 2320
			FIG. A4

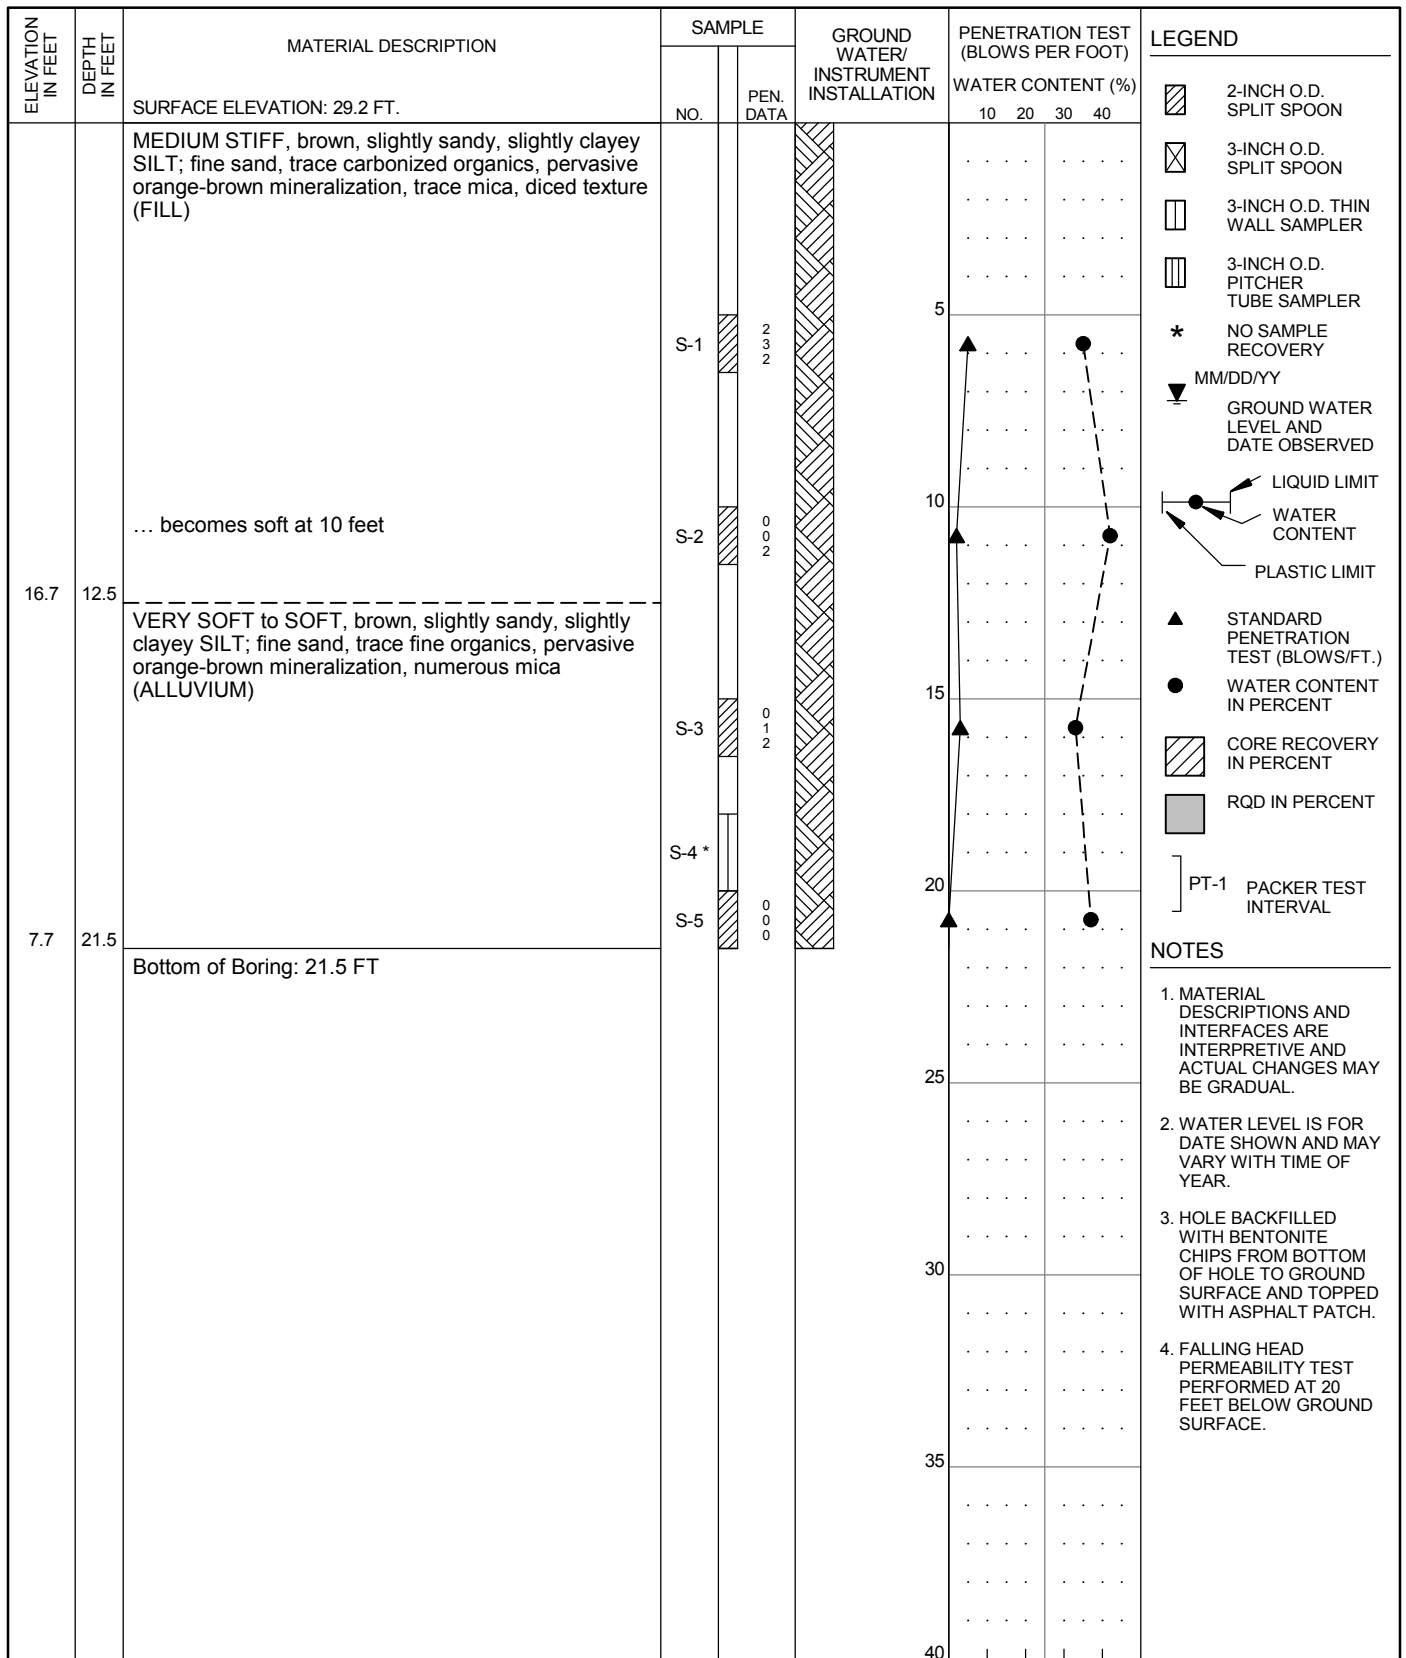
HAMMER ASSEMBLY: AUTO TRIP SPT SAMPLER: NO LINER - RECESSED ID RECOVERY/RQD (%)

DRILL ROD USED: NWJ BOREHOLE DIAM.: 8 1/4"

DRILLER: WESTERN STATES DATE START: 4/7/2014 FINISH: 4/7/2014 DRILLING TECHNIQUE: HOLLOW STEM AUGER	CORNFORTH CONSULTANTS 10250 S.W. Greenburg Road, Suite 111 Portland, Oregon 97223 Phone 503-452-1100 Fax 503-452-1528	SUMMARY BORING LOG P2-CC-9 PENINSULA DISTRICT 2 LEVEE PORTLAND, OR	SEP 2014
			PROJ 2320
			FIG. A9

- NOTES**
- MATERIAL DESCRIPTIONS AND INTERFACES ARE INTERPRETIVE AND ACTUAL CHANGES MAY BE GRADUAL.
 - WATER LEVEL IS FOR DATE SHOWN AND MAY VARY WITH TIME OF YEAR.
 - HOLE BACKFILLED WITH BENTONITE CHIPS FROM BOTTOM OF HOLE TO GROUND SURFACE AND TOPPED WITH ASPHALT PATCH.
 - FALLING HEAD PERMEABILITY TEST PERFORMED AT 20 FEET BELOW GROUND SURFACE.

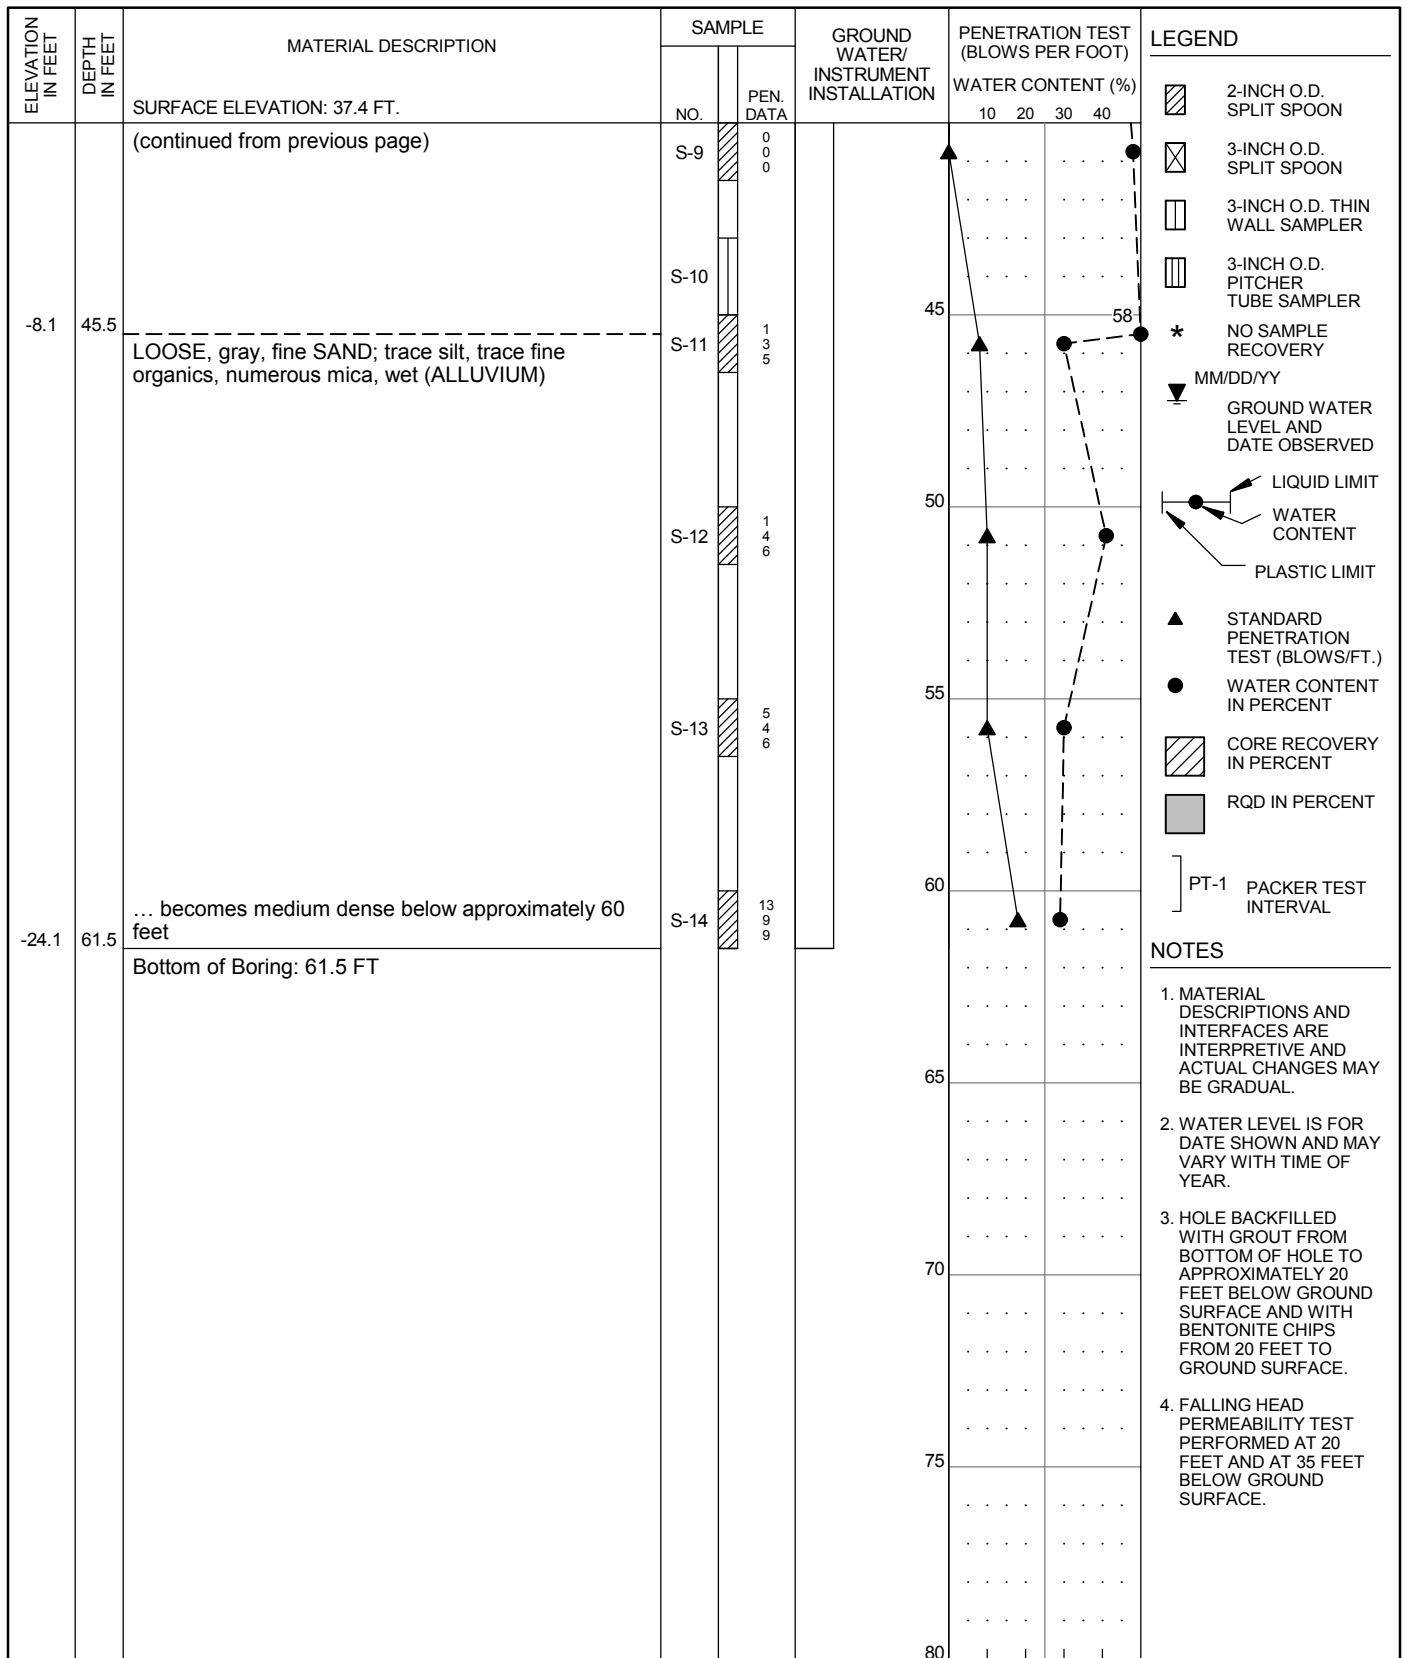
HAMMER ASSEMBLY: AUTO TRIP SPT SAMPLER: NO LINER - RECESSED ID
 DRILL ROD USED: NWJ BOREHOLE DIAM.: 8 1/4" RECOVERY/RQD (%)

DRILLER: WESTERN STATES DATE START: 4/8/2014 FINISH: 4/8/2014 DRILLING TECHNIQUE: HOLLOW STEM AUGER	  CORNFORTH CONSULTANTS 10250 S.W. Greenburg Road, Suite 111 Portland, Oregon 97223 Phone 503-452-1100 Fax 503-452-1528	SUMMARY BORING LOG P2-CC-10 (2 of 2) PENINSULA DISTRICT 2 LEVEE PORTLAND, OR	SEP 2014
			PROJ 2320
			FIG. A10
