Peninsula Drainage District No. 2

Levee Engineering Assessment

**PENINSULA DRAINAGE DISTRICT NO. 2
LEVEE ENGINEERING ASSESSMENT**

October 2, 2014

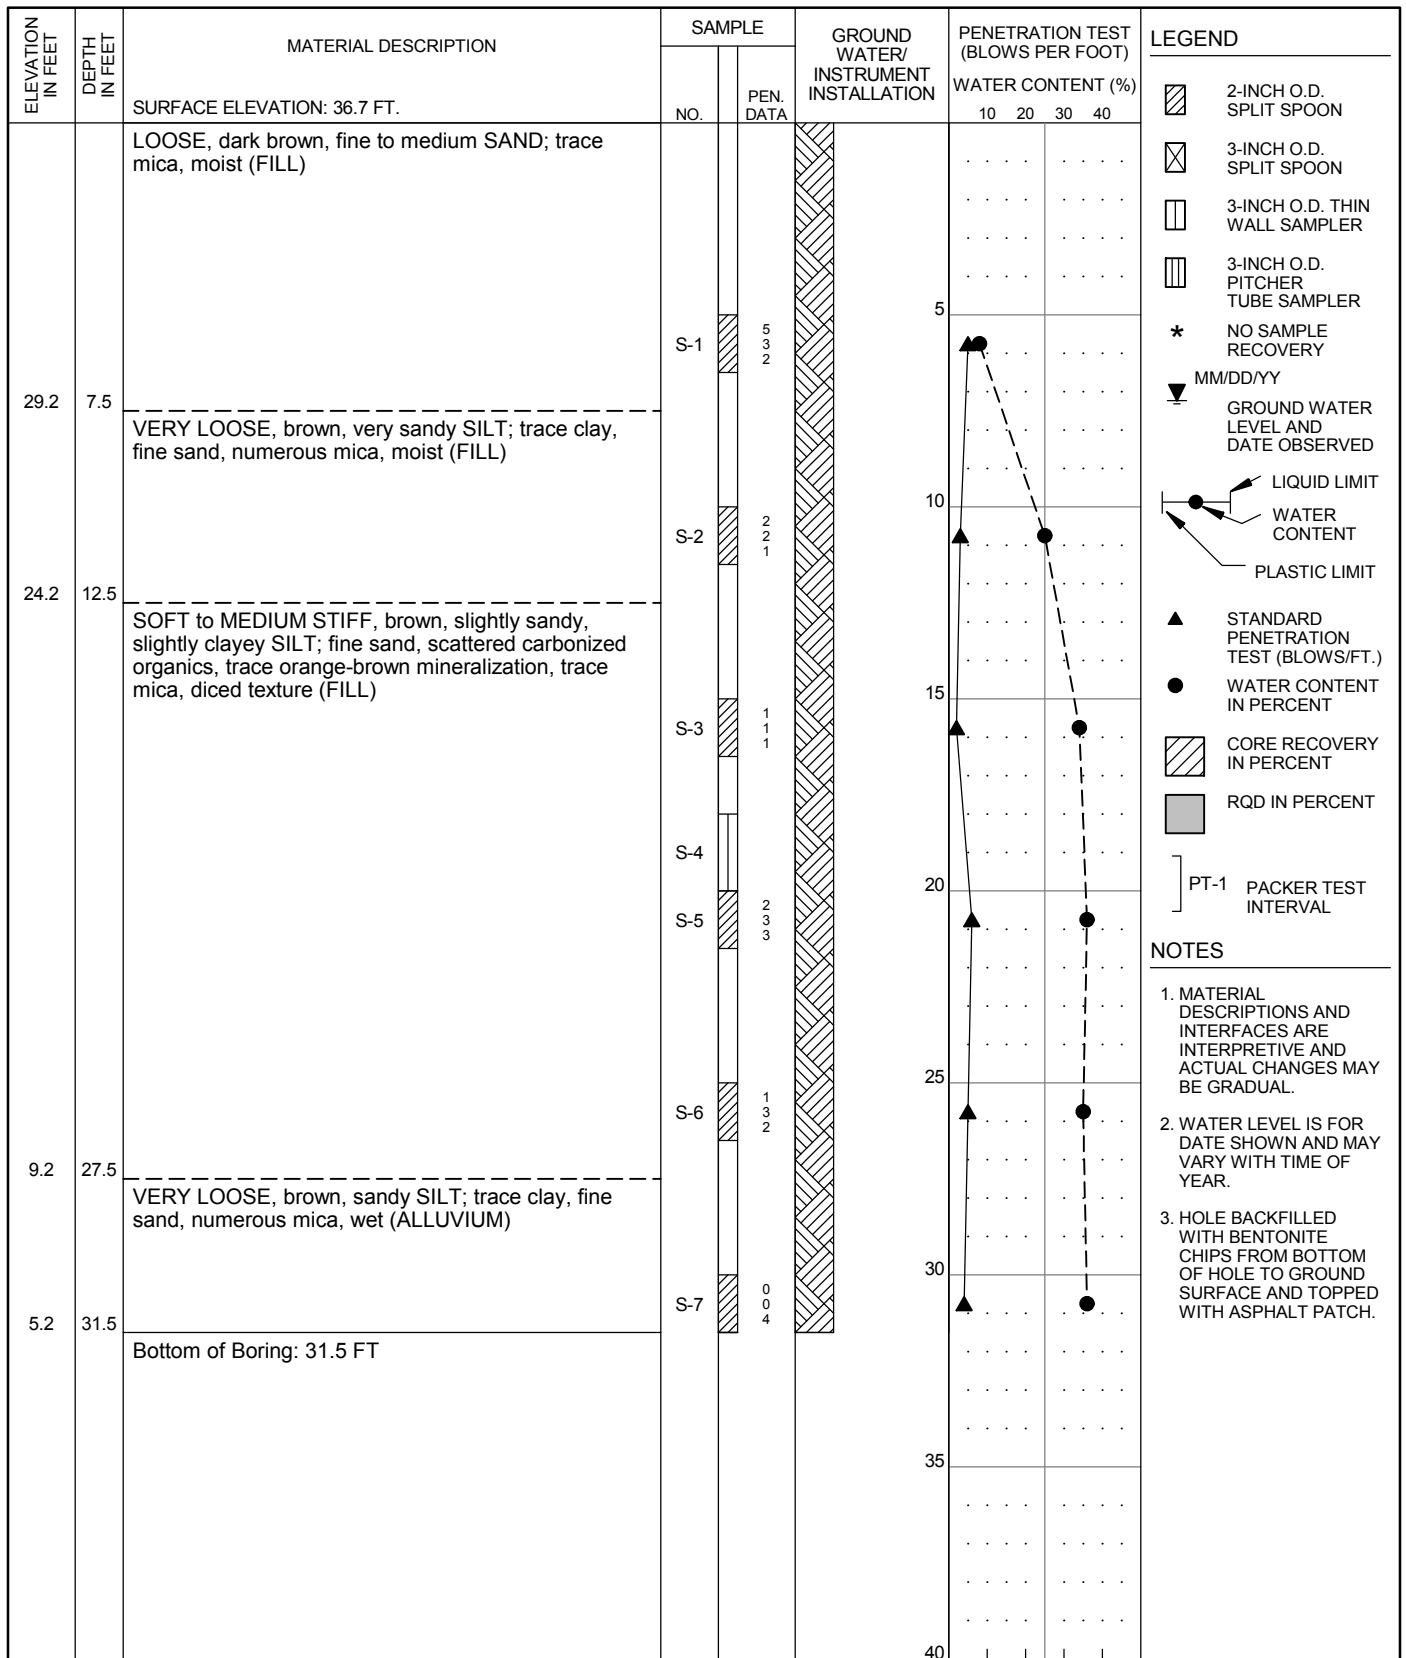
HAMMER ASSEMBLY: AUTO TRIP SPT SAMPLER: NO LINER - RECESSED ID RECOVERY/RQD (%)

DRILL ROD USED: NWJ BOREHOLE DIAM.: 8 1/4"

DRILLER: WESTERN STATES DATE START: 4/7/2014 FINISH: 4/7/2014 DRILLING TECHNIQUE: HOLLOW STEM AUGER	 10250 S.W. Greenburg Road, Suite 111 Portland, Oregon 97223 Phone 503-452-1100 Fax 503-452-1528	SUMMARY BORING LOG P2-CC-13 PENINSULA DISTRICT 2 LEVEE PORTLAND, OR	SEP 2014
			PROJ 2320
			FIG. A13

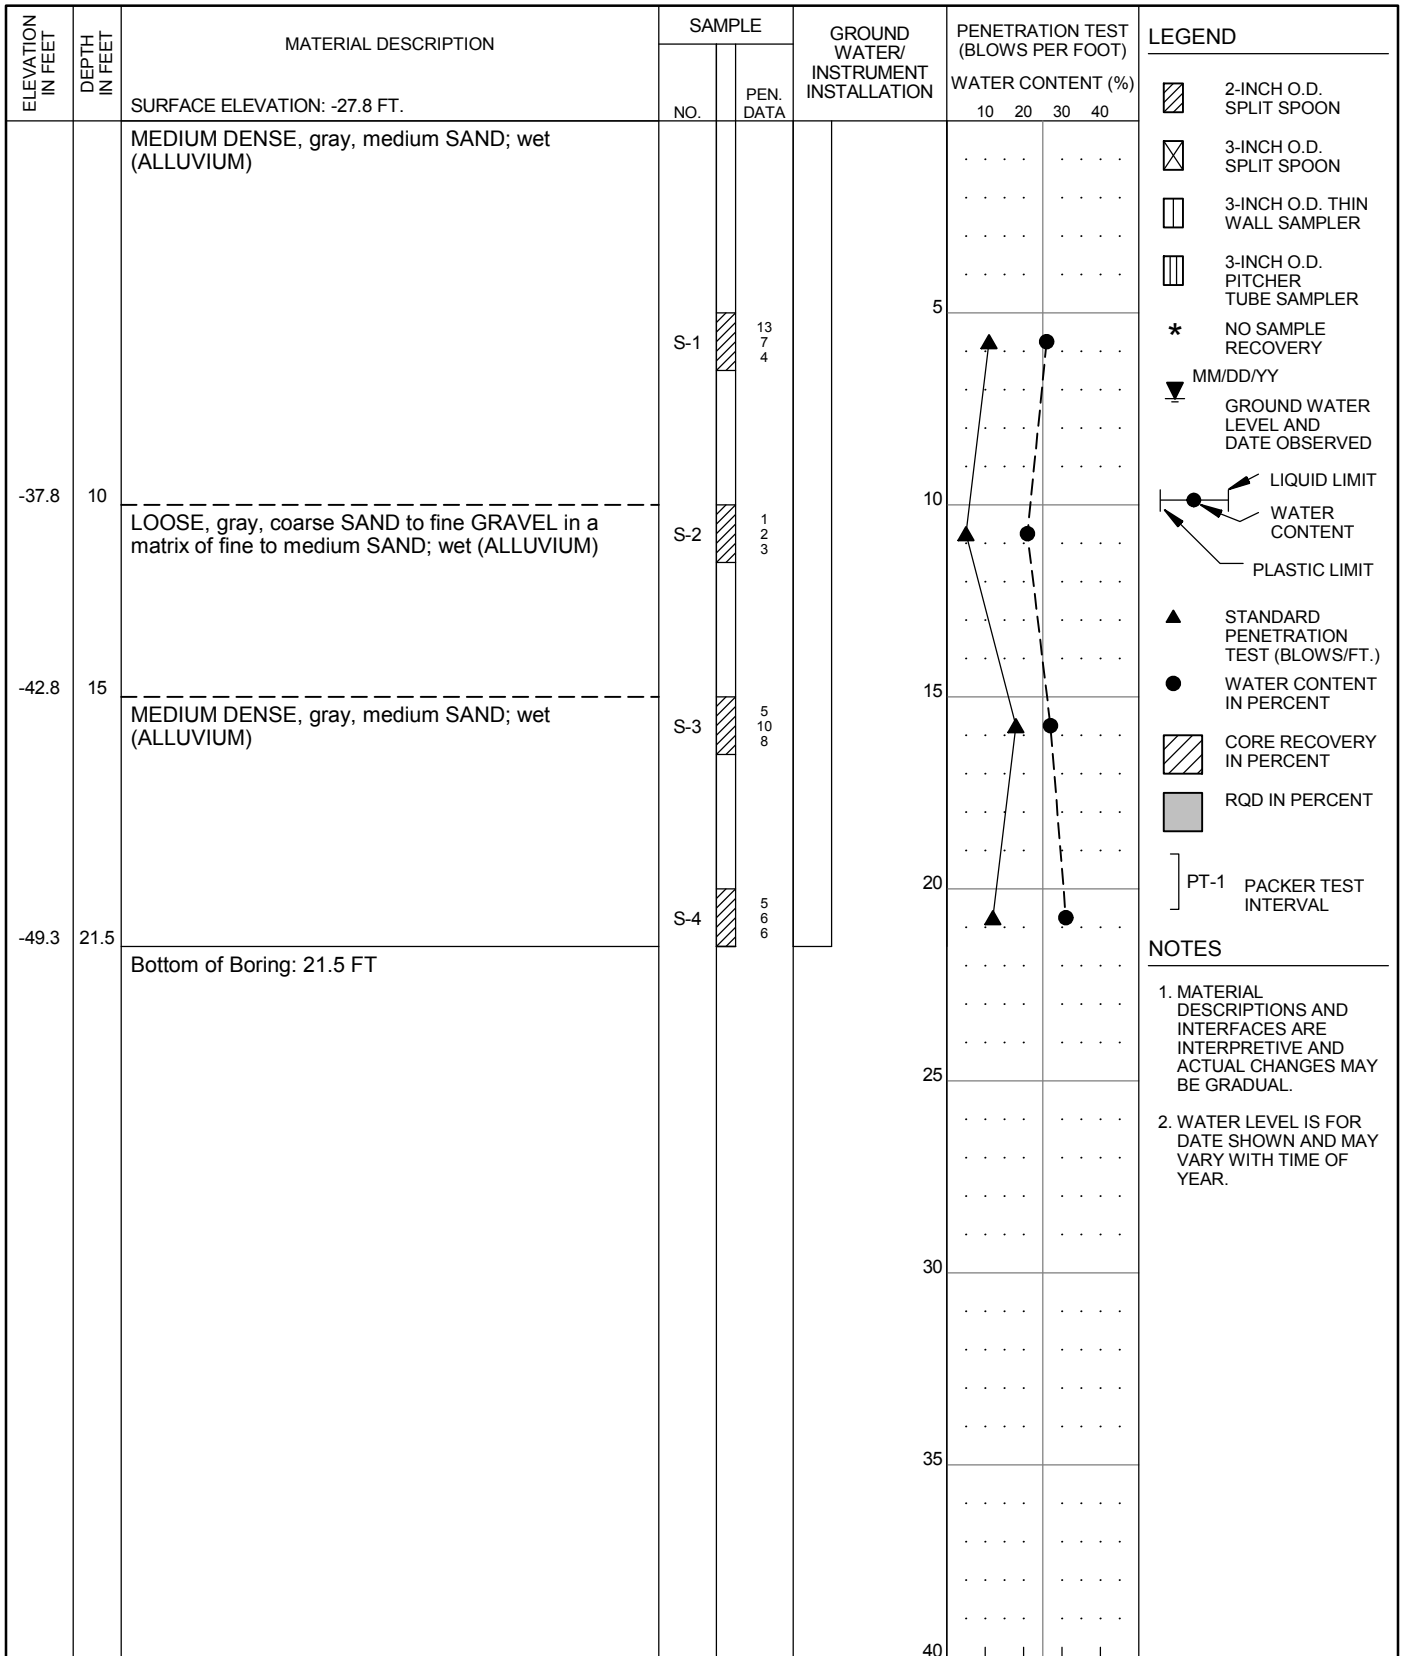
HAMMER ASSEMBLY: AUTO TRIP SPT SAMPLER: NO LINER - RECESSED ID RECOVERY/RQD (%)

DRILL ROD USED: NWJ BOREHOLE DIAM.: 3 7/8"

DRILLER: WESTERN STATES DATE START: 5/13/2014 FINISH: 5/13/2014 DRILLING TECHNIQUE: MUD ROTARY	CORNFORTH CONSULTANTS 10250 S.W. Greenburg Road, Suite 111 Portland, Oregon 97223 Phone 503-452-1100 Fax 503-452-1528	SUMMARY BORING LOG P2-CC-14 PENINSULA DISTRICT 2 LEVEE PORTLAND, OR	SEP 2014 PROJ 2320 FIG. A14
------------------------------------------------------------------------------------------------------	------------------------------------------------------------------------------------------------------------------------------------------	--------------------------------------------------------------------------------------------	------------------------------------------

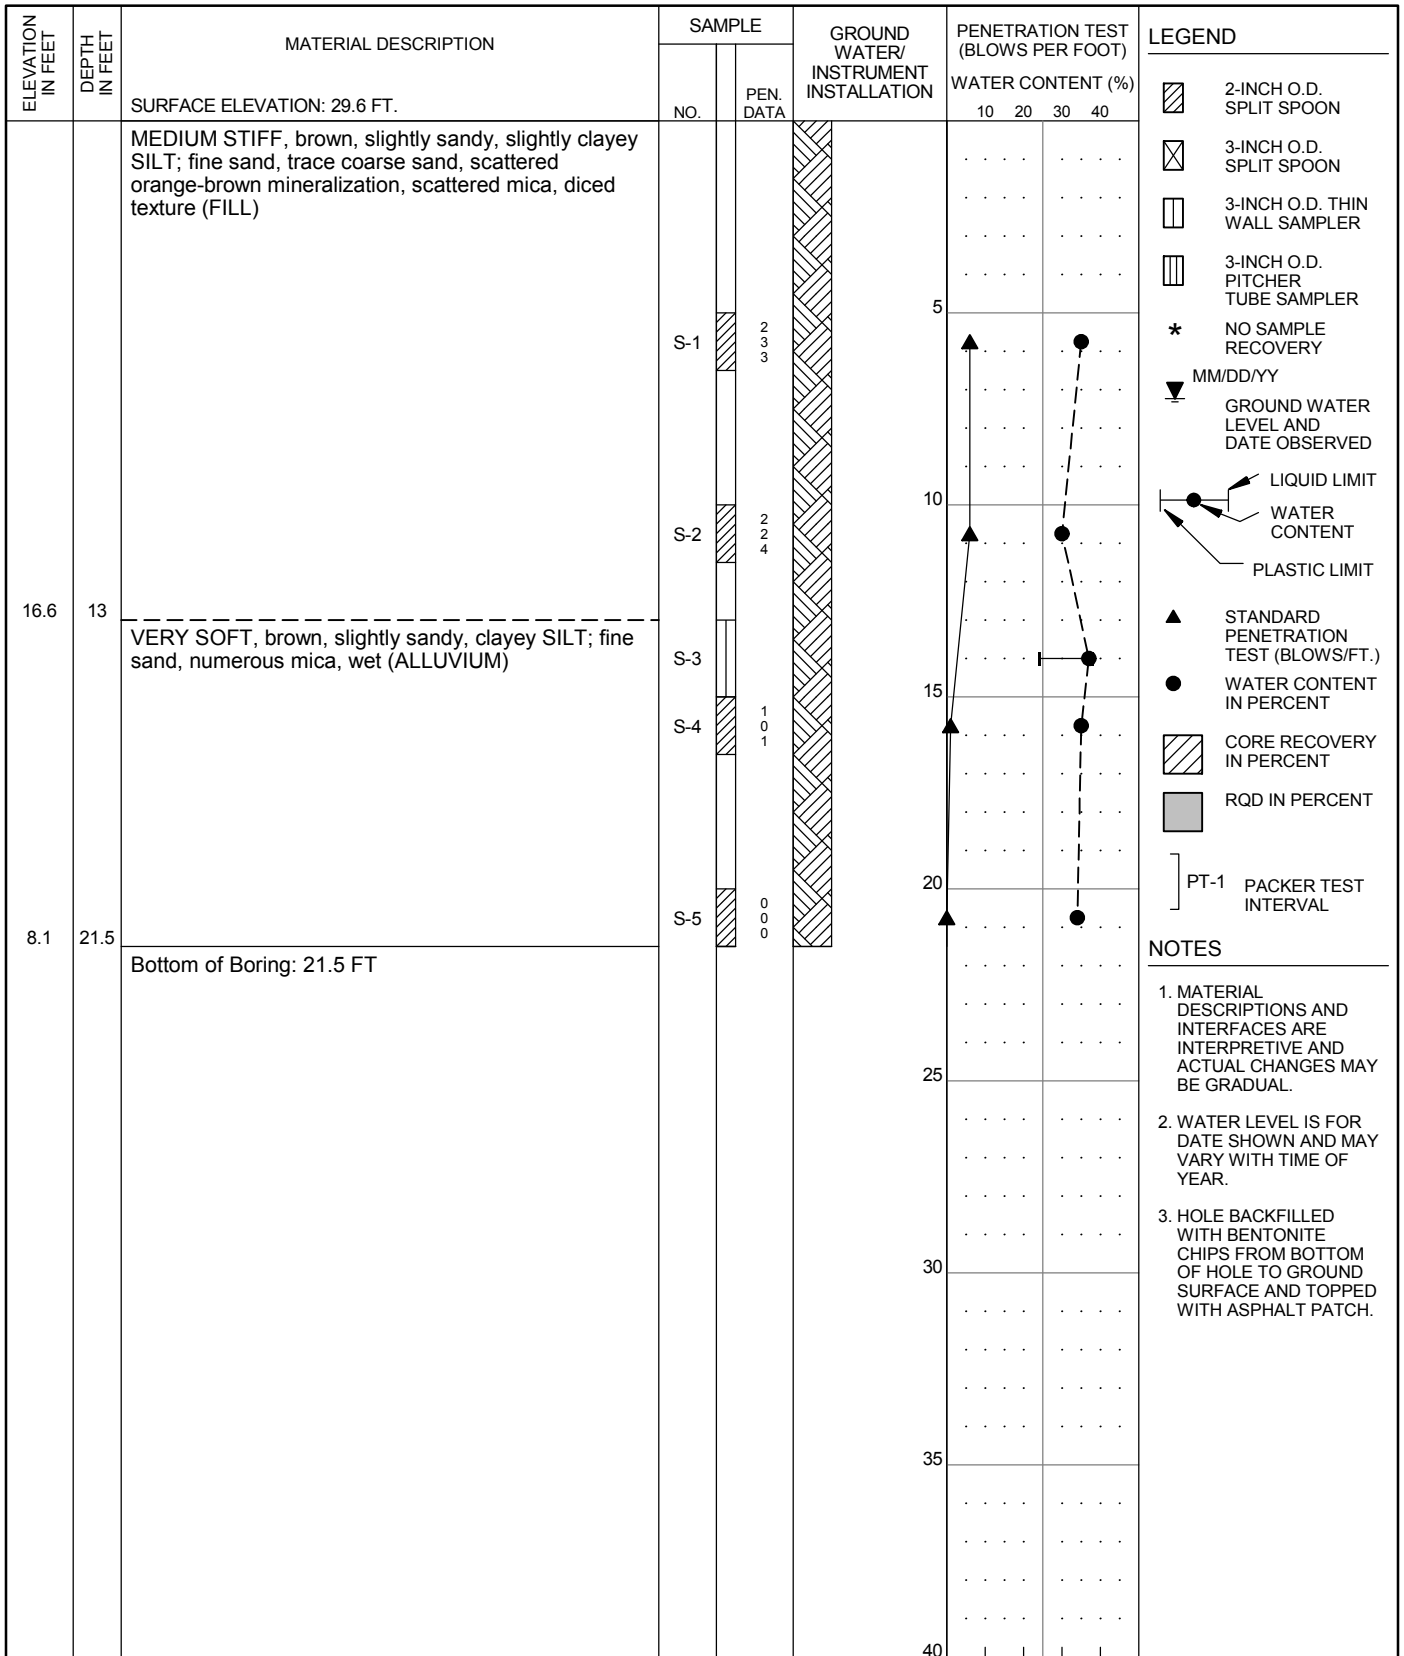
HAMMER ASSEMBLY: AUTO TRIP SPT SAMPLER: NO LINER - RECESSED ID RECOVERY/RQD (%)

DRILL ROD USED: NWJ BOREHOLE DIAM.: 8 1/4"

DRILLER: WESTERN STATES DATE START: 4/7/2014 FINISH: 4/7/2014 DRILLING TECHNIQUE: HOLLOW STEM AUGER	CORNFORTH CONSULTANTS 10250 S.W. Greenburg Road, Suite 111 Portland, Oregon 97223 Phone 503-452-1100 Fax 503-452-1528	SUMMARY BORING LOG P2-CC-15 PENINSULA DISTRICT 2 LEVEE PORTLAND, OR	SEP 2014
			PROJ 2320
			FIG. A15

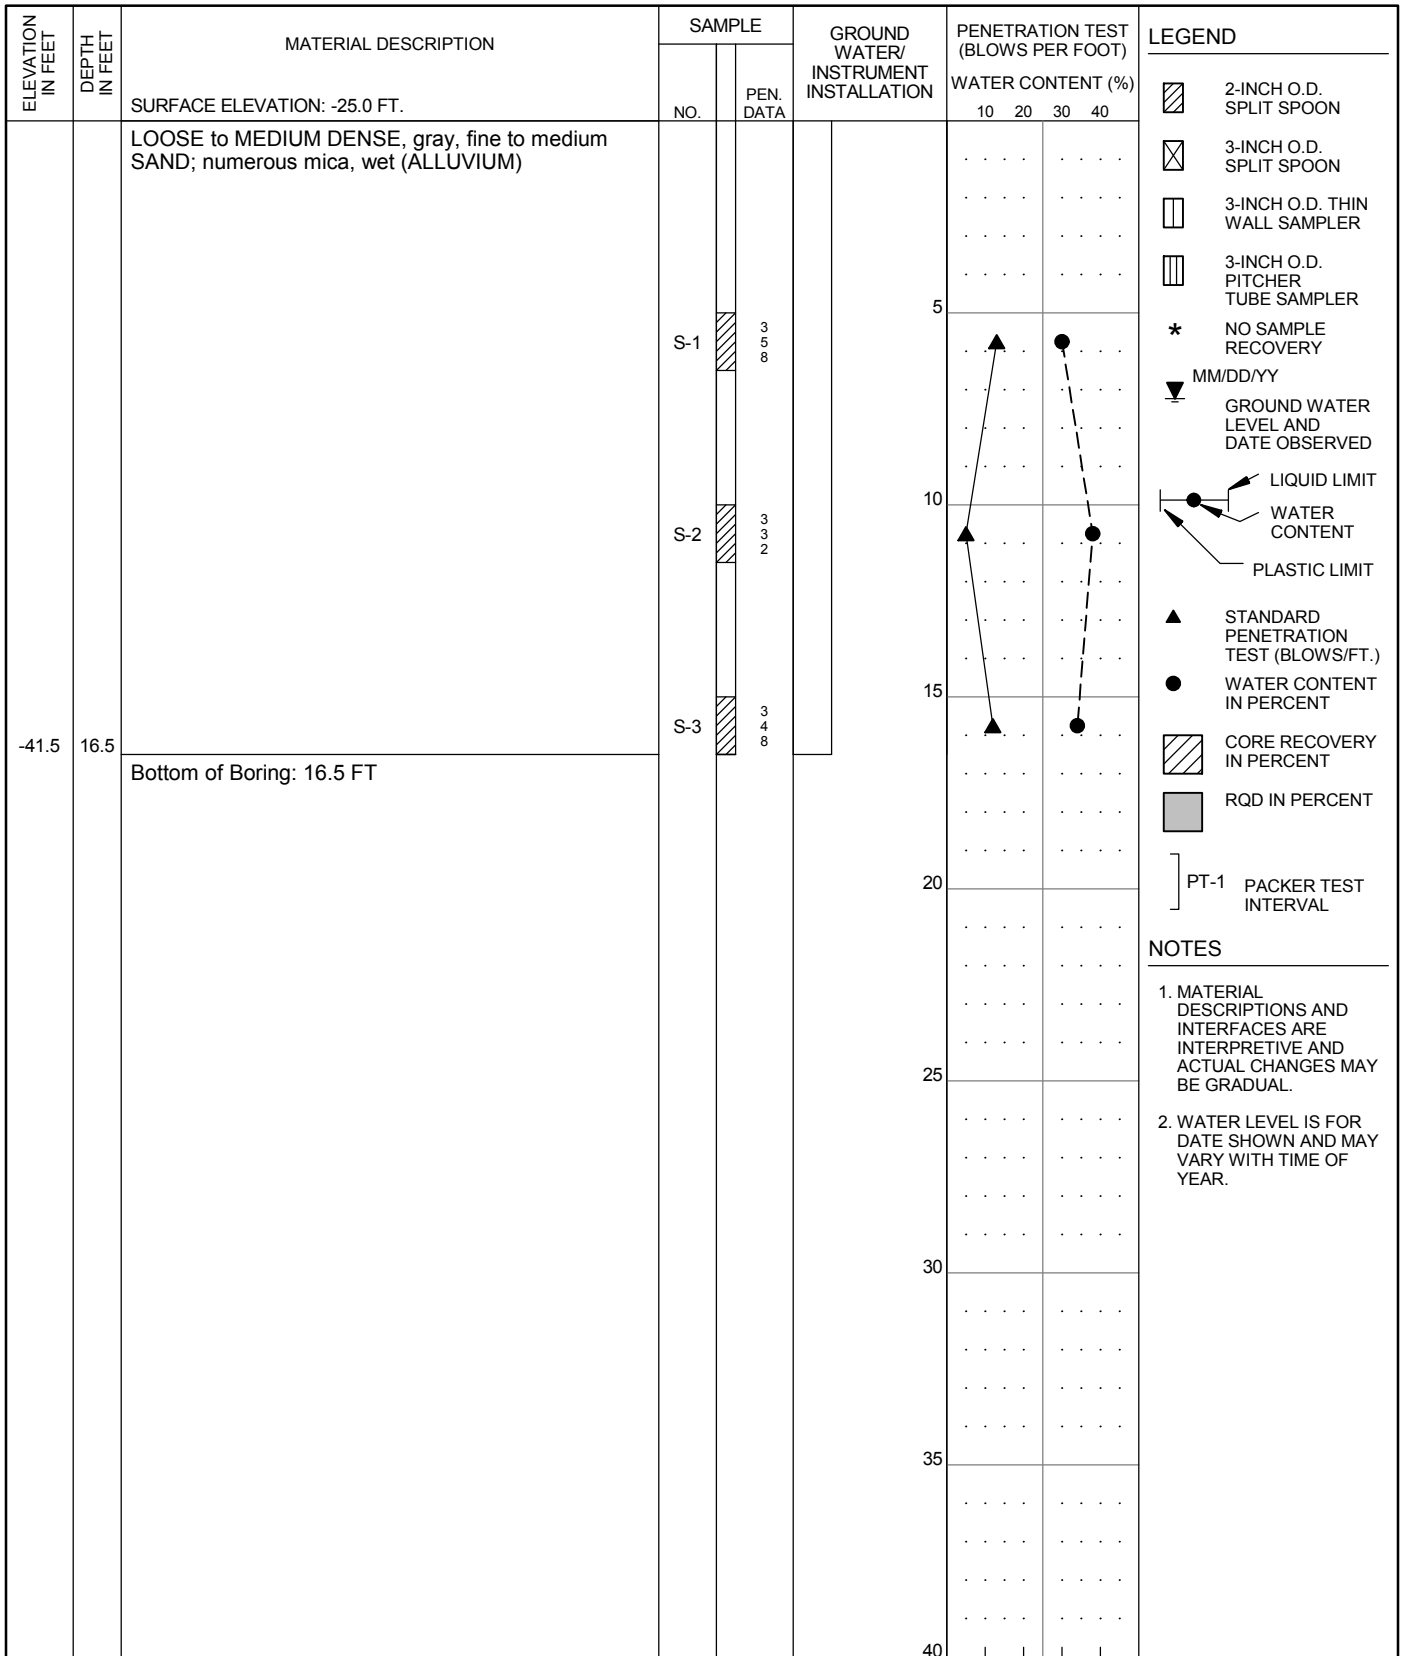
HAMMER ASSEMBLY: AUTO TRIP SPT SAMPLER: NO LINER - RECESSED ID RECOVERY/RQD (%)

DRILL ROD USED: NWJ BOREHOLE DIAM.: 3 7/8"

DRILLER: WESTERN STATES DATE START: 5/13/2014 FINISH: 5/13/2014 DRILLING TECHNIQUE: MUD ROTARY	CORNFORTH CONSULTANTS 10250 S.W. Greenburg Road, Suite 111 Portland, Oregon 97223 Phone 503-452-1100 Fax 503-452-1528	SUMMARY BORING LOG P2-CC-17 PENINSULA DISTRICT 2 LEVEE PORTLAND, OR	SEP 2014 PROJ 2320 FIG. A17
------------------------------------------------------------------------------------------------------	------------------------------------------------------------------------------------------------------------------------------------------	--------------------------------------------------------------------------------------------	------------------------------------------

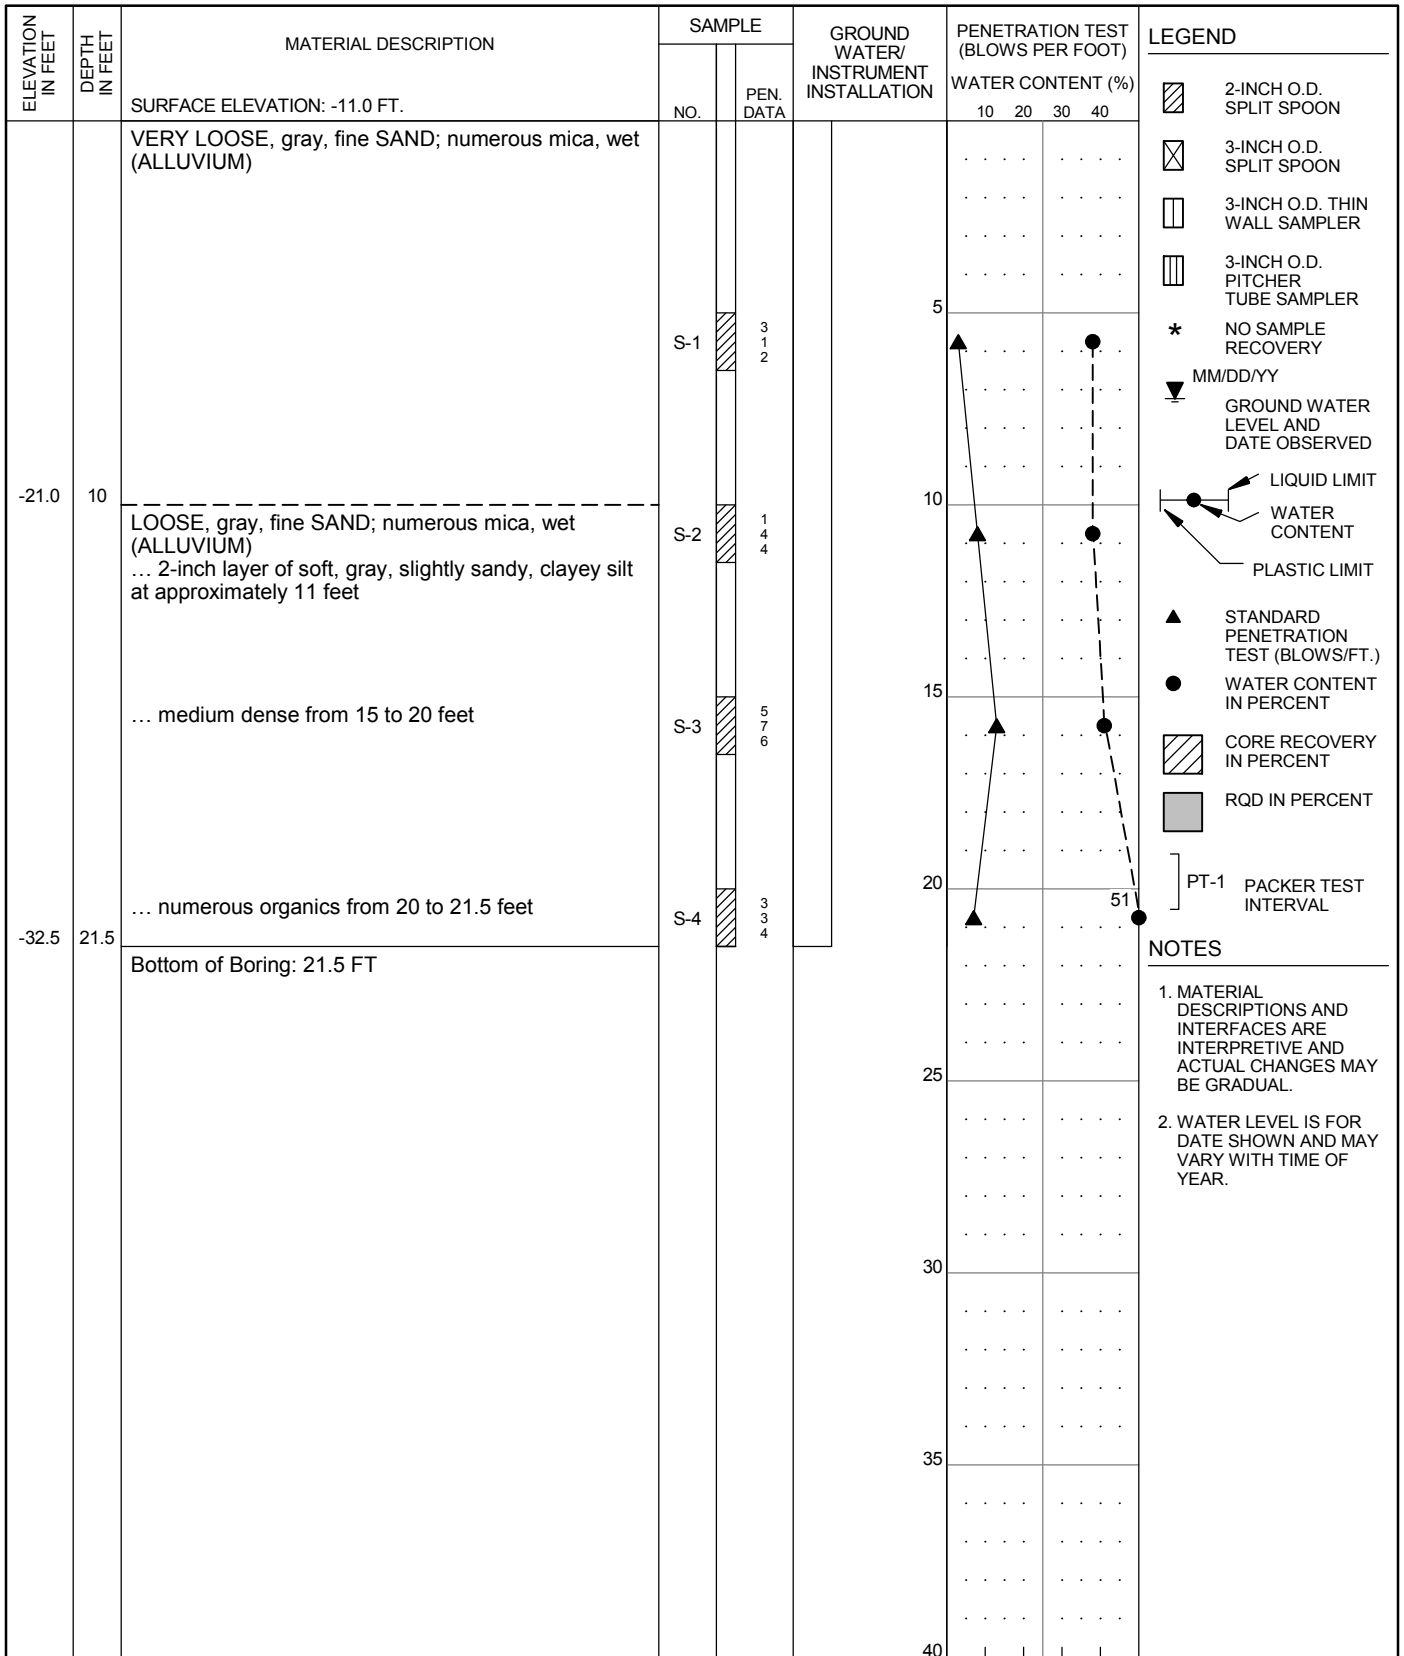
HAMMER ASSEMBLY: AUTO TRIP SPT SAMPLER: NO LINER - RECESSED ID RECOVERY/RQD (%)

DRILL ROD USED: NWJ BOREHOLE DIAM.: 3 7/8"

DRILLER: WESTERN STATES DATE START: 5/15/2014 FINISH: 5/15/2014 DRILLING TECHNIQUE: MUD ROTARY	CORNFORTH CONSULTANTS 10250 S.W. Greenburg Road, Suite 111 Portland, Oregon 97223 Phone 503-452-1100 Fax 503-452-1528	SUMMARY BORING LOG P2-CC-20 PENINSULA DISTRICT 2 LEVEE PORTLAND, OR	SEP 2014
			PROJ 2320
			FIG. A20

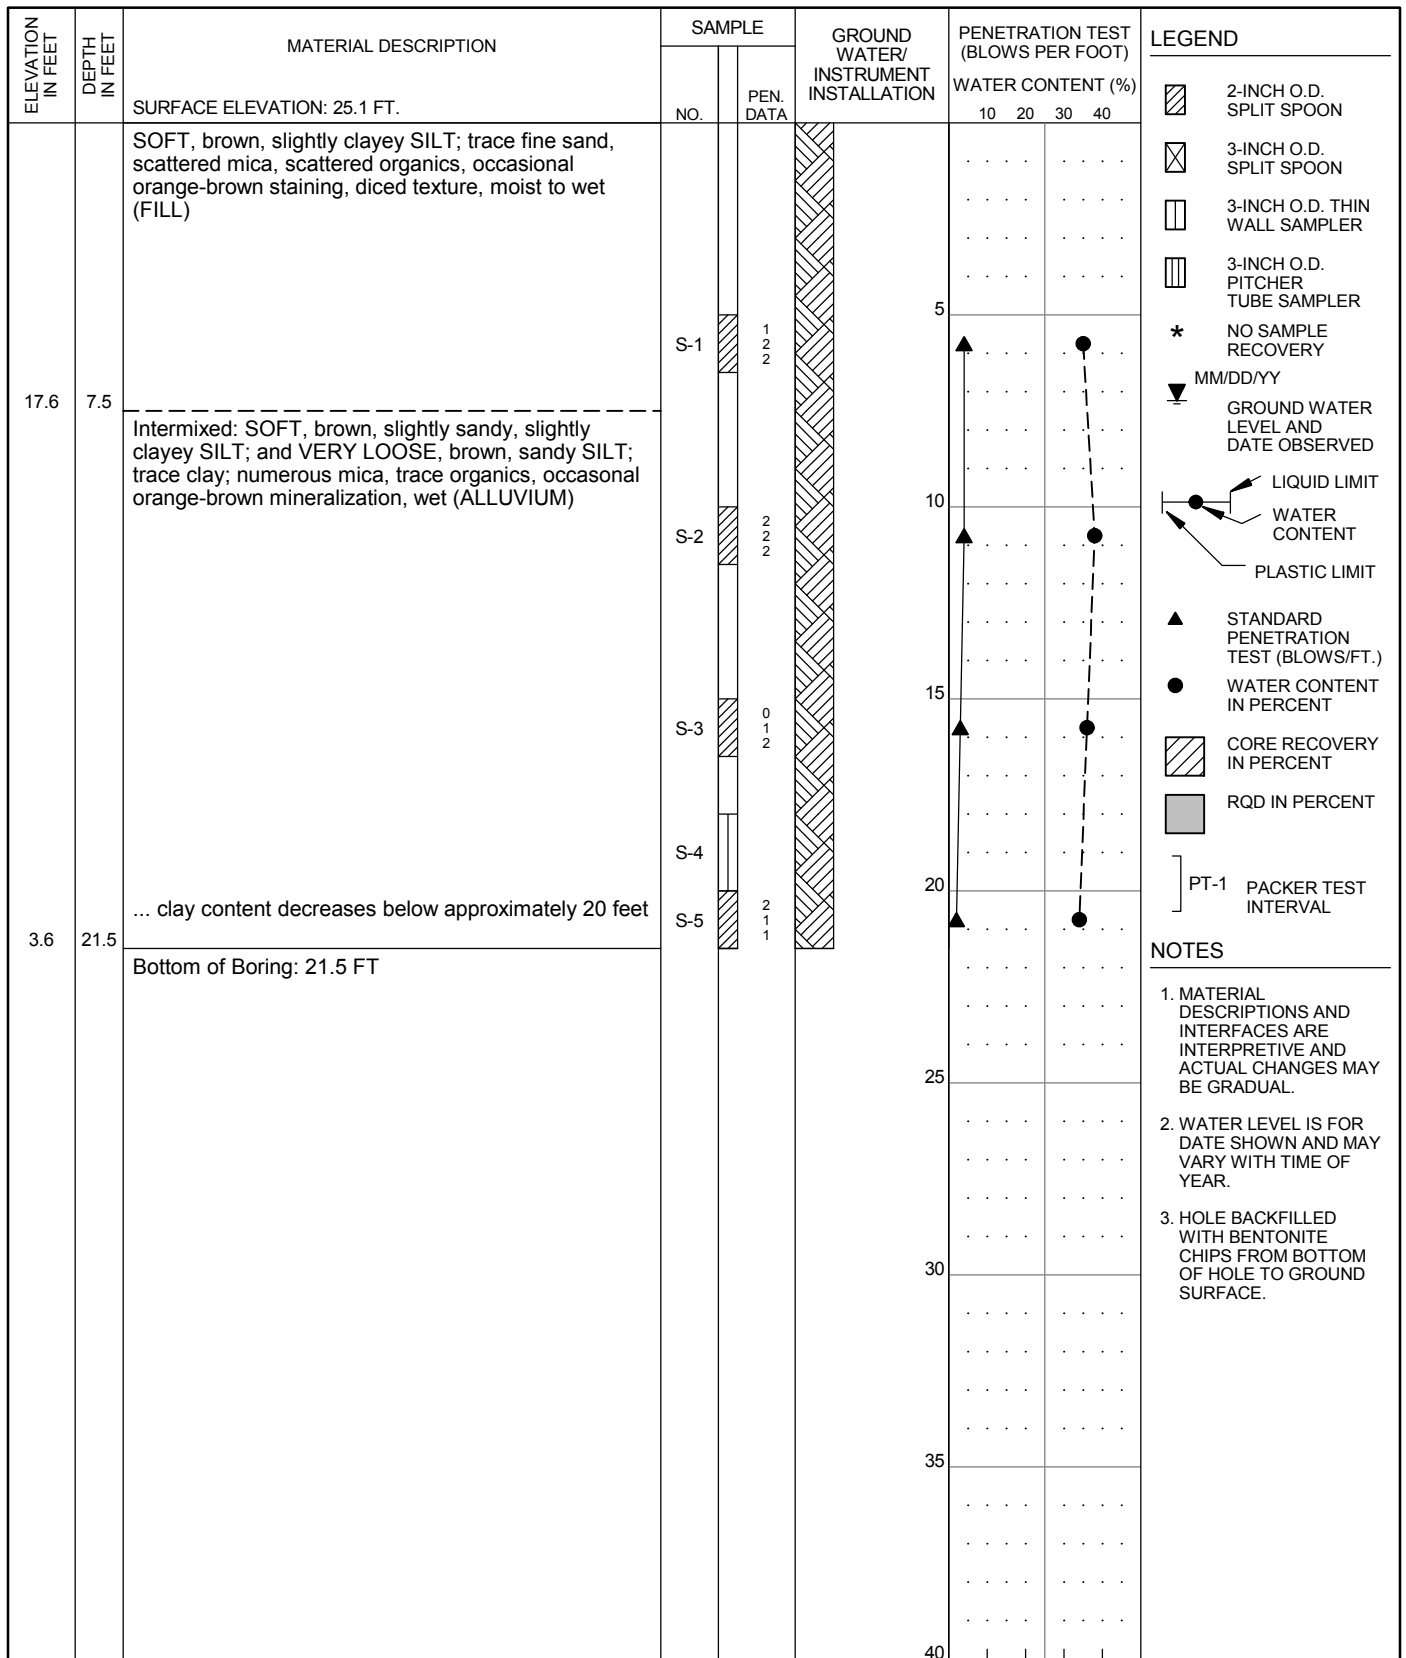
HAMMER ASSEMBLY: AUTO TRIP SPT SAMPLER: NO LINER - RECESSED ID RECOVERY/RQD (%)

DRILL ROD USED: NWJ BOREHOLE DIAM.: 4 7/8"

DRILLER: WESTERN STATES DATE START: 4/2/2014 FINISH: 4/2/2014 DRILLING TECHNIQUE: MUD ROTARY	CORNFORTH CONSULTANTS 10250 S.W. Greenburg Road, Suite 111 Portland, Oregon 97223 Phone 503-452-1100 Fax 503-452-1528	SUMMARY BORING LOG P2-CC-21 PENINSULA DISTRICT 2 LEVEE PORTLAND, OR	SEP 2014 PROJ 2320 FIG. A21
----------------------------------------------------------------------------------------------------	------------------------------------------------------------------------------------------------------------------------------------------	--------------------------------------------------------------------------------------------	------------------------------------------

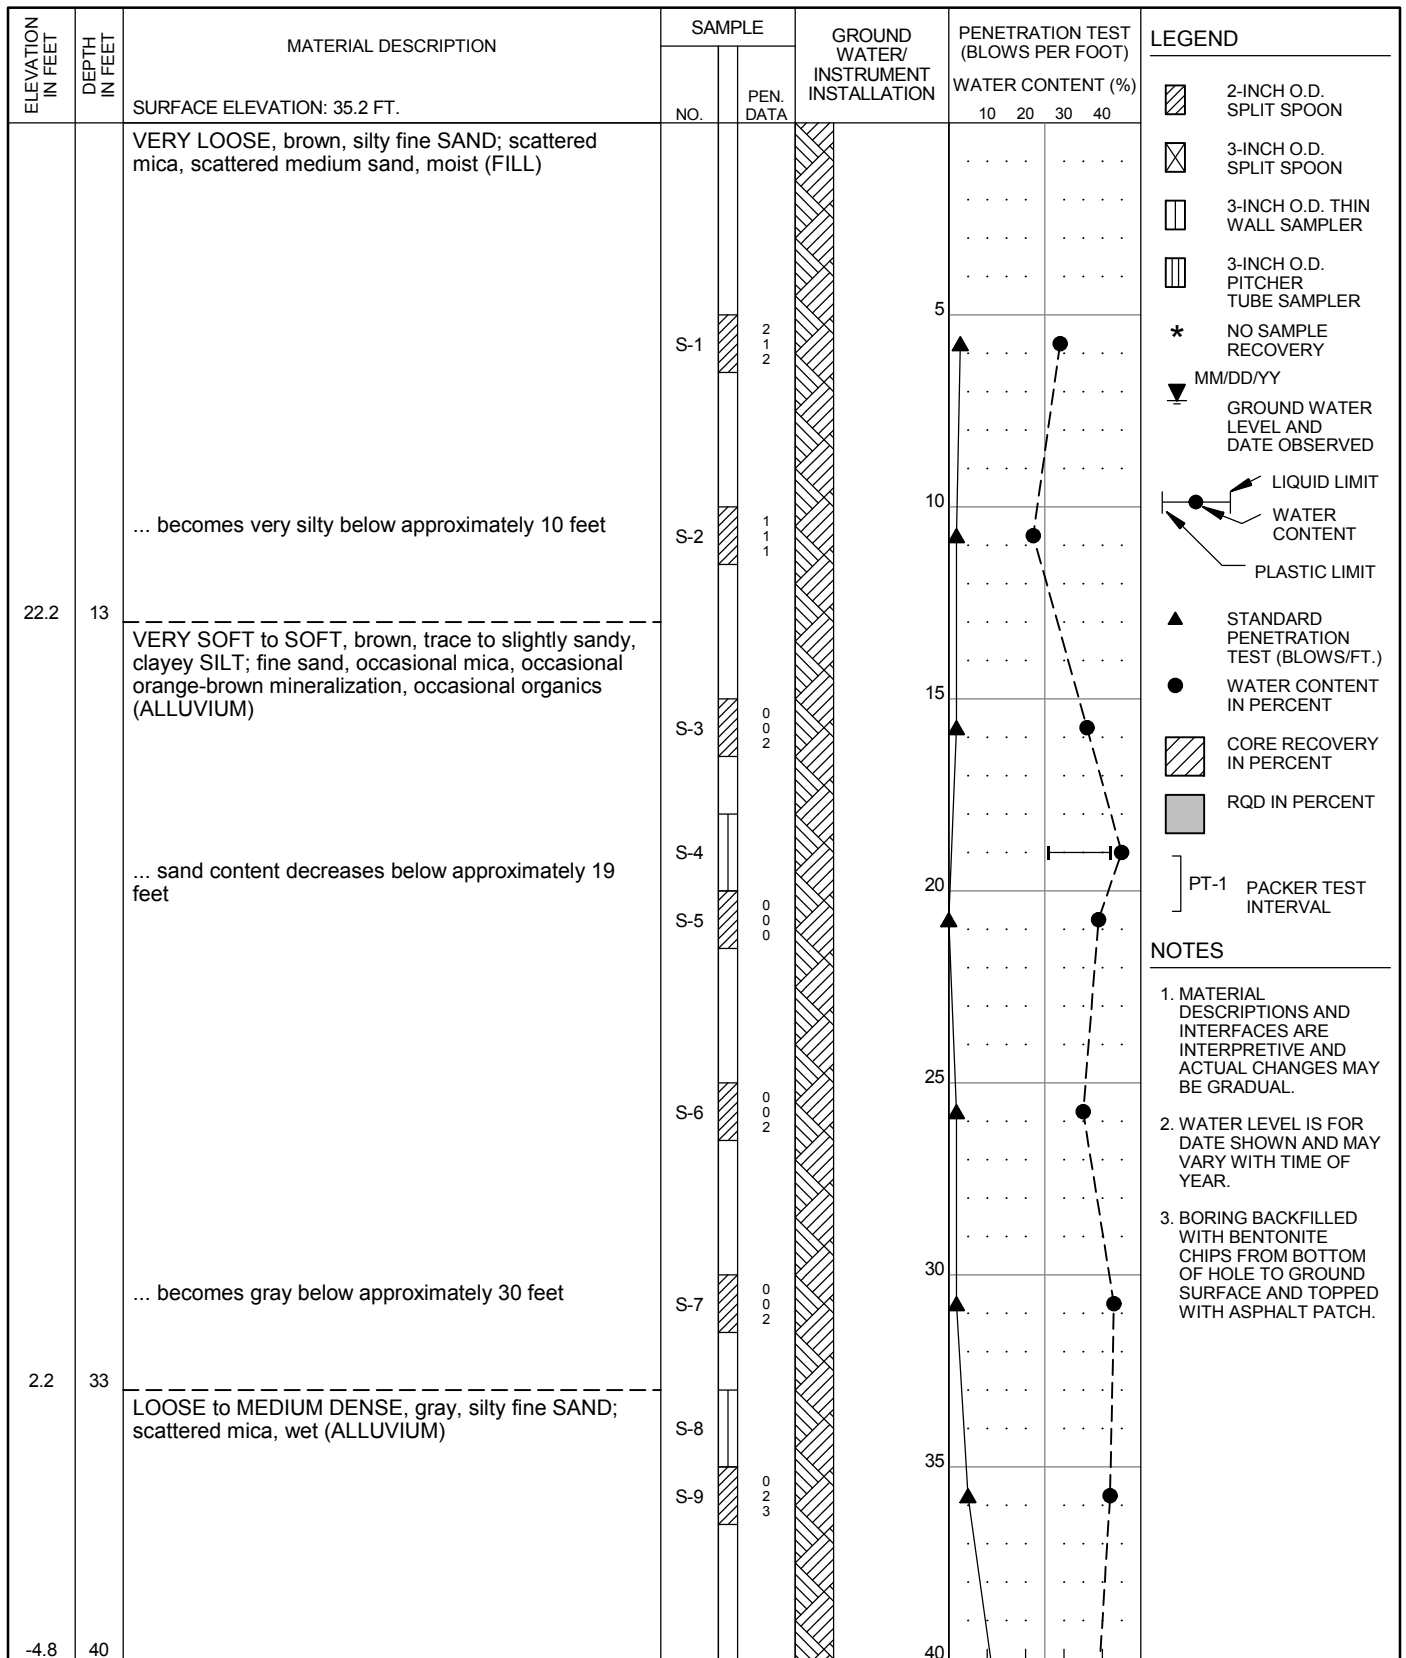
HAMMER ASSEMBLY: AUTO TRIP SPT SAMPLER: NO LINER - RECESSED ID
 DRILL ROD USED: NWJ BOREHOLE DIAM.: 8 1/4"

DRILLER: WESTERN STATES
 DATE START: 4/2/2014 FINISH: 4/2/2014
 DRILLING TECHNIQUE: HOLLOW STEM
 AUGER

HAMMER ASSEMBLY: AUTO TRIP SPT SAMPLER: NO LINER - RECESSED ID RECOVERY/RQD (%)
DRILL ROD USED: NWJ BOREHOLE DIAM.: 8 1/4"

DRILLER: WESTERN STATES DATE START: 4/2/2014 FINISH: 4/2/2014 DRILLING TECHNIQUE: HOLLOW STEM AUGER	CORNFORTH CONSULTANTS 10250 S.W. Greenburg Road, Suite 111 Portland, Oregon 97223 Phone 503-452-1100 Fax 503-452-1528	SUMMARY BORING LOG P2-CC-22 (2 of 2) PENINSULA DISTRICT 2 LEVEE PORTLAND, OR	SEP 2014
			PROJ 2320
			FIG. A22

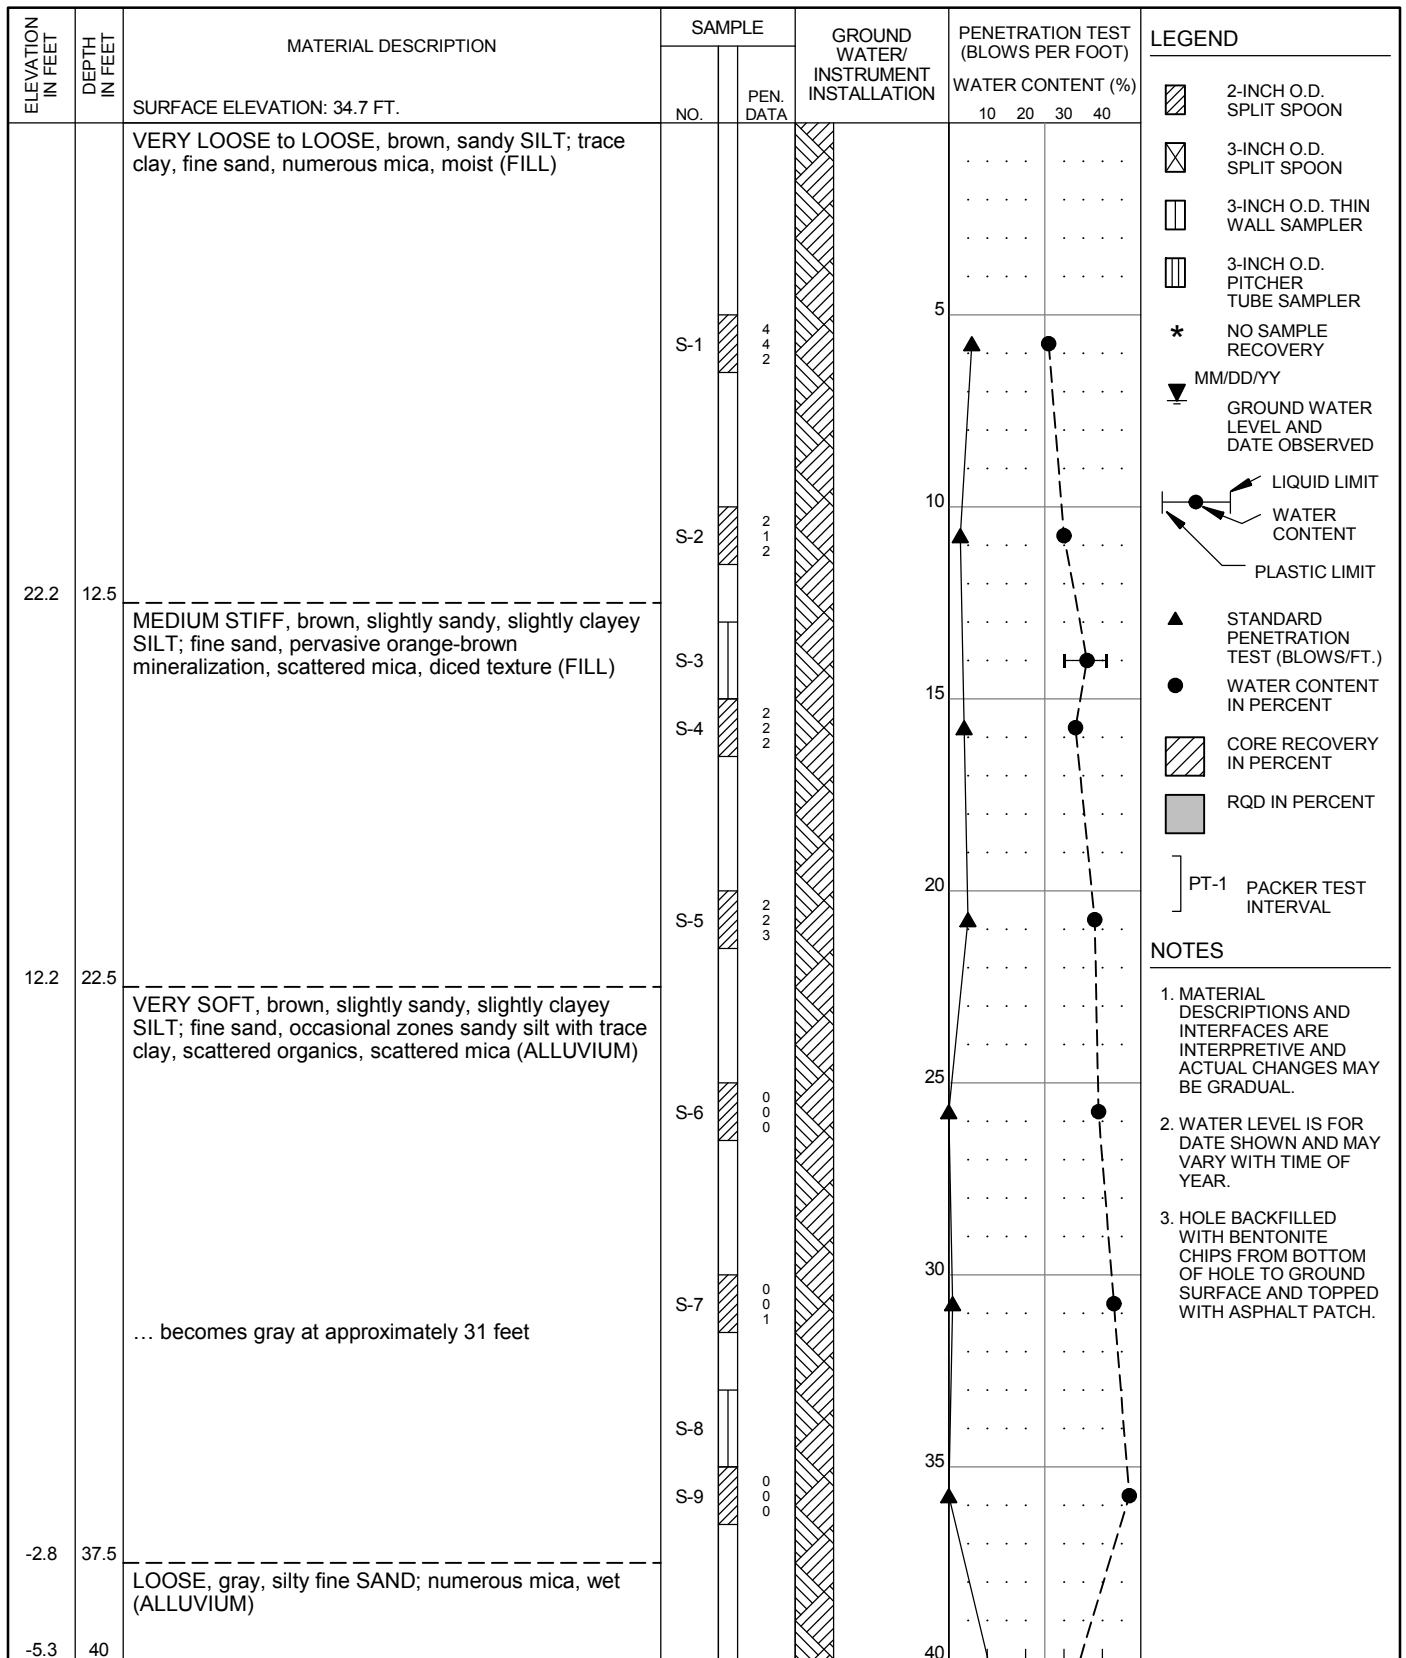
DRILLER: WESTERN STATES DATE START: 4/14/2014 FINISH: 4/14/2014 DRILLING TECHNIQUE: MUD ROTARY	CORNFORTH CONSULTANTS 10250 S.W. Greenburg Road, Suite 111 Portland, Oregon 97223 Phone 503-452-1100 Fax 503-452-1528	SUMMARY BORING LOG P2-CC-24 PENINSULA DISTRICT 2 LEVEE PORTLAND, OR	SEP 2014 PROJ 2320 FIG. A24
------------------------------------------------------------------------------------------------------	------------------------------------------------------------------------------------------------------------------------------------------	--------------------------------------------------------------------------------------------	------------------------------------------

- NOTES**
1. MATERIAL DESCRIPTIONS AND INTERFACES ARE INTERPRETIVE AND ACTUAL CHANGES MAY BE GRADUAL.
 2. WATER LEVEL IS FOR DATE SHOWN AND MAY VARY WITH TIME OF YEAR.
 3. HOLE BACKFILLED WITH BENTONITE CHIPS FROM BOTTOM OF HOLE TO GROUND SURFACE AND TOPPED WITH ASPHALT PATCH.

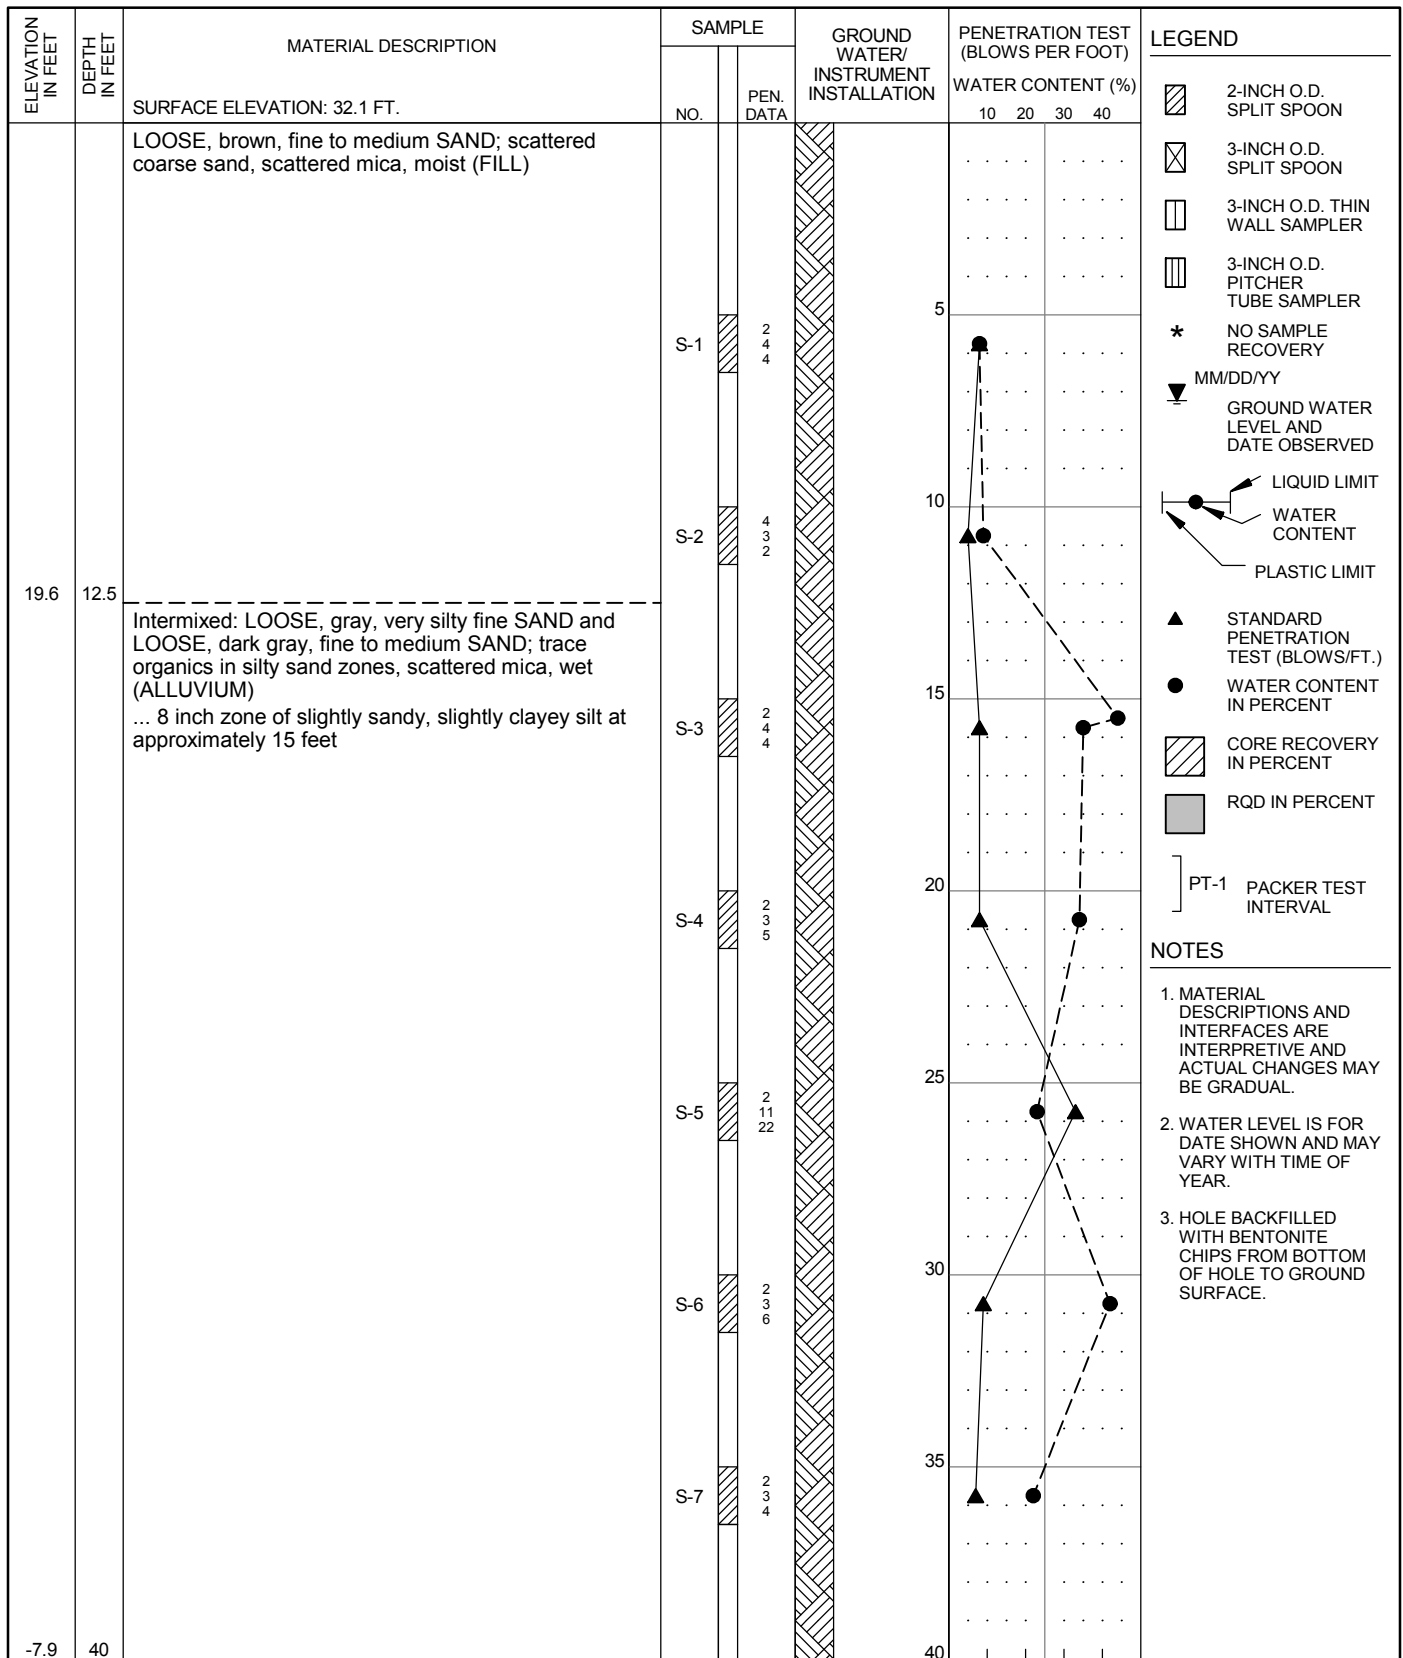
DRILLER: WESTERN STATES DATE START: 4/16/2014 FINISH: 4/16/2014 DRILLING TECHNIQUE: HOLLOW STEM AUGER	CORNFORTH CONSULTANTS 10250 S.W. Greenburg Road, Suite 111 Portland, Oregon 97223 Phone 503-452-1100 Fax 503-452-1528	SUMMARY BORING LOG P2-CC-25 (2 of 2) PENINSULA DISTRICT 2 LEVEE PORTLAND, OR	SEP 2014 PROJ 2320 FIG. A25
-------------------------------------------------------------------------------------------------------------	------------------------------------------------------------------------------------------------------------------------------------------	-----------------------------------------------------------------------------------------------------	------------------------------------------
