Peninsula Drainage District No. 2

Levee Engineering Assessment

**PENINSULA DRAINAGE DISTRICT NO. 2
LEVEE ENGINEERING ASSESSMENT**

October 2, 2014

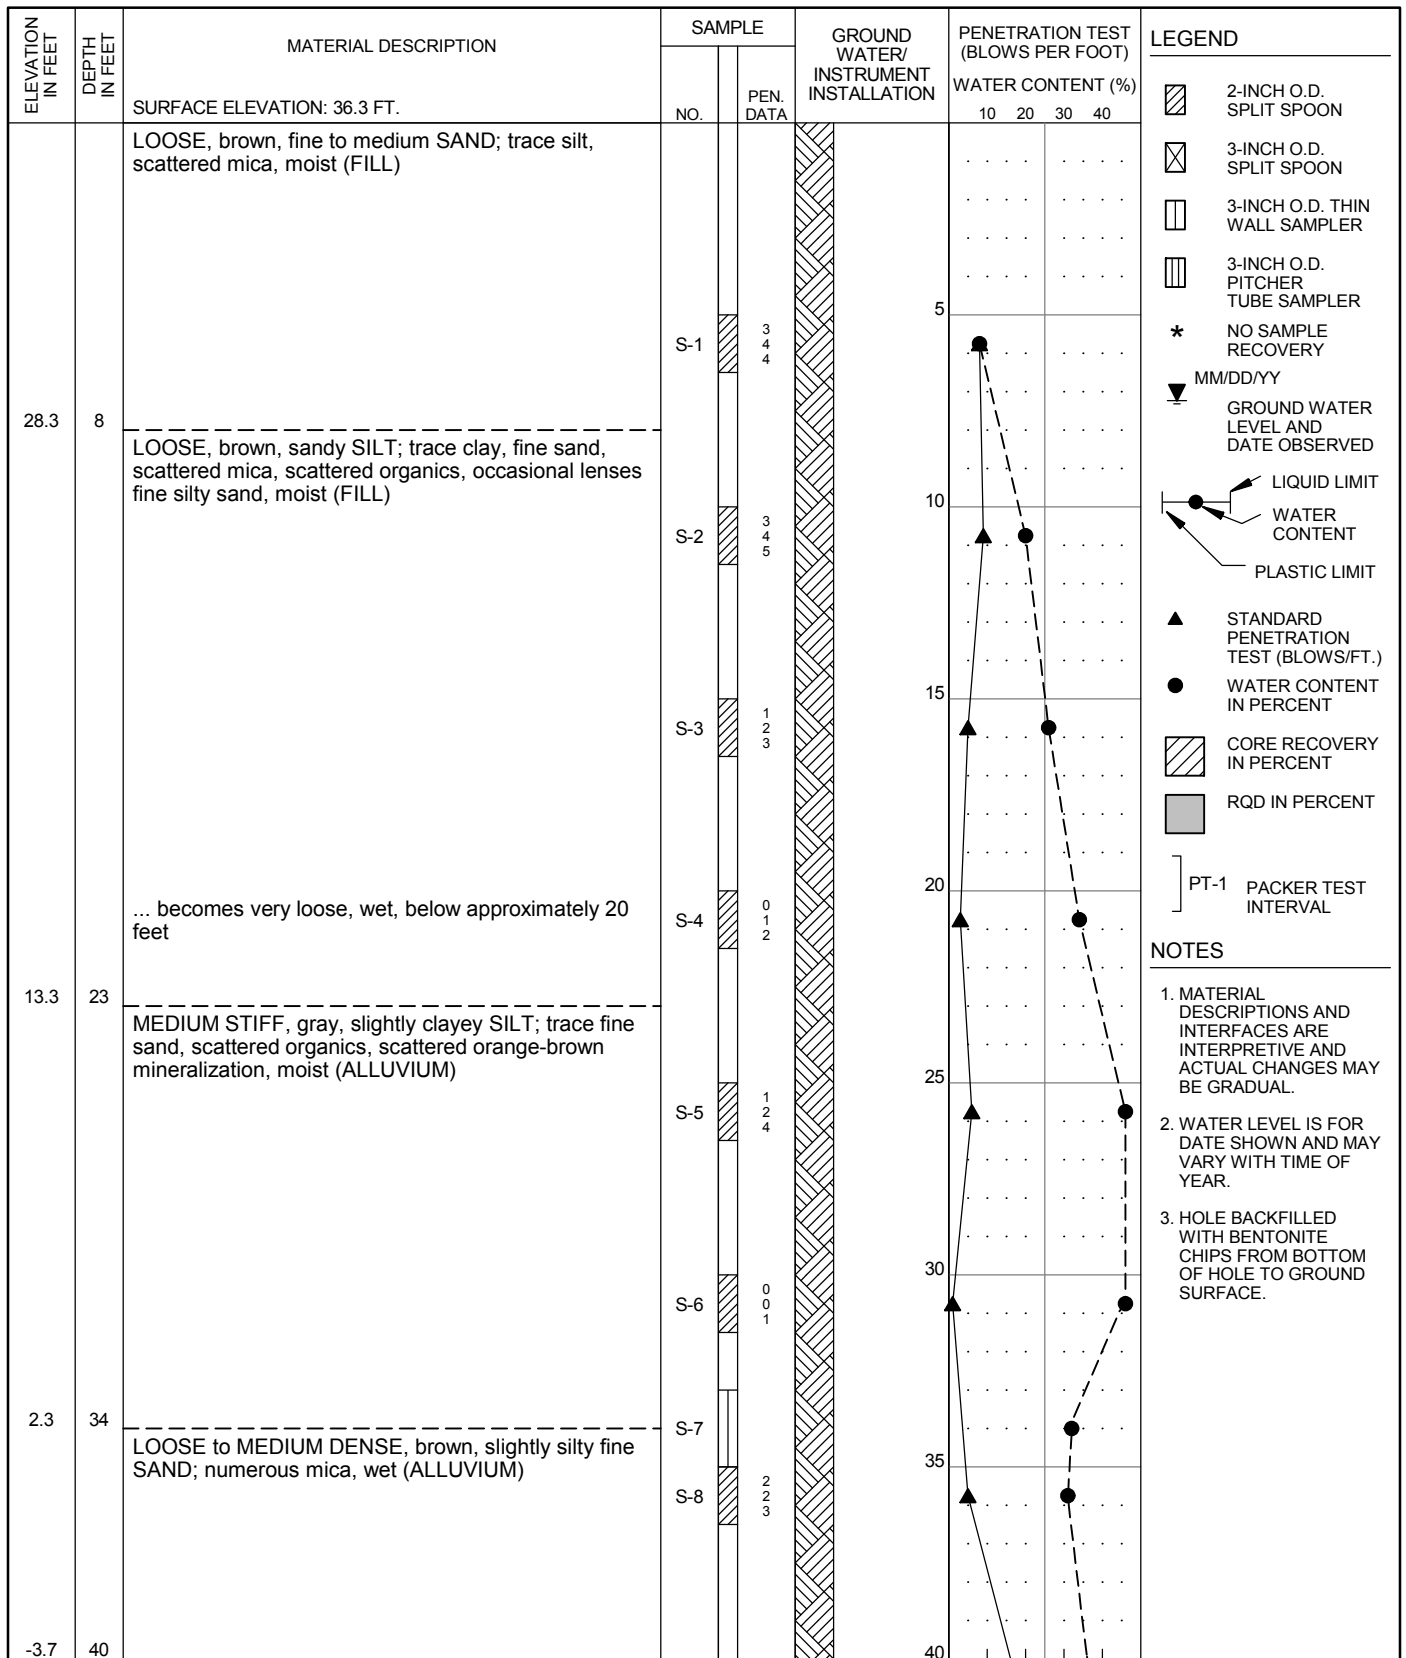
SEP 2014
 PROJ 2320
 FIG. **A27**

- NOTES**
- MATERIAL DESCRIPTIONS AND INTERFACES ARE INTERPRETIVE AND ACTUAL CHANGES MAY BE GRADUAL.
 - WATER LEVEL IS FOR DATE SHOWN AND MAY VARY WITH TIME OF YEAR.
 - HOLE BACKFILLED WITH BENTONITE CHIPS FROM BOTTOM OF HOLE TO GROUND SURFACE.
 - FALLING HEAD PERMEABILITY TEST PERFORMED AT 20 FEET BELOW GROUND SURFACE.

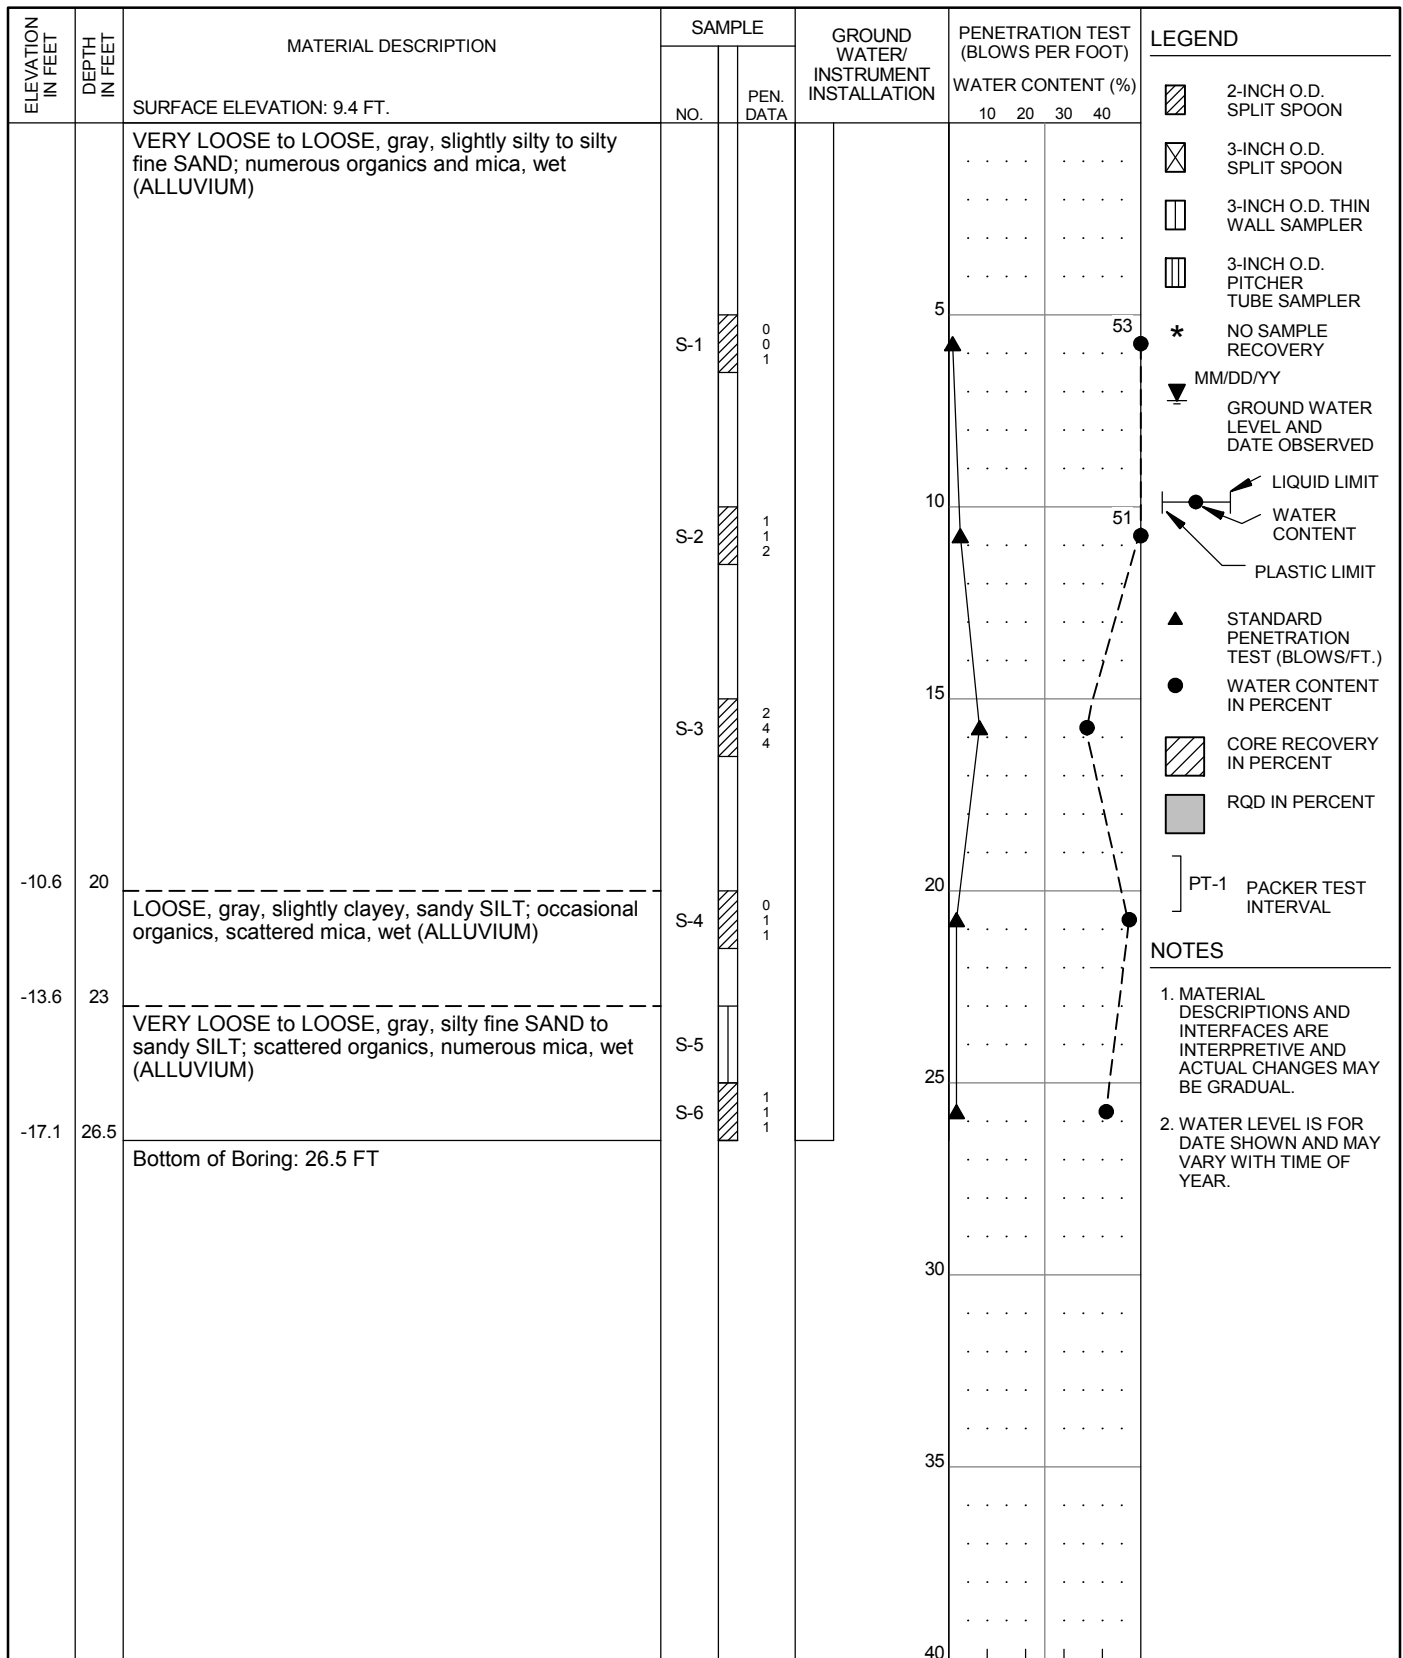
DRILLER: WESTERN STATES DATE START: 3/12/2014 FINISH: 3/12/2014 DRILLING TECHNIQUE: HOLLOW STEM AUGER	CORNFORTH CONSULTANTS 10250 S.W. Greenburg Road, Suite 111 Portland, Oregon 97223 Phone 503-452-1100 Fax 503-452-1528	SUMMARY BORING LOG P2-CC-29 (2 of 2) PENINSULA DISTRICT 2 LEVEE PORTLAND, OR	SEP 2014
			PROJ 2320
			FIG. A29

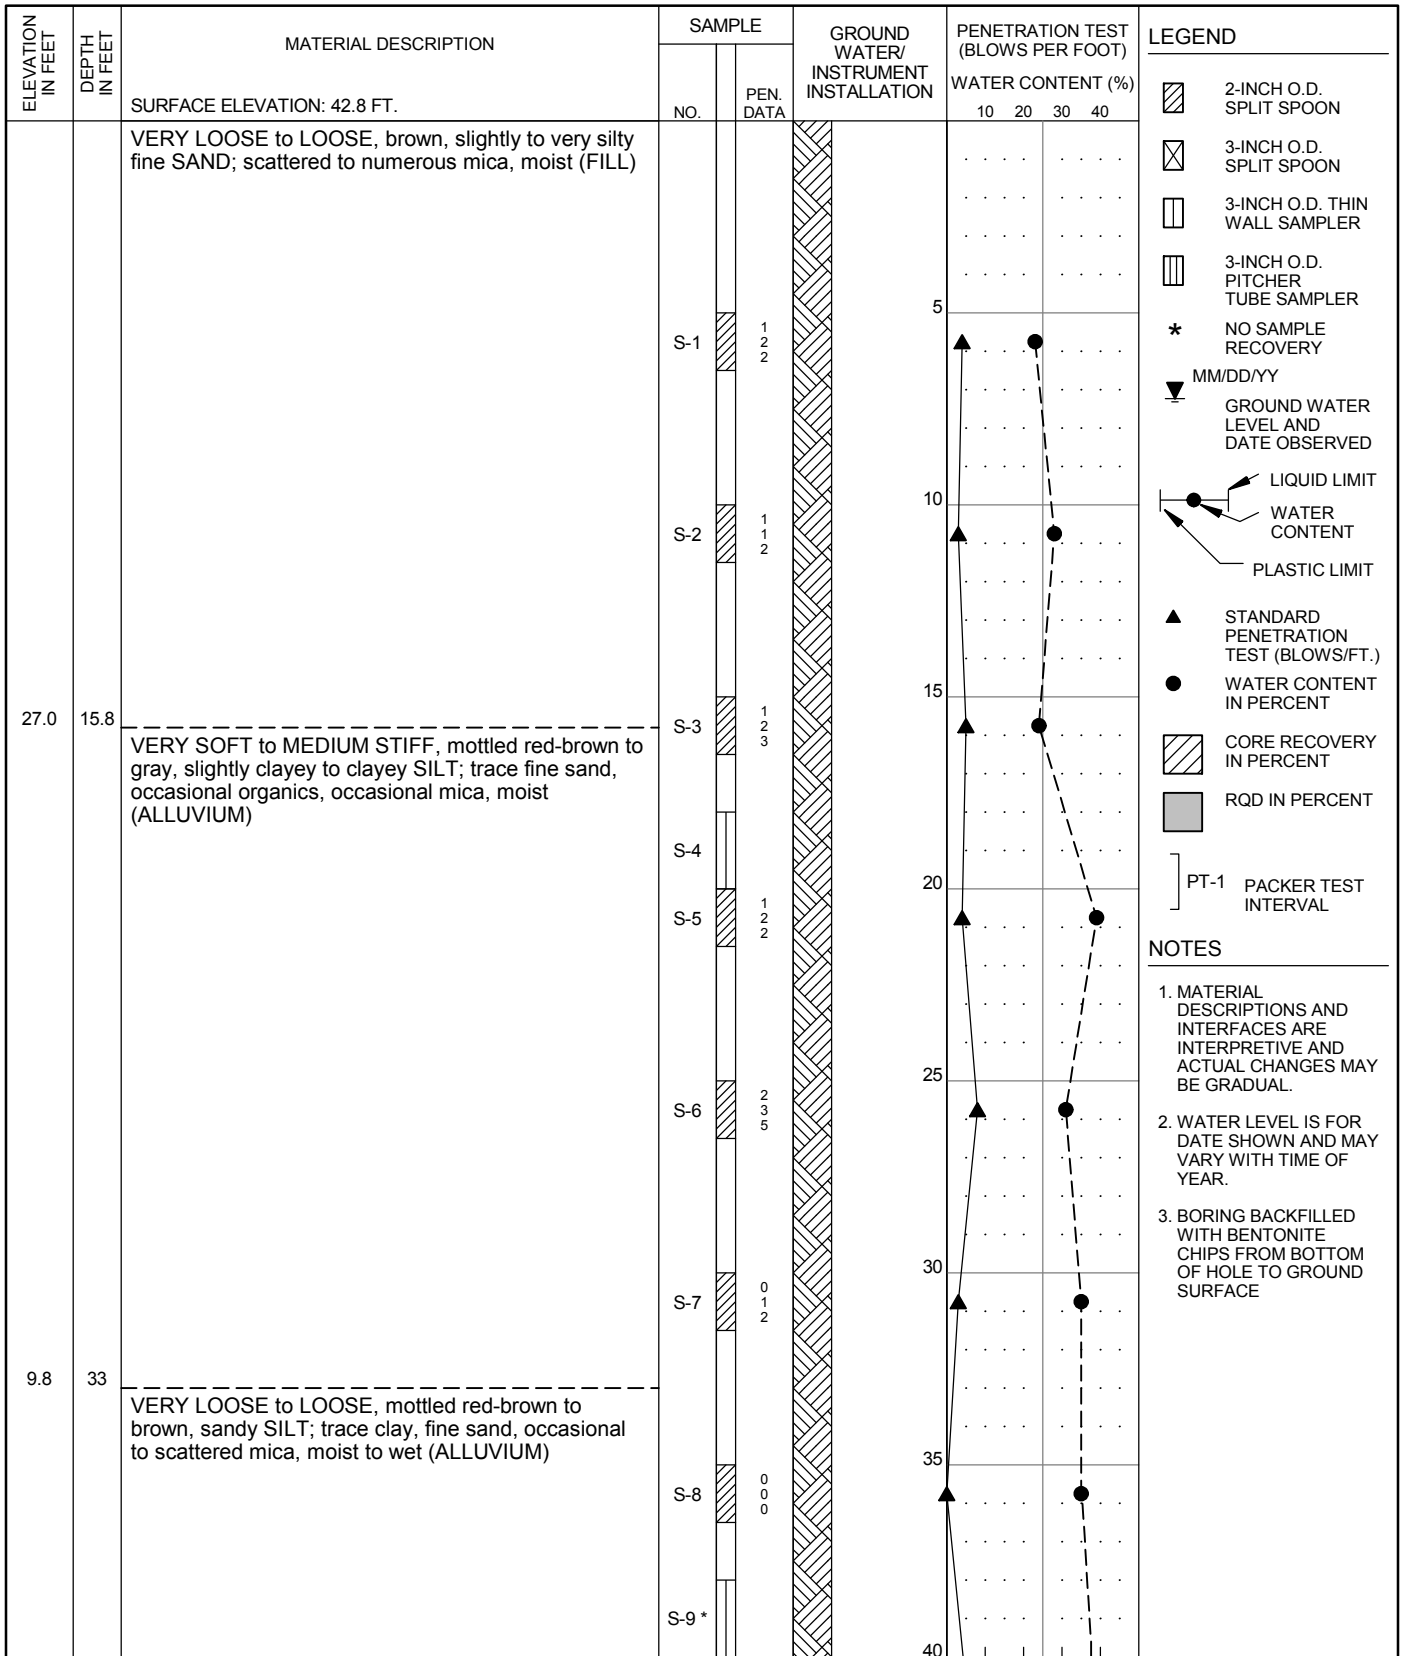
DRILLER: WESTERN STATES DATE START: 4/24/2014 FINISH: 4/24/2014 DRILLING TECHNIQUE: MUD ROTARY	  CORNFORTH CONSULTANTS 10250 S.W. Greenburg Road, Suite 111 Portland, Oregon 97223 Phone 503-452-1100 Fax 503-452-1528	SUMMARY BORING LOG P2-CC-30 PENINSULA DISTRICT 2 LEVEE PORTLAND, OR	SEP 2014 PROJ 2320 FIG. A30
------------------------------------------------------------------------------------------------------	------------------------------------------------------------------------------------------------------------------------------------------------------------------------------------------------------------------------------	--------------------------------------------------------------------------------------------	------------------------------------------

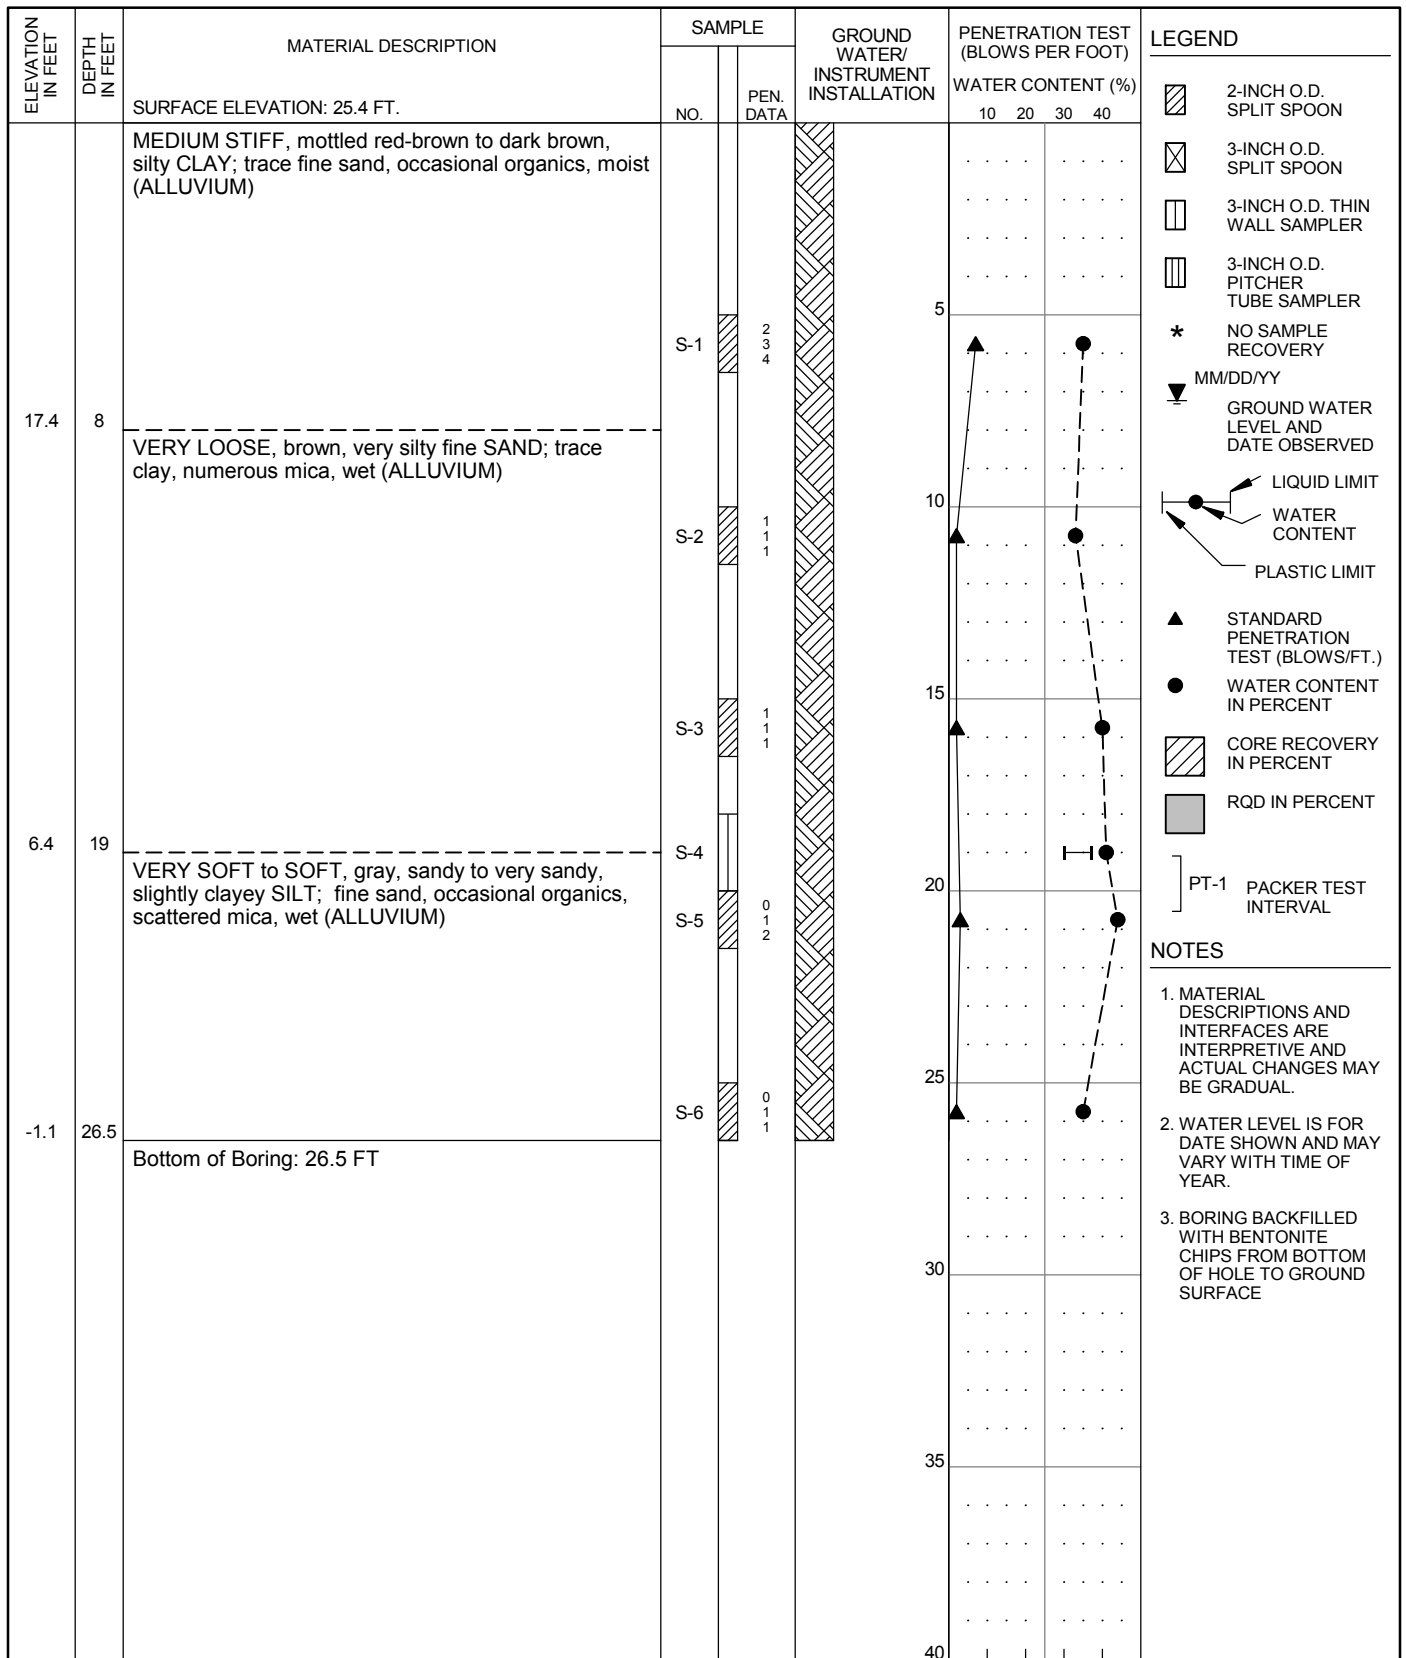
DRILLER: WESTERN STATES DATE START: 3/13/2014 FINISH: 3/13/2014 DRILLING TECHNIQUE: HOLLOW STEM AUGER	 10250 S.W. Greenburg Road, Suite 111 Portland, Oregon 97223 Phone 503-452-1100 Fax 503-452-1528	SUMMARY BORING LOG P2-CC-31 (1 of 2) PENINSULA DISTRICT 2 LEVEE PORTLAND, OR	SEP 2014
			PROJ 2320
			FIG. A31

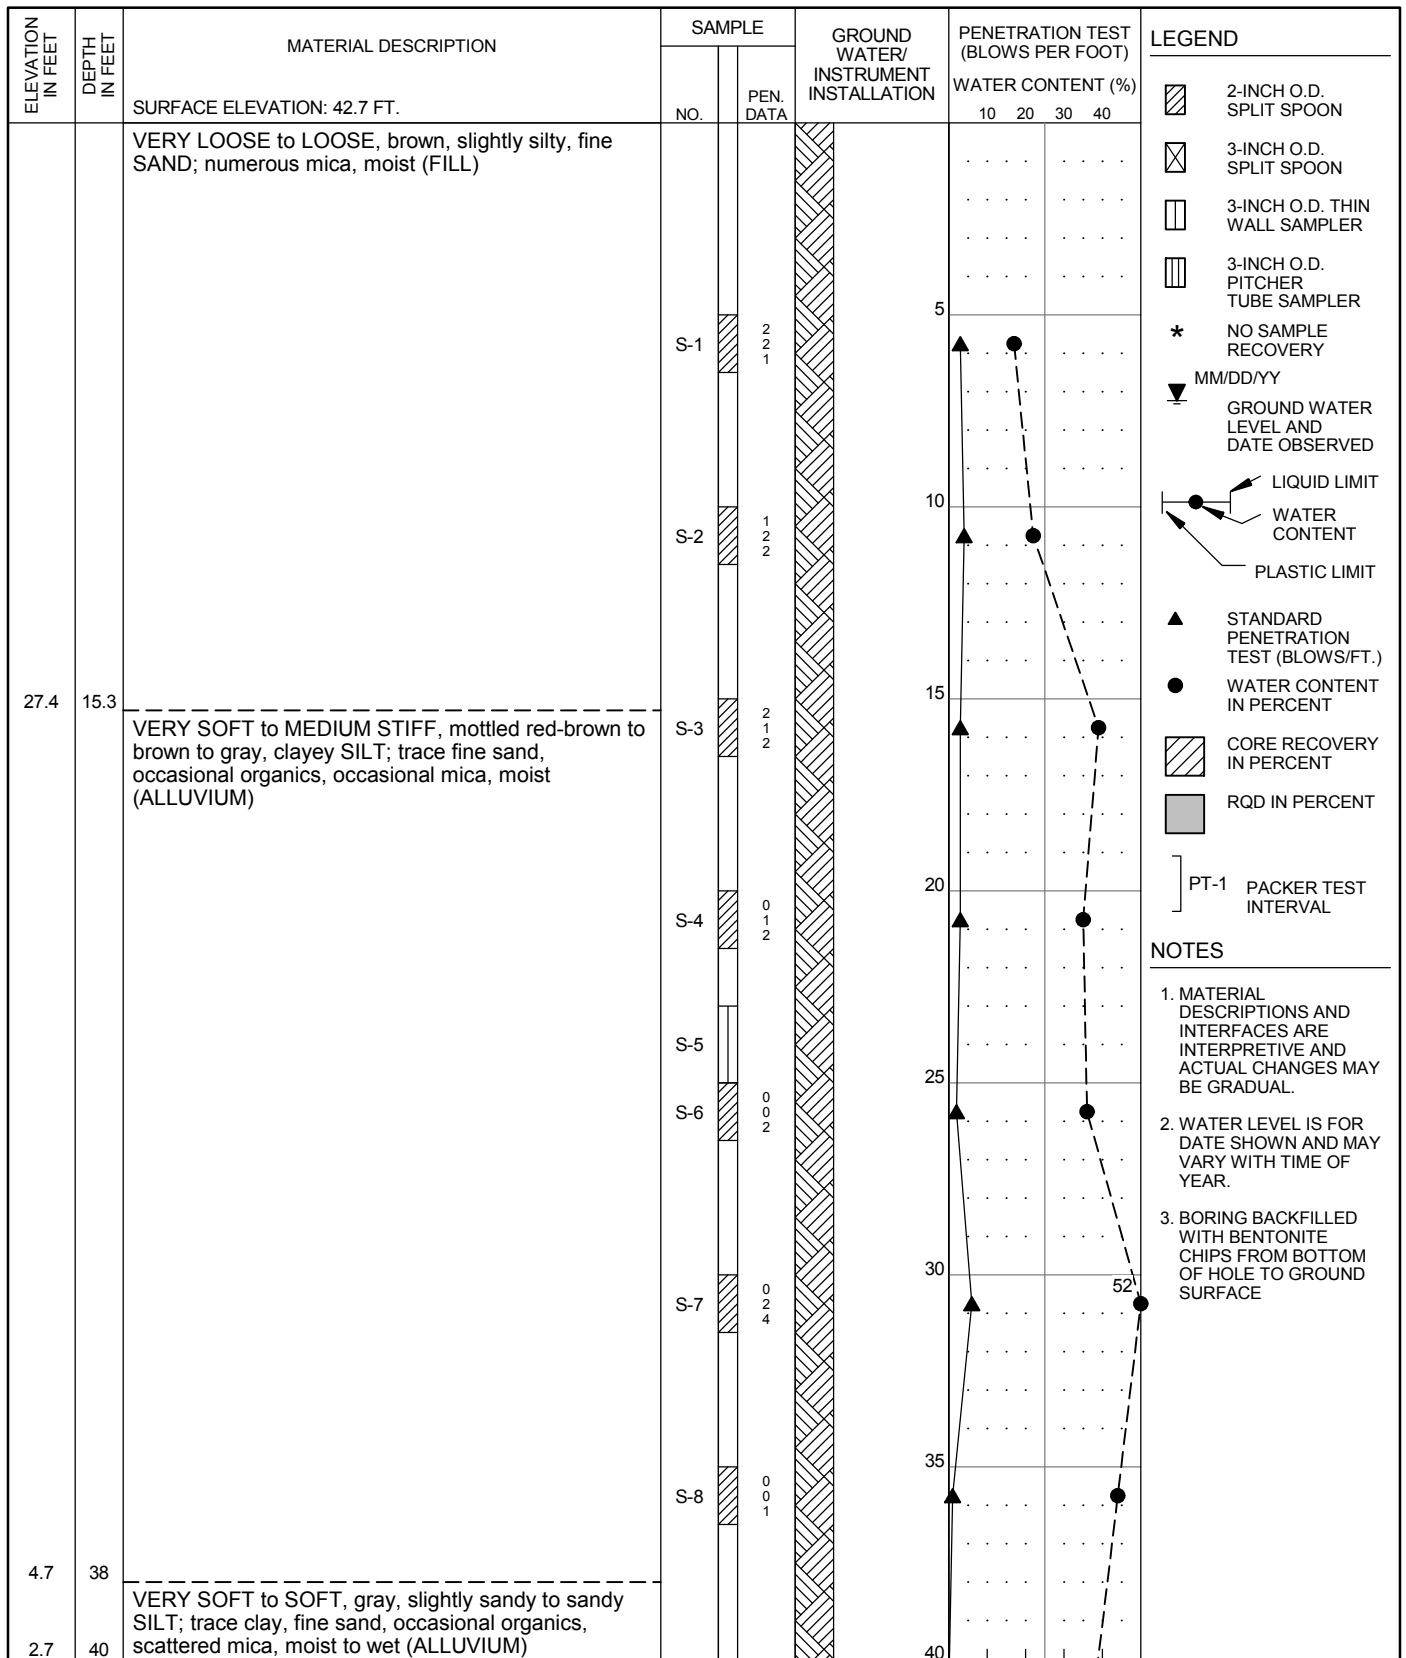
DRILLER: WESTERN STATES DATE START: 4/25/2014 FINISH: 4/25/2014 DRILLING TECHNIQUE: MUD ROTARY	CORNFORTH CONSULTANTS 10250 S.W. Greenburg Road, Suite 111 Portland, Oregon 97223 Phone 503-452-1100 Fax 503-452-1528	SUMMARY BORING LOG P2-CC-33 PENINSULA DISTRICT 2 LEVEE PORTLAND, OR	SEP 2014 PROJ 2320 FIG. A33
------------------------------------------------------------------------------------------------------	------------------------------------------------------------------------------------------------------------------------------------------	--------------------------------------------------------------------------------------------	------------------------------------------

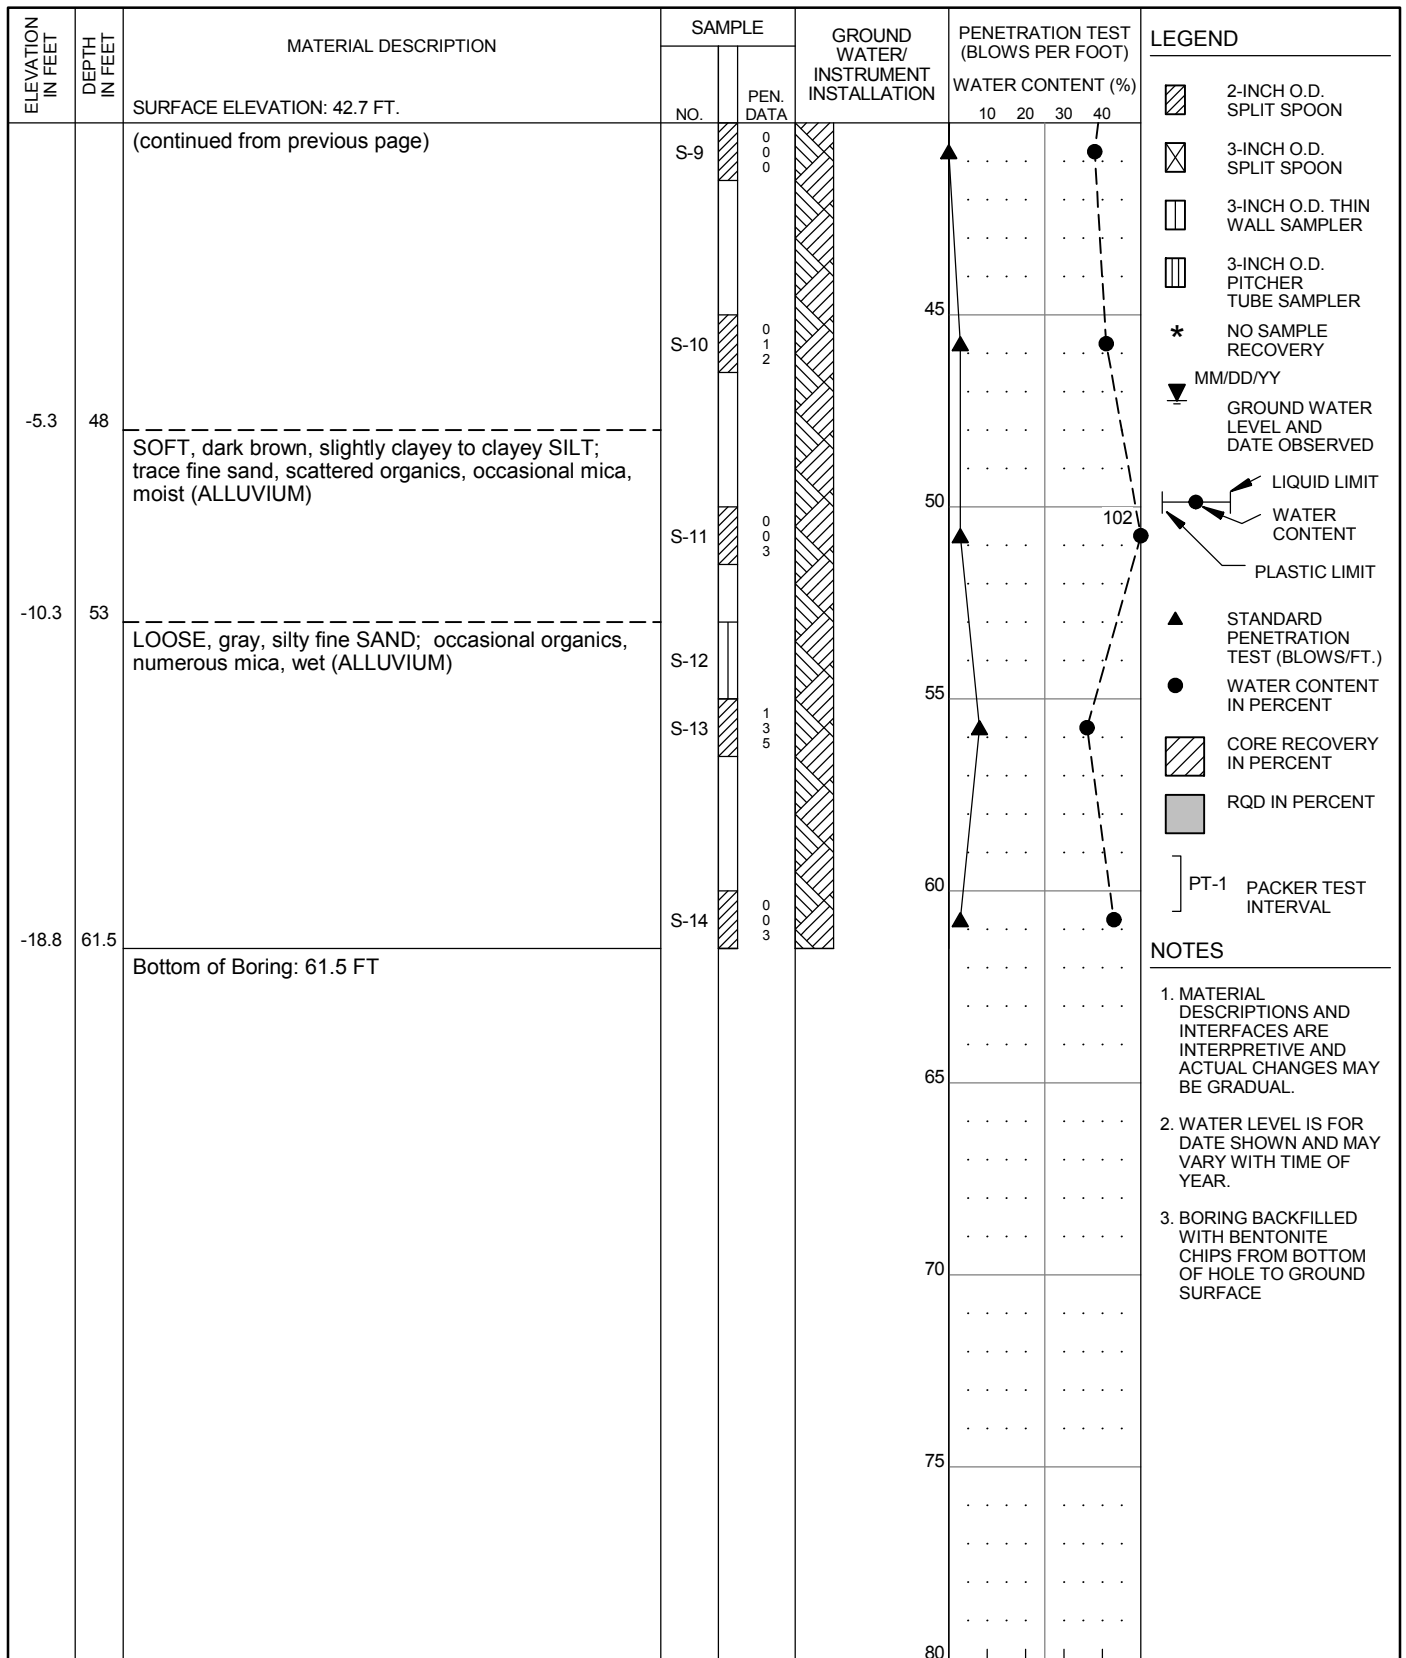
DRILLER: WESTERN STATES DATE START: 3/12/2014 FINISH: 3/12/2014 DRILLING TECHNIQUE: HOLLOW STEM AUGER	CORNFORTH CONSULTANTS 10250 S.W. Greenburg Road, Suite 111 Portland, Oregon 97223 Phone 503-452-1100 Fax 503-452-1528	SUMMARY BORING LOG P2-CC-34 (1 of 2) PENINSULA DISTRICT 2 LEVEE PORTLAND, OR	SEP 2014 PROJ 2320 FIG. A34
----------------------------------------------------------------------------------------------------------------	------------------------------------------------------------------------------------------------------------------------------------------	-----------------------------------------------------------------------------------------------------	------------------------------------------

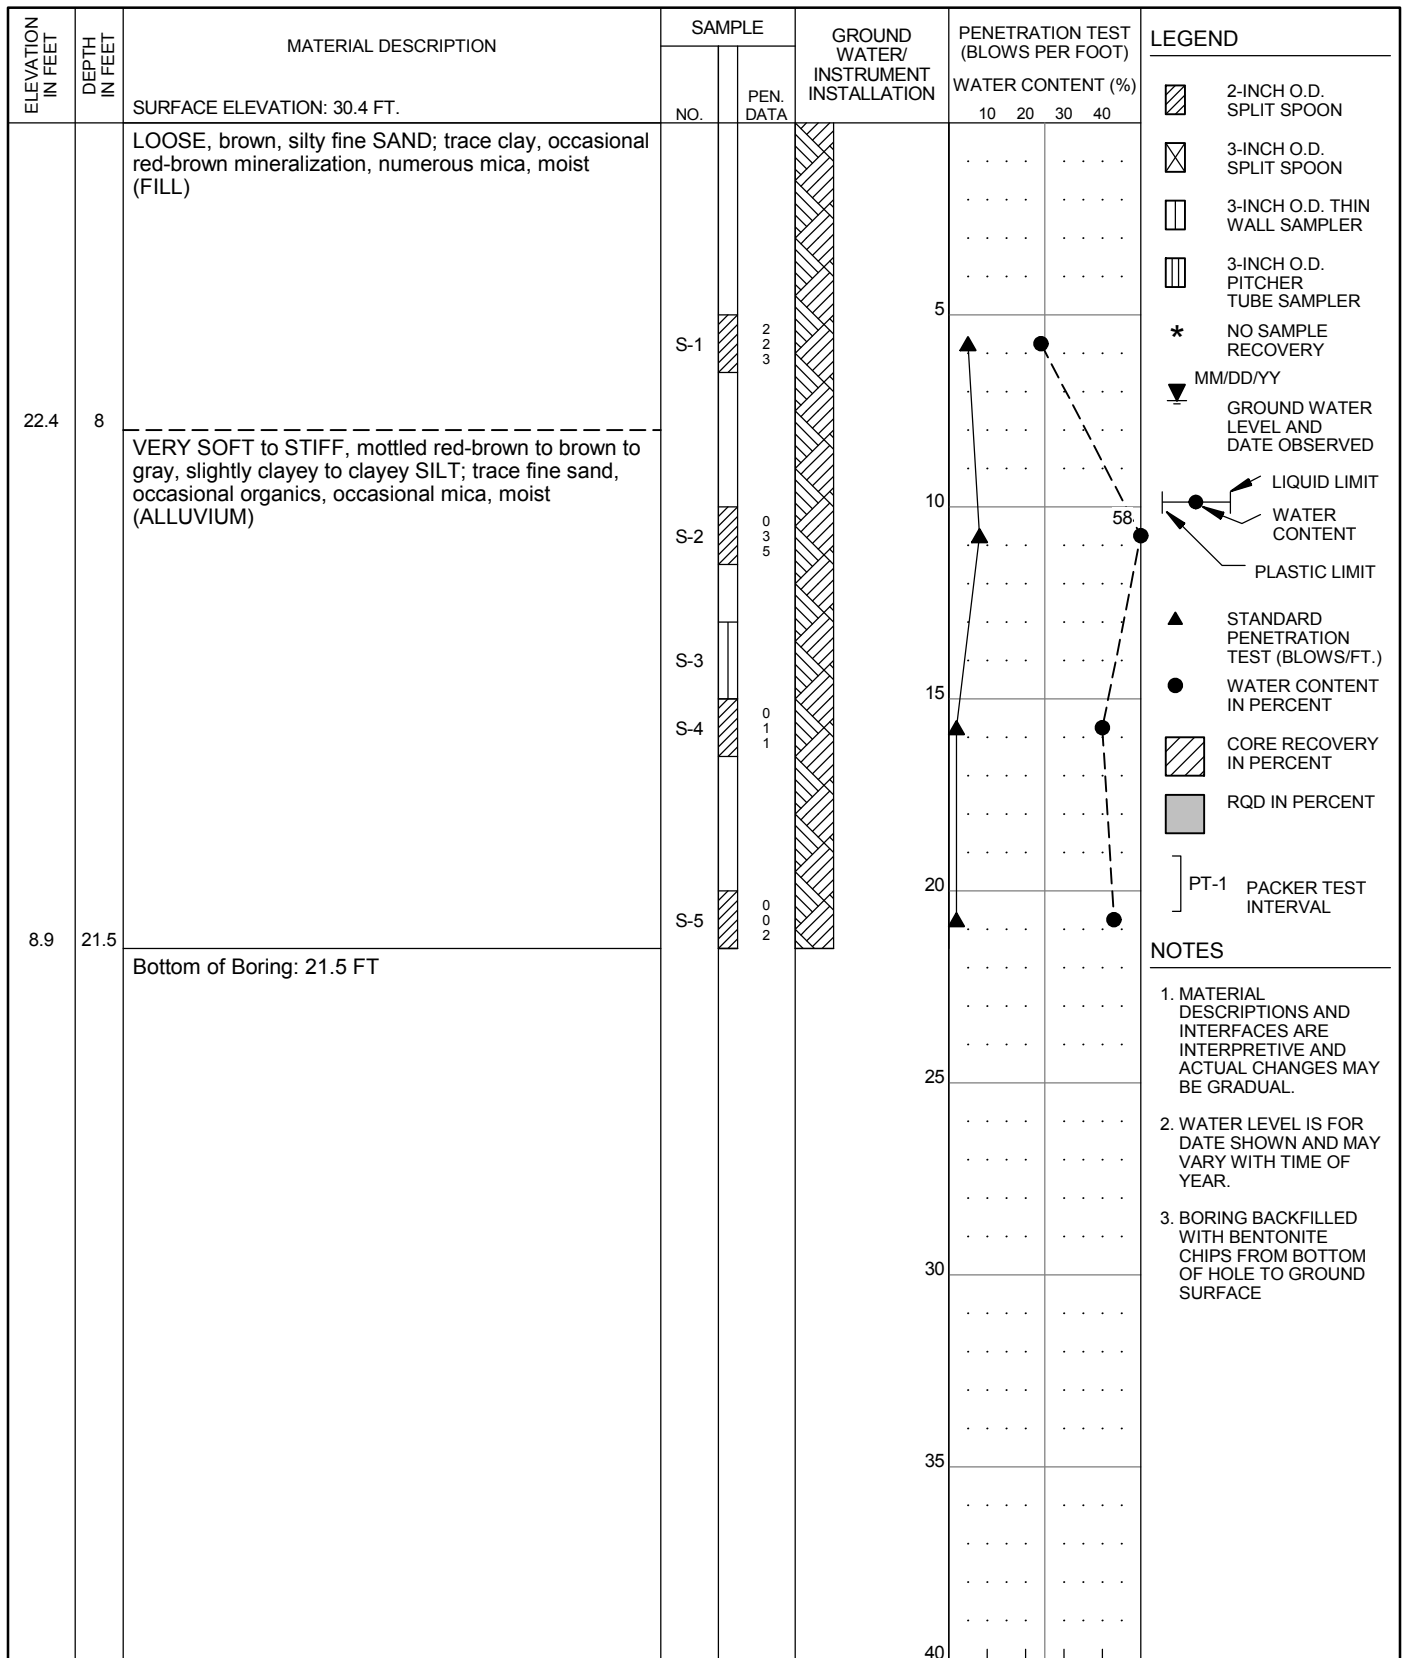
DRILLER: WESTERN STATES DATE START: 3/12/2014 FINISH: 3/12/2014 DRILLING TECHNIQUE: HOLLOW STEM AUGER	 10250 S.W. Greenburg Road, Suite 111 Portland, Oregon 97223 Phone 503-452-1100 Fax 503-452-1528	SUMMARY BORING LOG P2-CC-34 (2 of 2) PENINSULA DISTRICT 2 LEVEE PORTLAND, OR	SEP 2014
			PROJ 2320
			FIG. A34

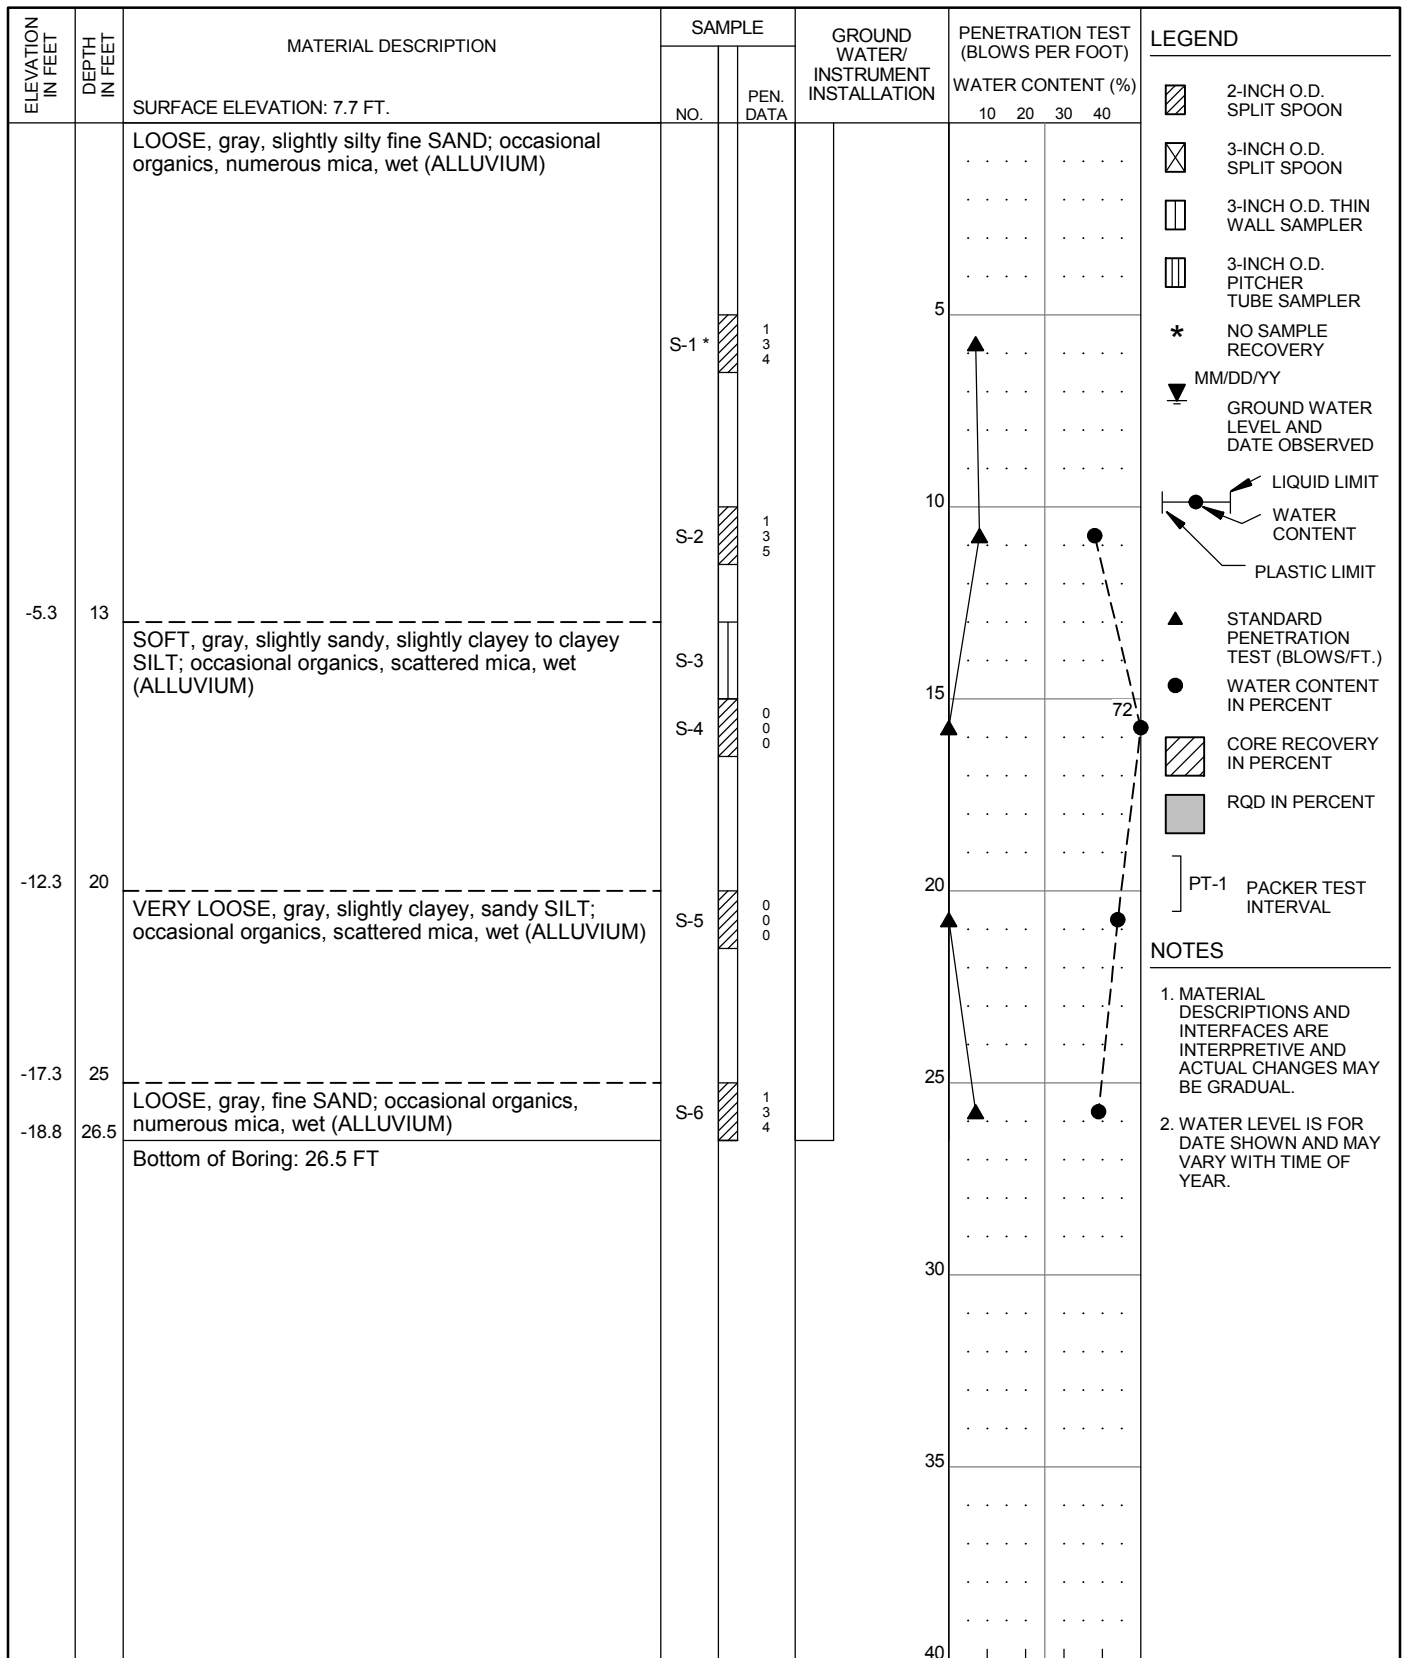
DRILLER: WESTERN STATES DATE START: 3/12/2014 FINISH: 3/12/2014 DRILLING TECHNIQUE: HOLLOW STEM AUGER	CORNFORTH CONSULTANTS 10250 S.W. Greenburg Road, Suite 111 Portland, Oregon 97223 Phone 503-452-1100 Fax 503-452-1528	SUMMARY BORING LOG P2-CC-35 PENINSULA DISTRICT 2 LEVEE PORTLAND, OR	SEP 2014 PROJ 2320 FIG. A35
-------------------------------------------------------------------------------------------------------------	------------------------------------------------------------------------------------------------------------------------------------------	--------------------------------------------------------------------------------------------	------------------------------------------

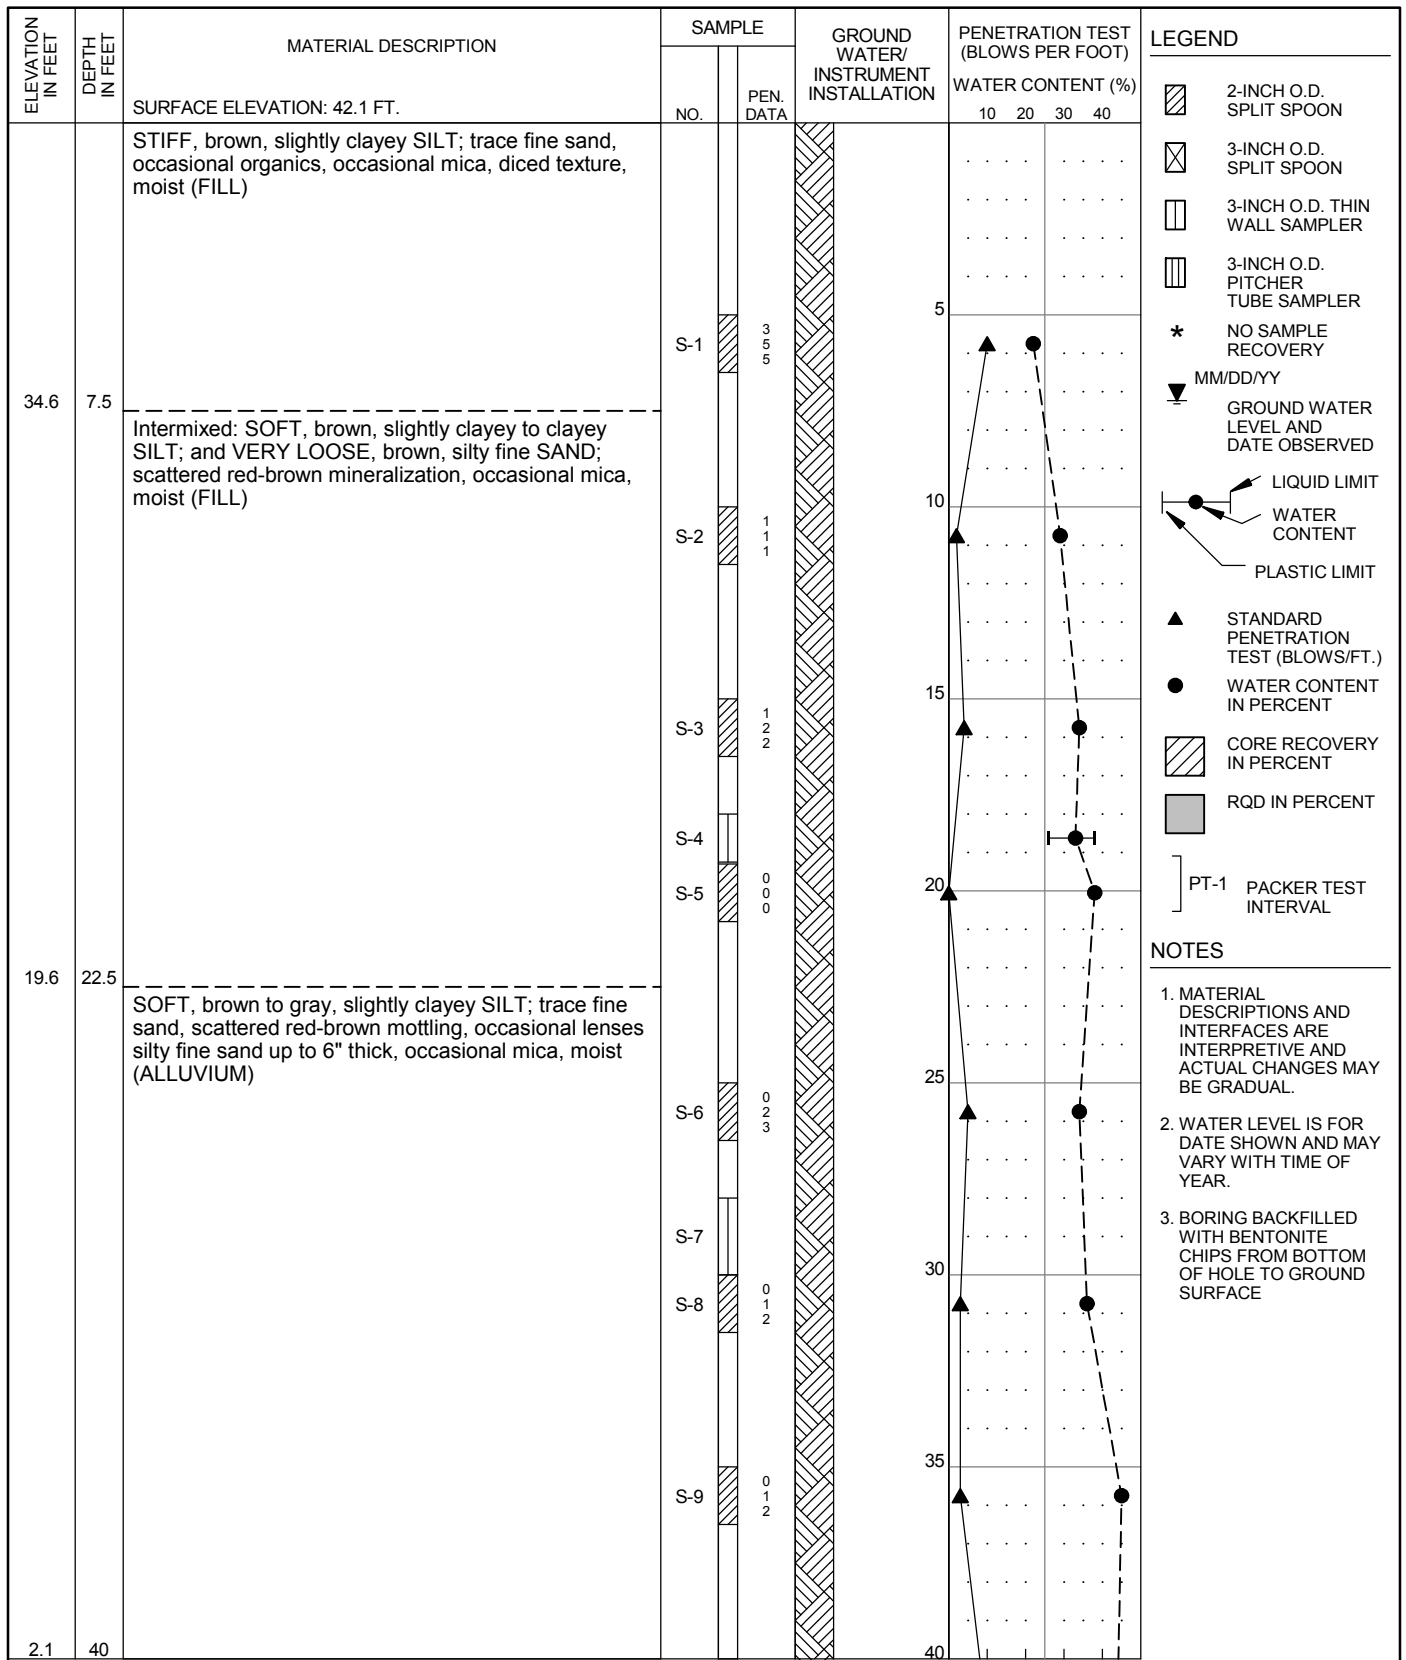
DRILLER: WESTERN STATES DATE START: 4/24/2014 FINISH: 4/24/2014 DRILLING TECHNIQUE: MUD ROTARY	CORNFORTH CONSULTANTS 10250 S.W. Greenburg Road, Suite 111 Portland, Oregon 97223 Phone 503-452-1100 Fax 503-452-1528	SUMMARY BORING LOG P2-CC-36 PENINSULA DISTRICT 2 LEVEE PORTLAND, OR	SEP 2014 PROJ 2320 FIG. A36
------------------------------------------------------------------------------------------------------	------------------------------------------------------------------------------------------------------------------------------------------	--------------------------------------------------------------------------------------------	------------------------------------------
