Peninsula Drainage District No. 2

Levee Engineering Assessment

**PENINSULA DRAINAGE DISTRICT NO. 2
LEVEE ENGINEERING ASSESSMENT**

October 2, 2014

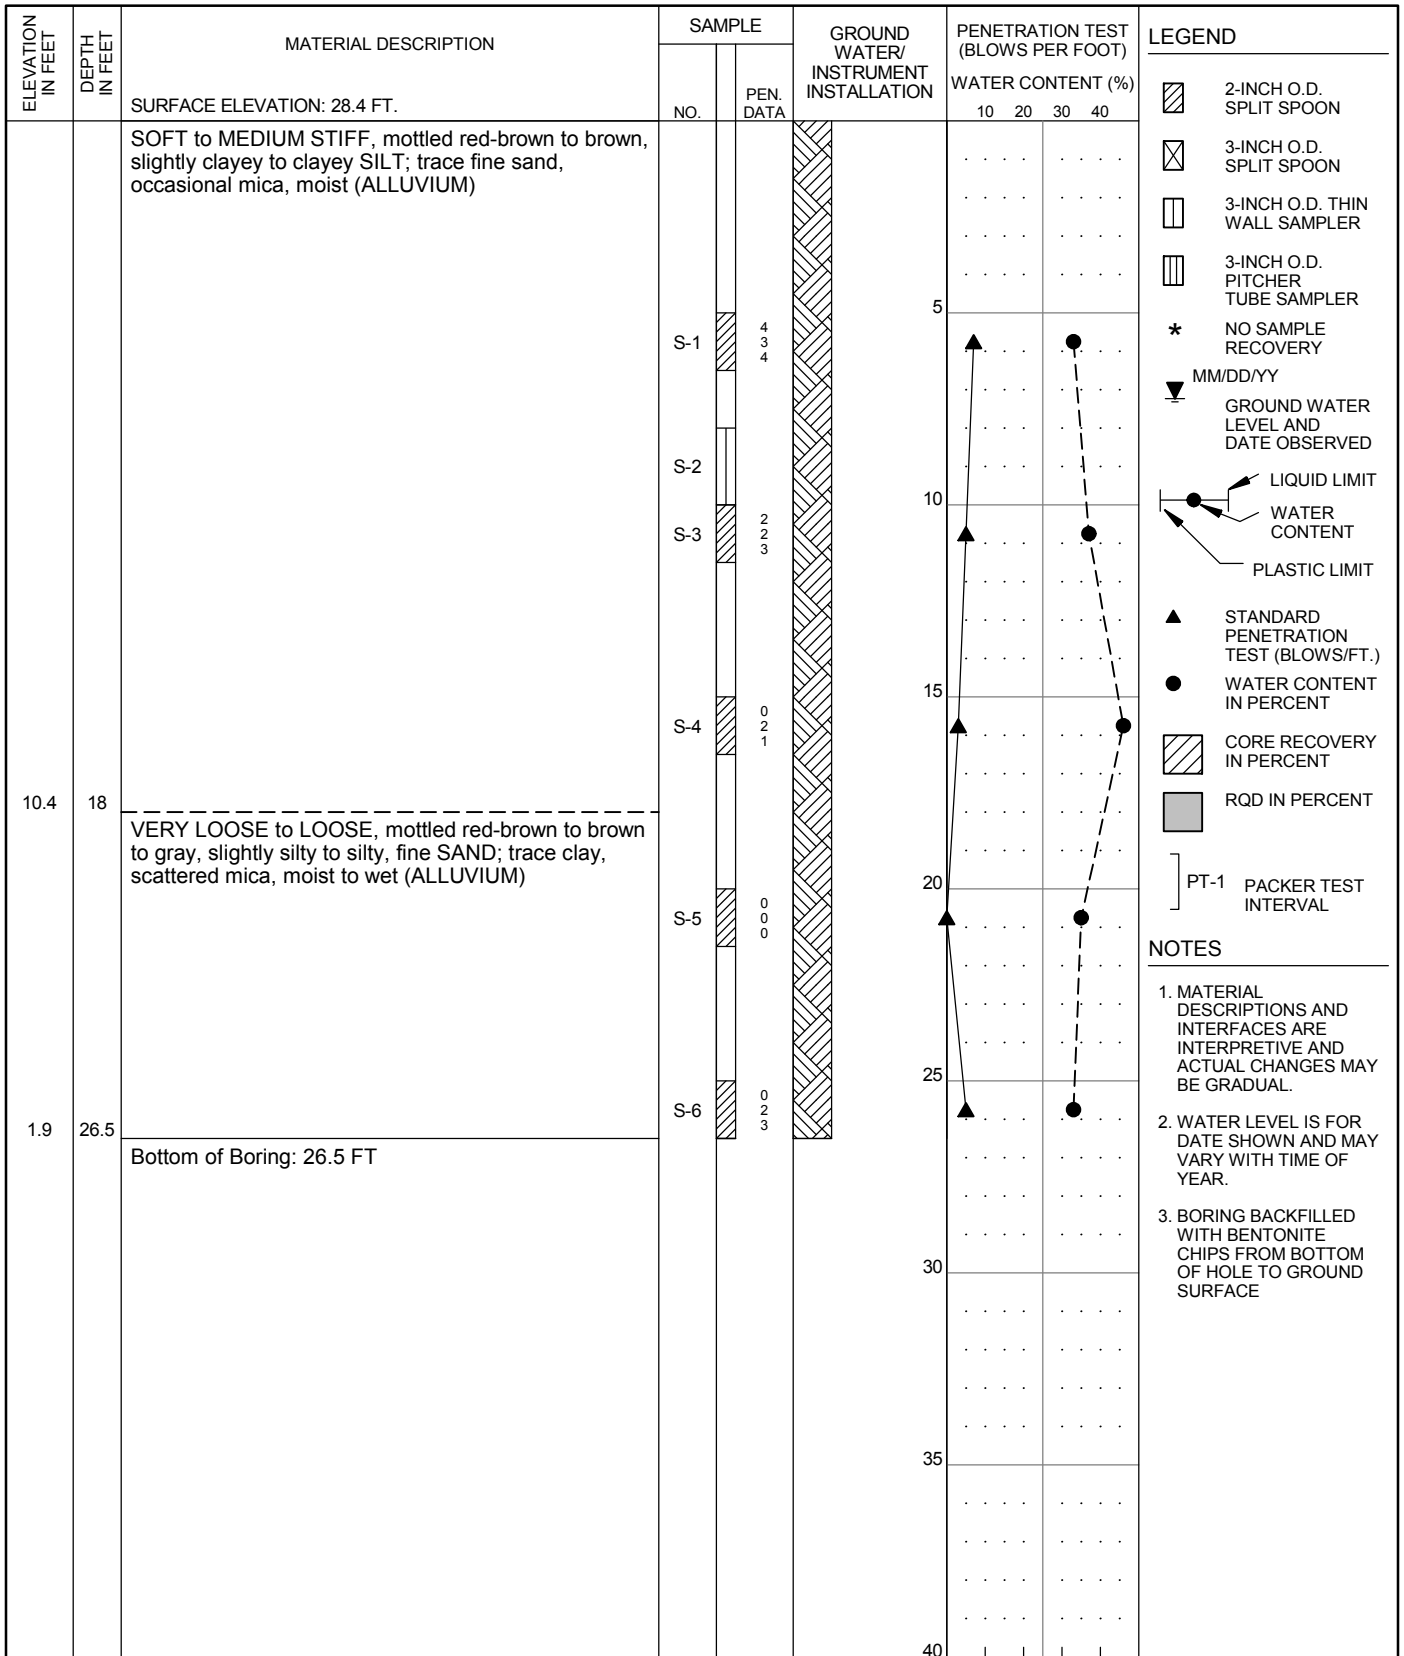
DRILLER: WESTERN STATES DATE START: 3/11/2014 FINISH: 3/11/2014 DRILLING TECHNIQUE: HOLLOW STEM AUGER	 10250 S.W. Greenburg Road, Suite 111 Portland, Oregon 97223 Phone 503-452-1100 Fax 503-452-1528	SUMMARY BORING LOG P2-CC-37 (1 of 2) PENINSULA DISTRICT 2 LEVEE PORTLAND, OR	SEP 2014
			PROJ 2320
			FIG. A37

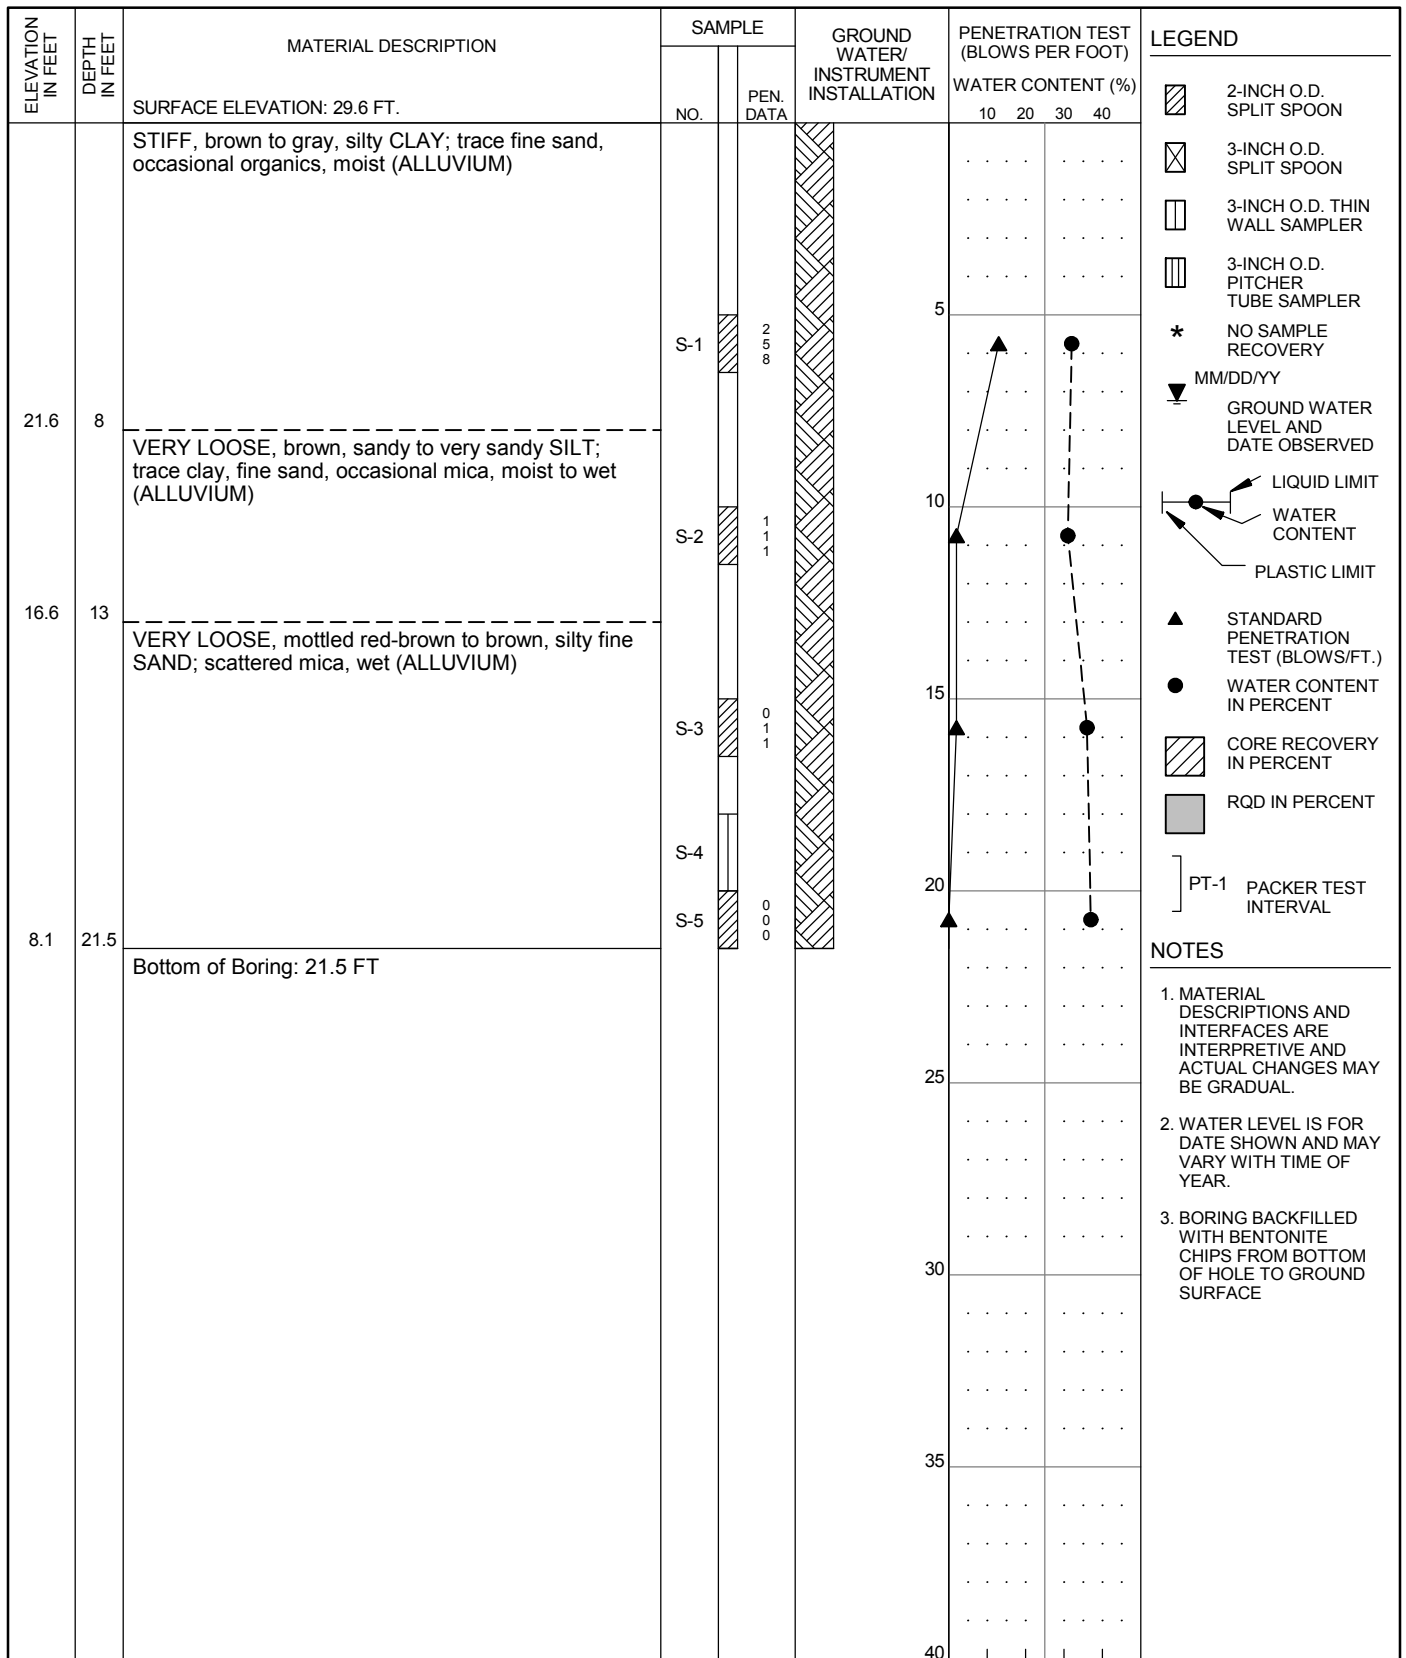
DRILLER: WESTERN STATES DATE START: 3/10/2014 FINISH: 3/10/2014 DRILLING TECHNIQUE: HOLLOW STEM AUGER	CORNFORTH CONSULTANTS 10250 S.W. Greenburg Road, Suite 111 Portland, Oregon 97223 Phone 503-452-1100 Fax 503-452-1528	SUMMARY BORING LOG P2-CC-40 (2 of 2) PENINSULA DISTRICT 2 LEVEE PORTLAND, OR	SEP 2014
			PROJ 2320
			FIG. A40

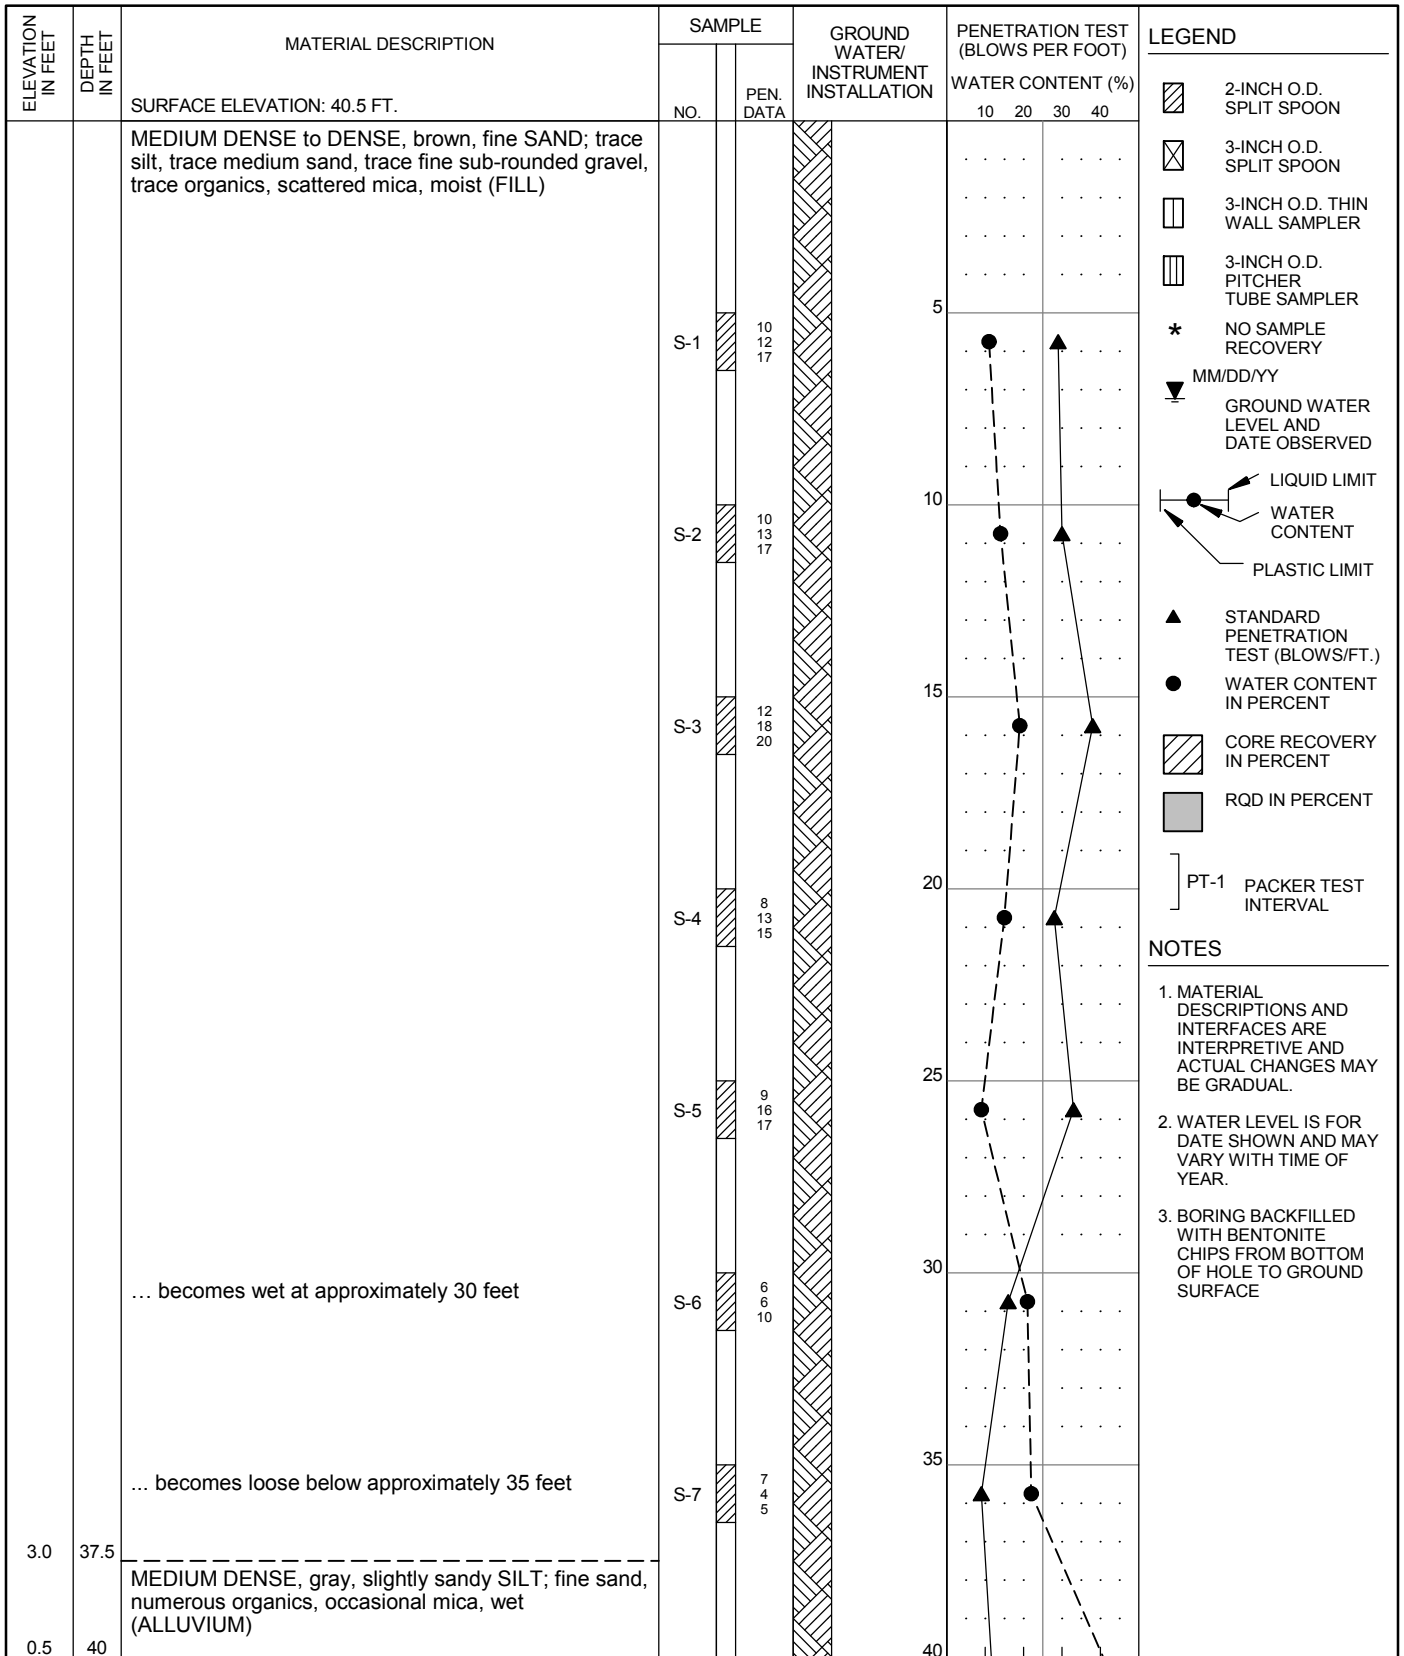
DRILLER: WESTERN STATES DATE START: 4/23/2014 FINISH: 4/23/2014 DRILLING TECHNIQUE: MUD ROTARY	  CORNFORTH CONSULTANTS 10250 S.W. Greenburg Road, Suite 111 Portland, Oregon 97223 Phone 503-452-1100 Fax 503-452-1528	SUMMARY BORING LOG P2-CC-42 PENINSULA DISTRICT 2 LEVEE PORTLAND, OR	SEP 2014 PROJ 2320 FIG. A42
------------------------------------------------------------------------------------------------------	------------------------------------------------------------------------------------------------------------------------------------------------------------------------------------------------------------------------------	--------------------------------------------------------------------------------------------	------------------------------------------

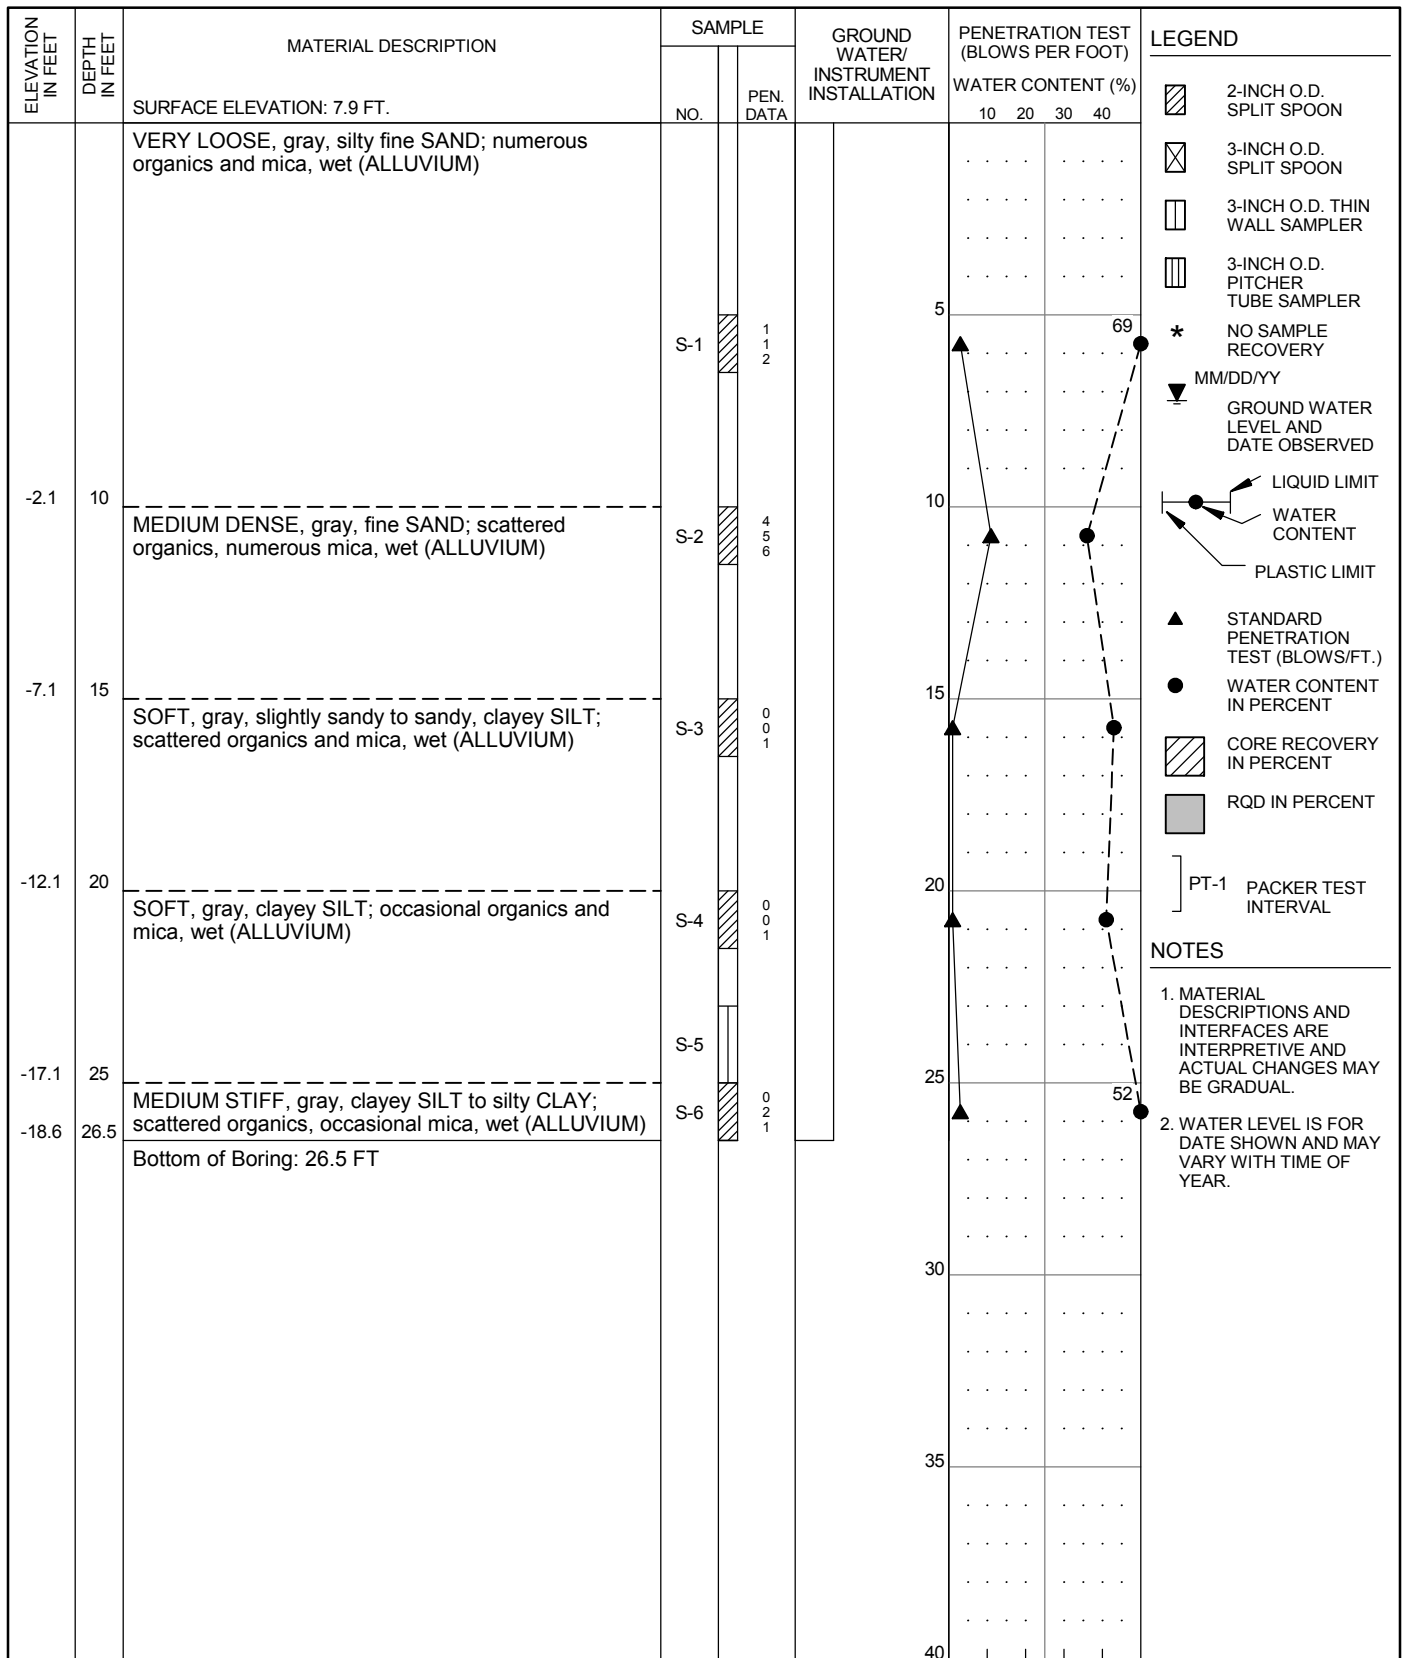
DRILLER: WESTERN STATES DATE START: 3/10/2014 FINISH: 3/10/2014 DRILLING TECHNIQUE: HOLLOW STEM AUGER	CORNFORTH CONSULTANTS 10250 S.W. Greenburg Road, Suite 111 Portland, Oregon 97223 Phone 503-452-1100 Fax 503-452-1528	SUMMARY BORING LOG P2-CC-43 (2 of 2) PENINSULA DISTRICT 2 LEVEE PORTLAND, OR	SEP 2014
			PROJ 2320
			FIG. A43

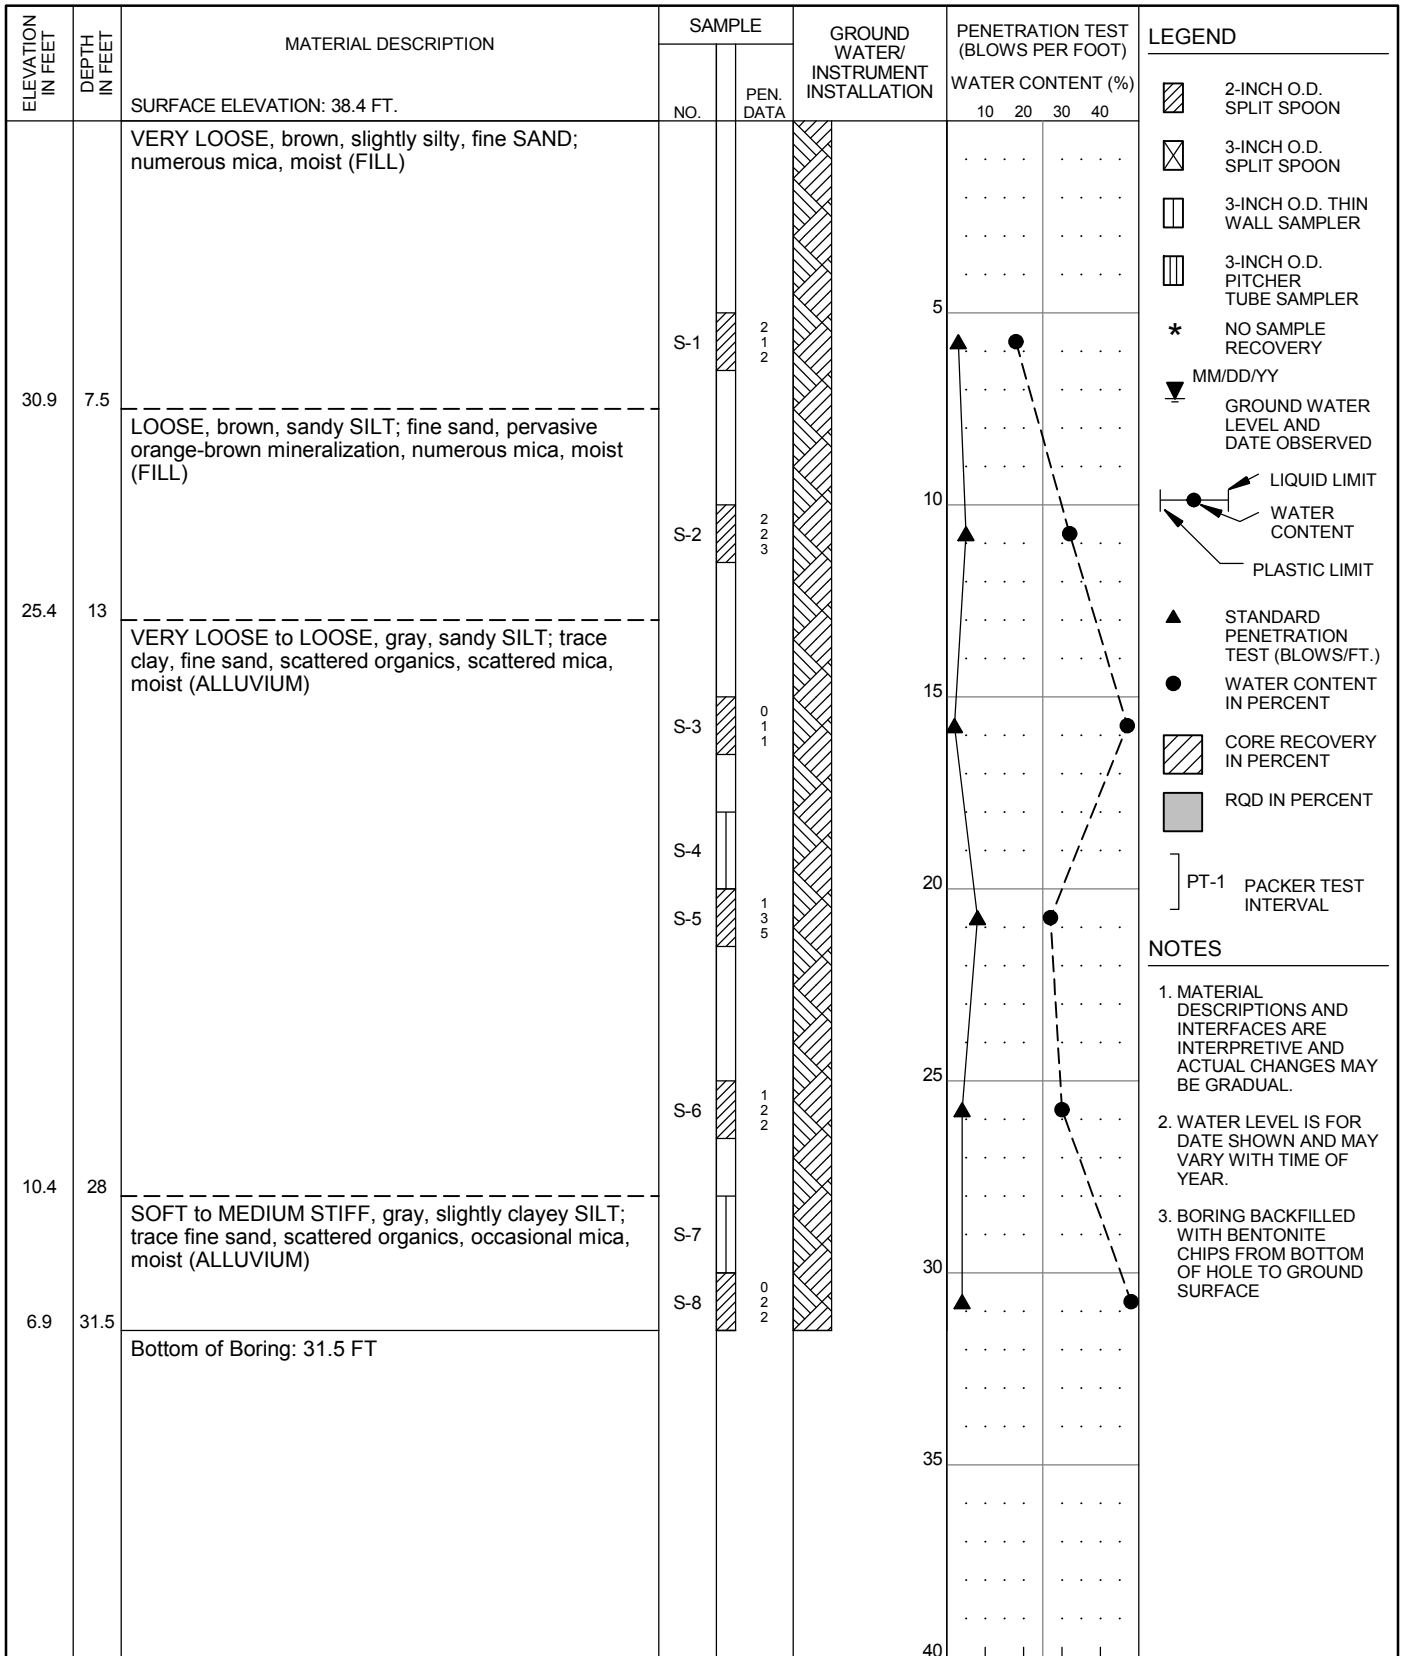
DRILLER: WESTERN STATES DATE START: 4/15/2014 FINISH: 4/15/2014 DRILLING TECHNIQUE: MUD ROTARY	CORNFORTH CONSULTANTS 10250 S.W. Greenburg Road, Suite 111 Portland, Oregon 97223 Phone 503-452-1100 Fax 503-452-1528	SUMMARY BORING LOG P2-CC-45 PENINSULA DISTRICT 2 LEVEE PORTLAND, OR	SEP 2014
			PROJ 2320
			FIG. A45

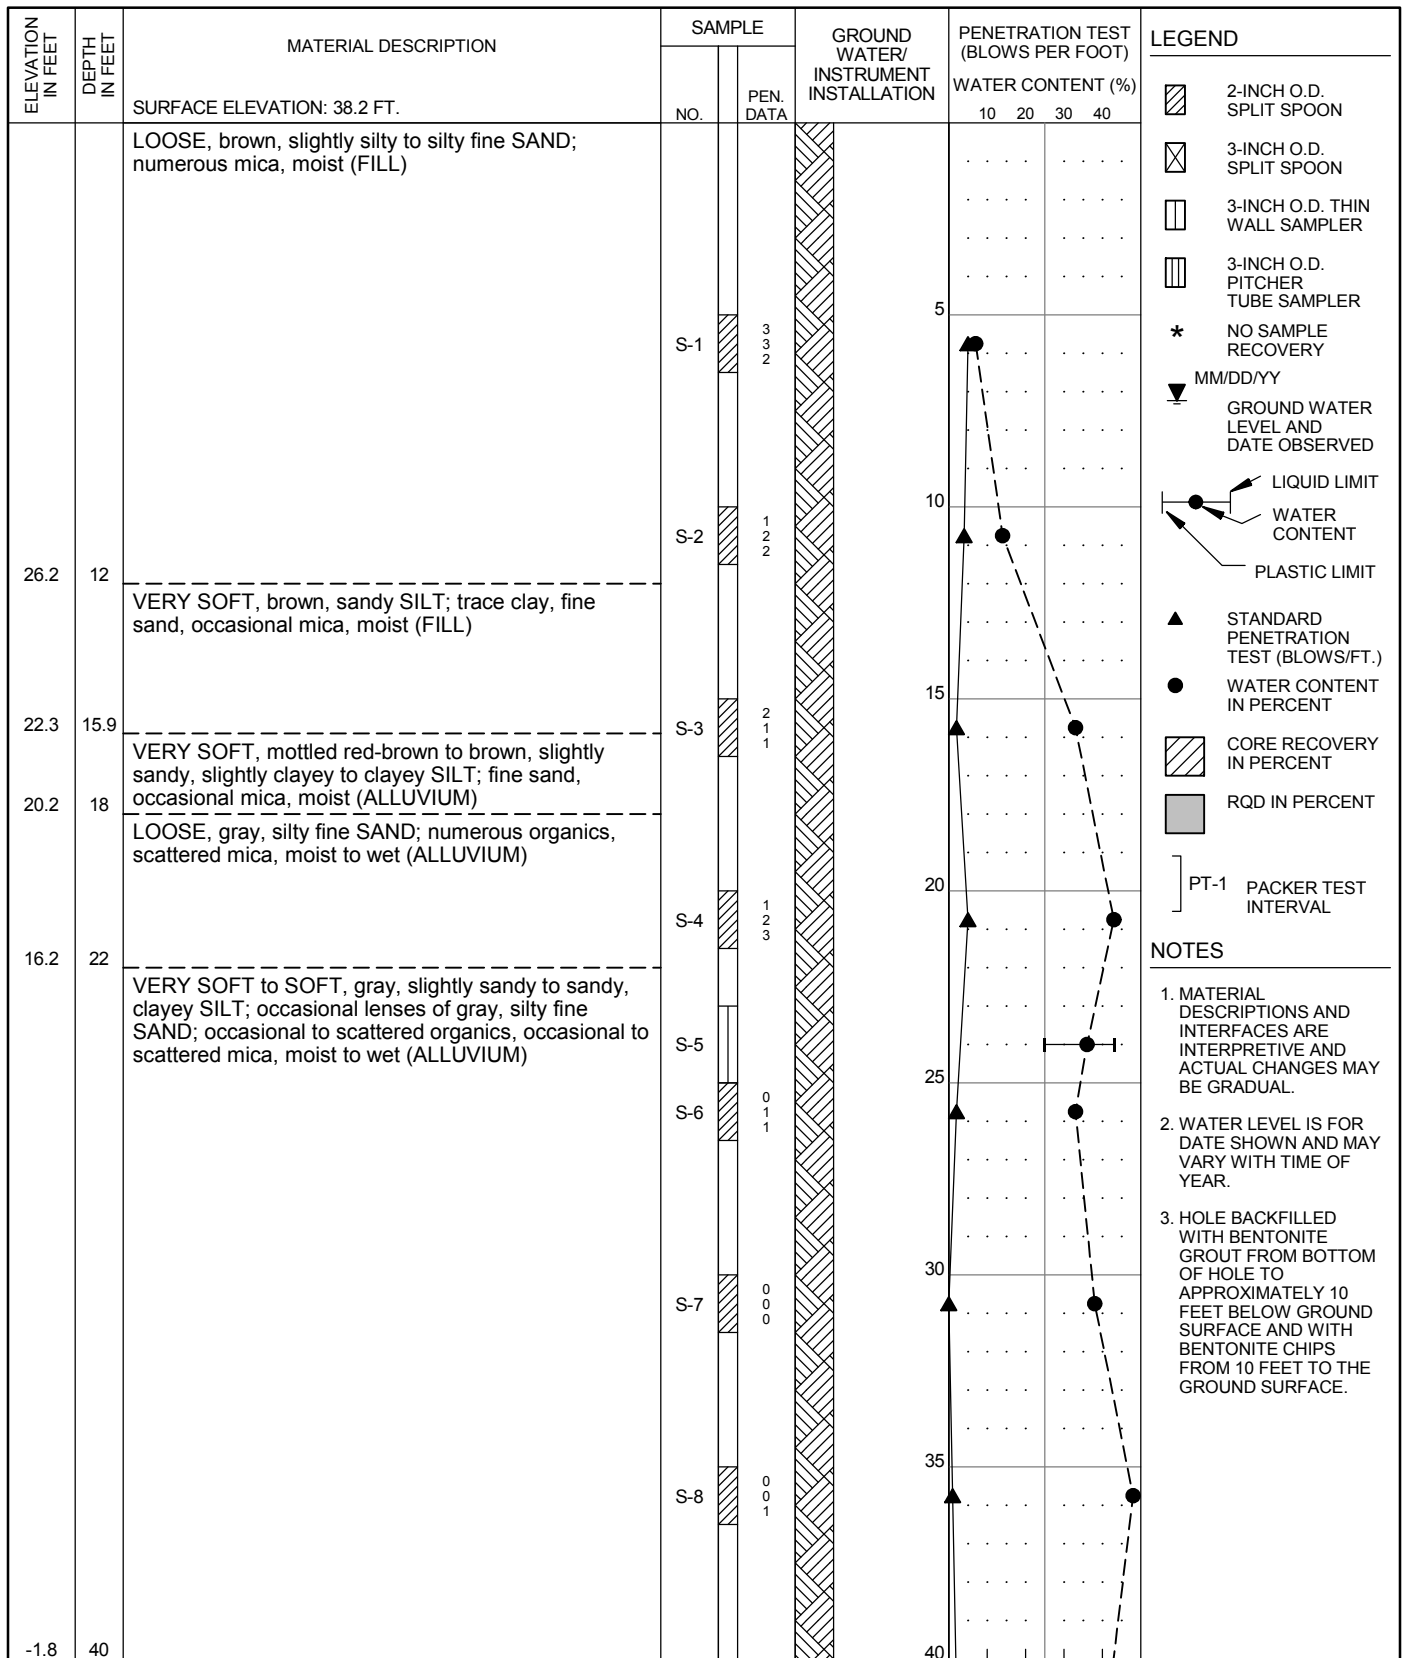
DRILLER: WESTERN STATES DATE START: 3/13/2014 FINISH: 3/13/2014 DRILLING TECHNIQUE: HOLLOW STEM AUGER	 10250 S.W. Greenburg Road, Suite 111 Portland, Oregon 97223 Phone 503-452-1100 Fax 503-452-1528	SUMMARY BORING LOG P2-CC-46 PENINSULA DISTRICT 2 LEVEE PORTLAND, OR	SEP 2014
			PROJ 2320
			FIG. A46

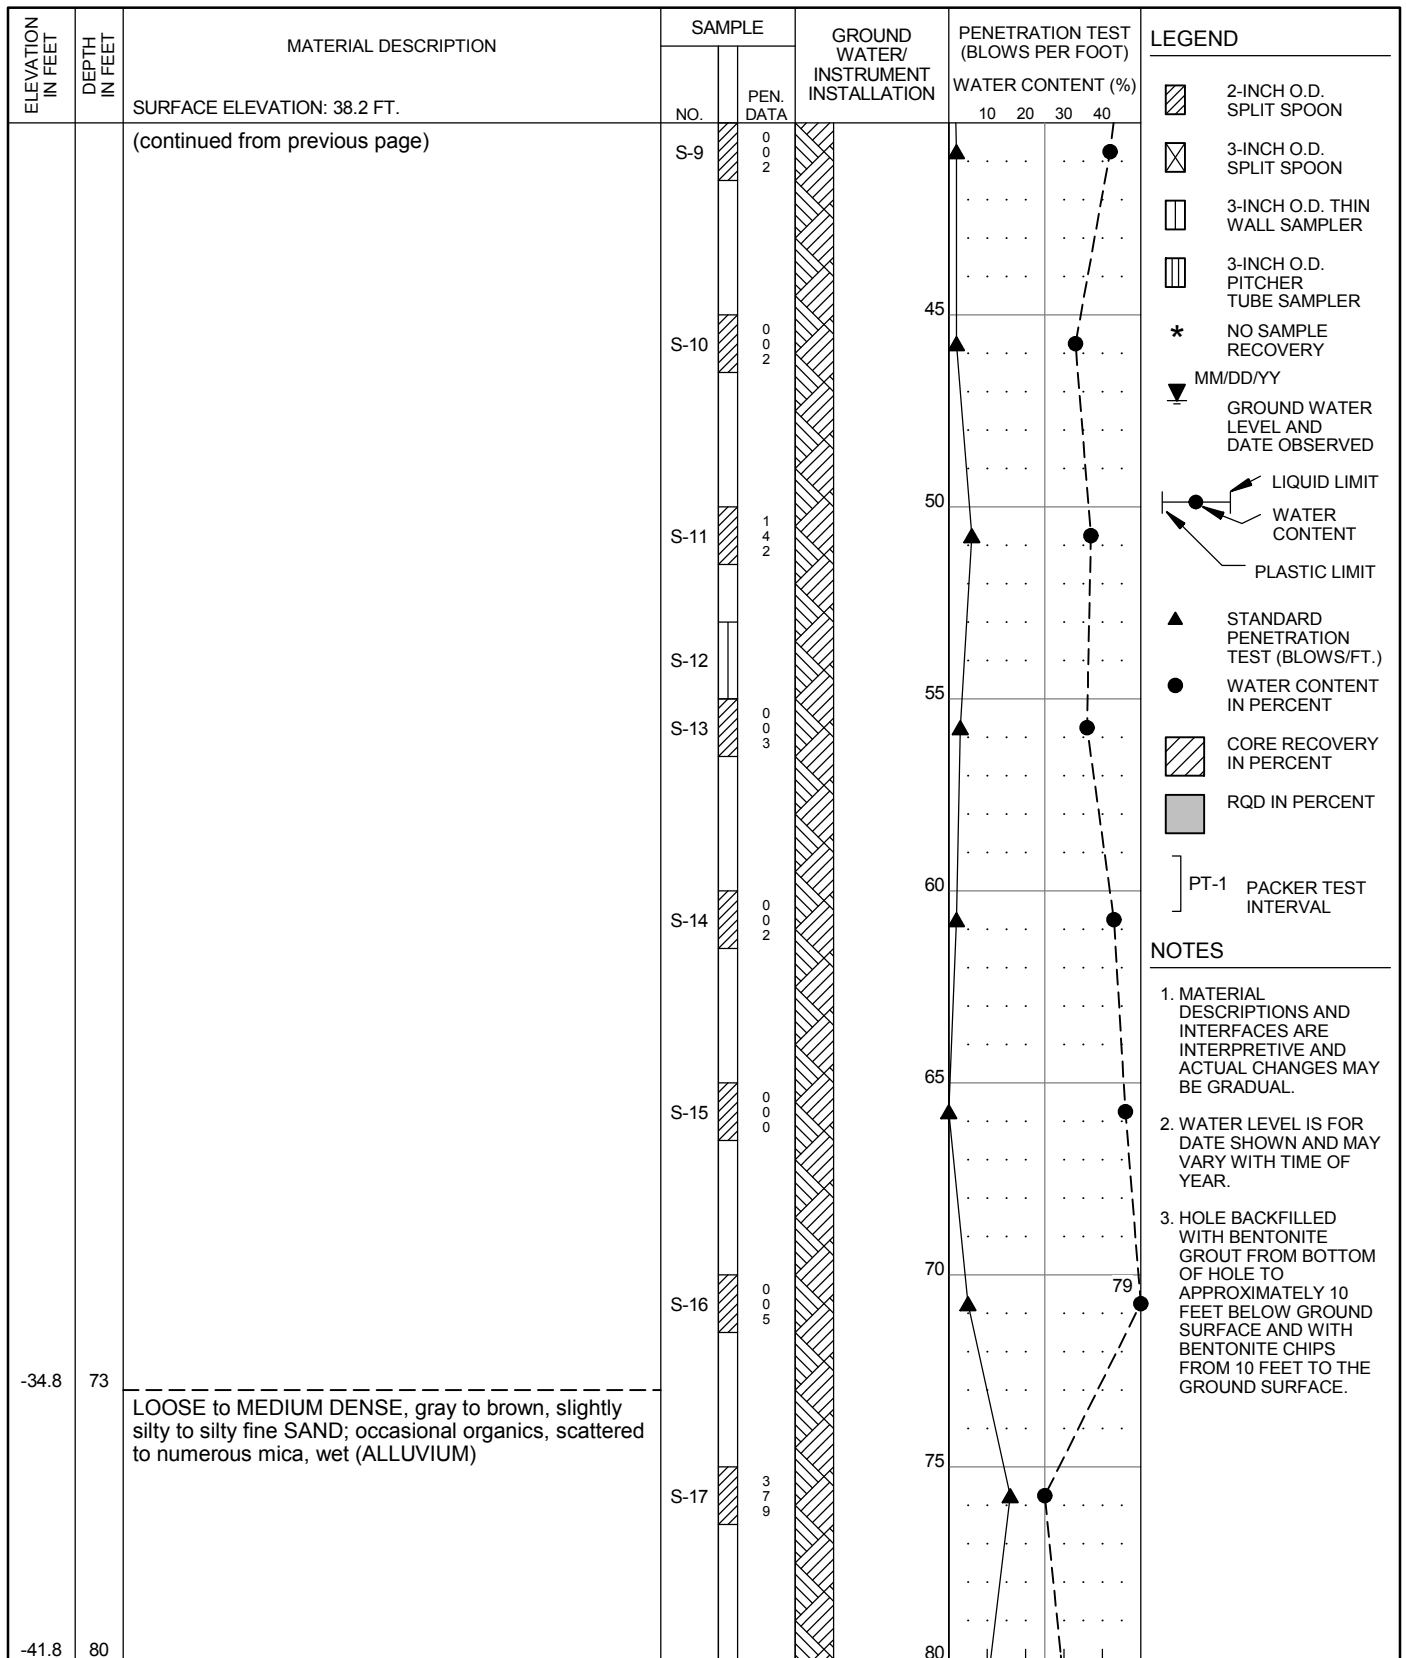
DRILLER: WESTERN STATES DATE START: 3/17/2014 FINISH: 3/17/2014 DRILLING TECHNIQUE: HOLLOW STEM AUGER	 10250 S.W. Greenburg Road, Suite 111 Portland, Oregon 97223 Phone 503-452-1100 Fax 503-452-1528	SUMMARY BORING LOG P2-CC-49 (1 of 3) PENINSULA DISTRICT 2 LEVEE PORTLAND, OR	SEP 2014
			PROJ 2320
			FIG. A49

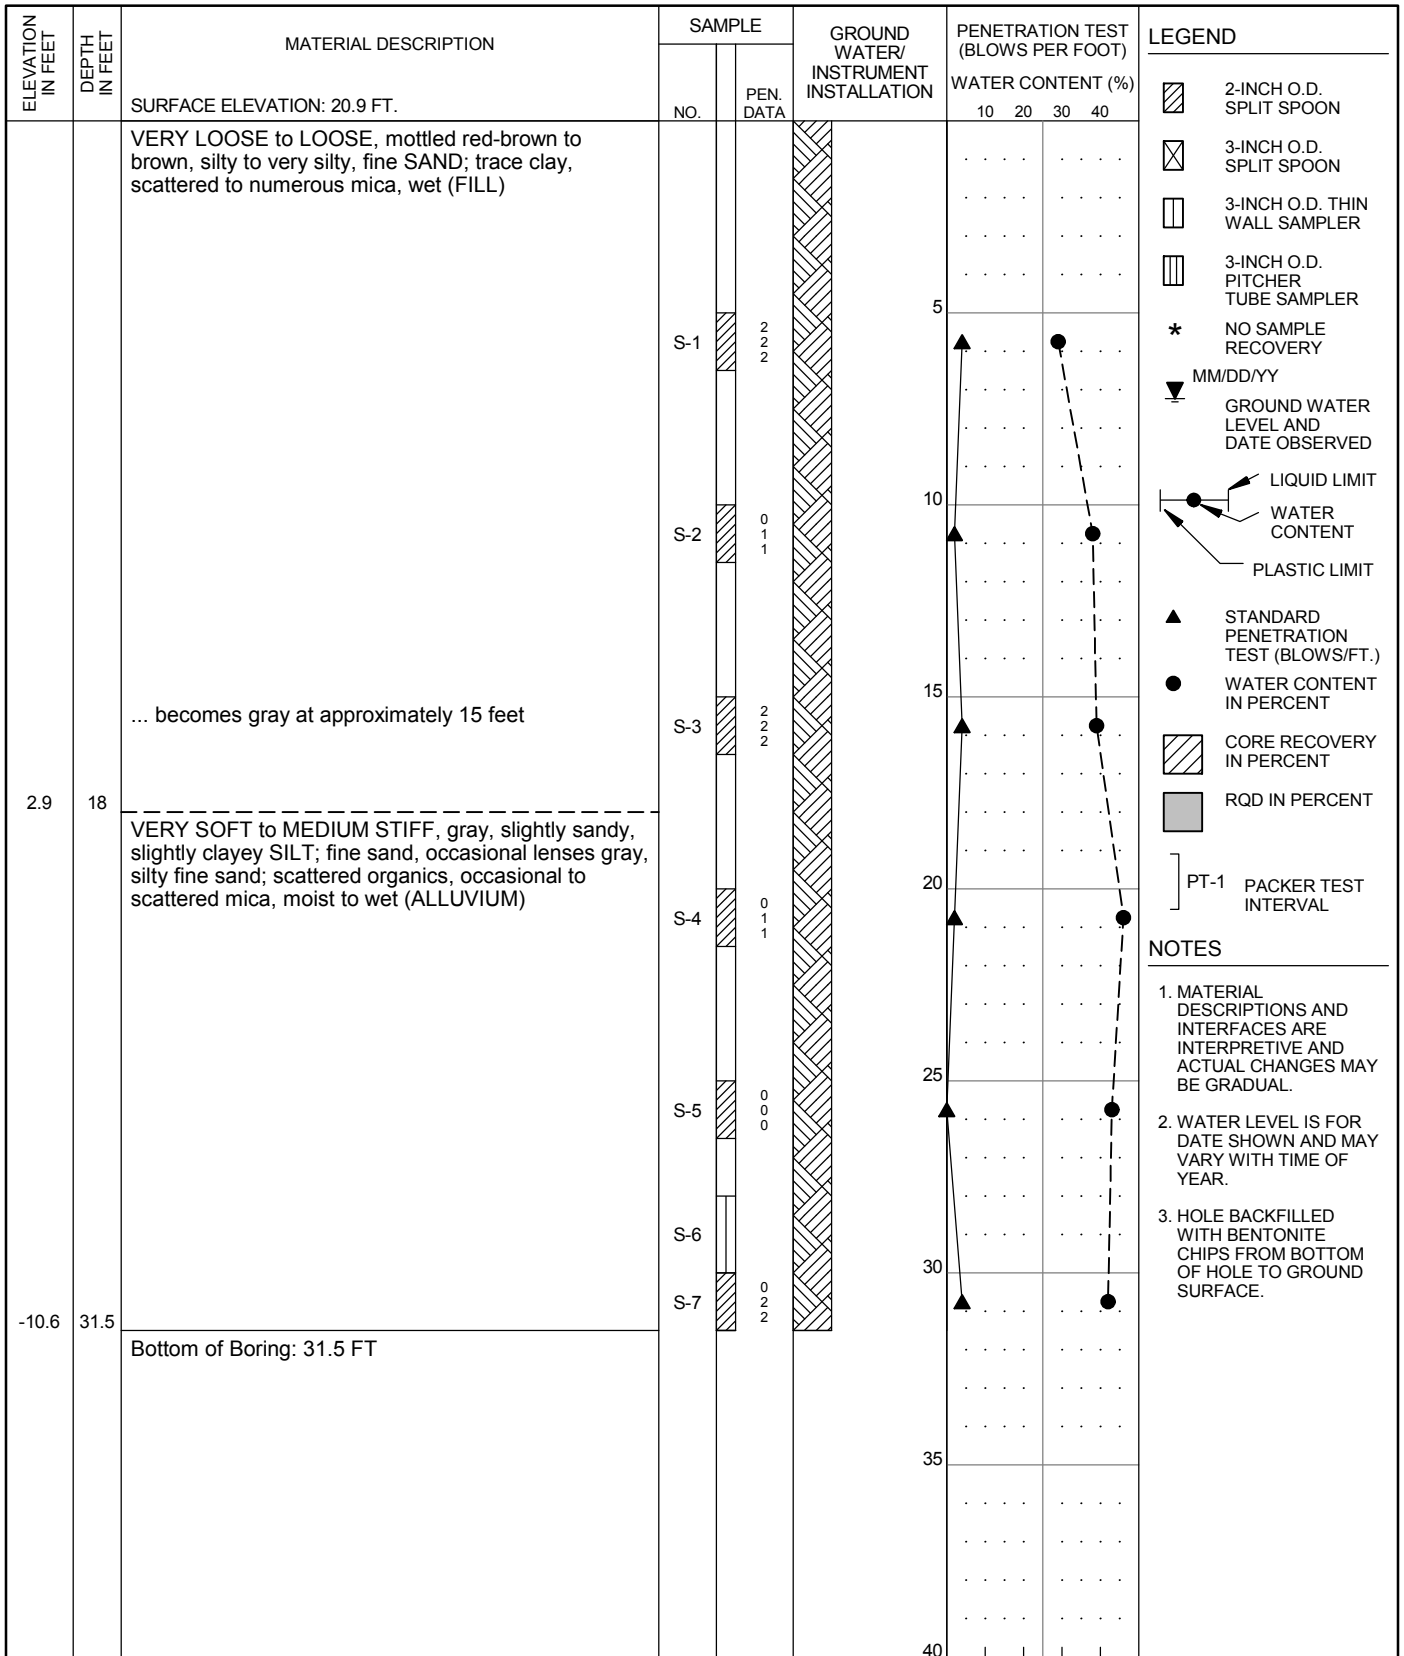
DRILLER: WESTERN STATES DATE START: 4/29/2014 FINISH: 4/29/2014 DRILLING TECHNIQUE: MUD ROTARY	CORNFORTH CONSULTANTS 10250 S.W. Greenburg Road, Suite 111 Portland, Oregon 97223 Phone 503-452-1100 Fax 503-452-1528	SUMMARY BORING LOG P2-CC-50 PENINSULA DISTRICT 2 LEVEE PORTLAND, OR	SEP 2014 PROJ 2320 FIG. A50
------------------------------------------------------------------------------------------------------	------------------------------------------------------------------------------------------------------------------------------------------	--------------------------------------------------------------------------------------------	------------------------------------------

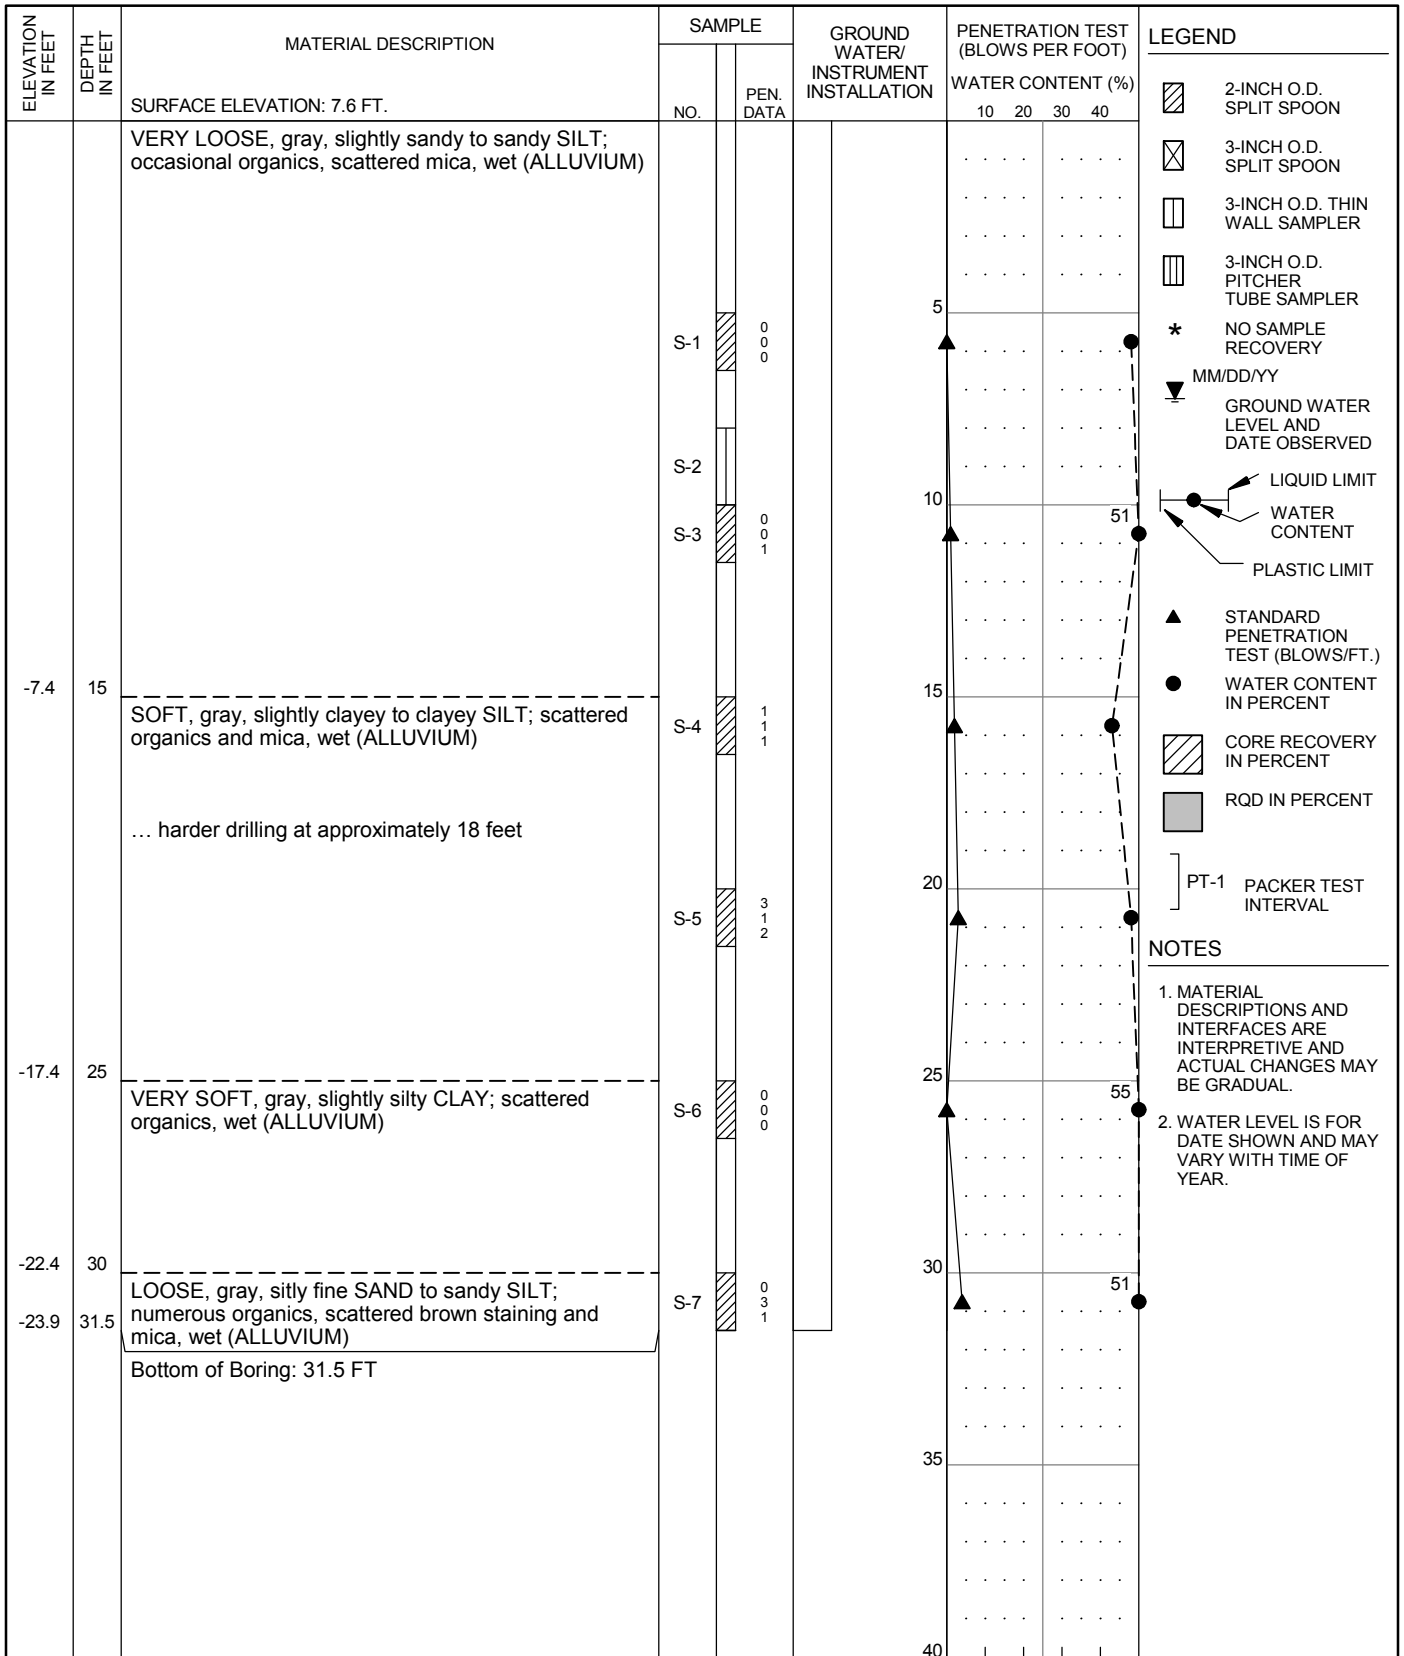
DRILLER: WESTERN STATES DATE START: 4/30/2014 FINISH: 4/30/2014 DRILLING TECHNIQUE: MUD ROTARY	 10250 S.W. Greenburg Road, Suite 111 Portland, Oregon 97223 Phone 503-452-1100 Fax 503-452-1528	SUMMARY BORING LOG P2-CC-53 PENINSULA DISTRICT 2 LEVEE PORTLAND, OR	SEP 2014
			PROJ 2320
			FIG. A53
