Peninsula Drainage District No. 2

Levee Engineering Assessment

**PENINSULA DRAINAGE DISTRICT NO. 2
LEVEE ENGINEERING ASSESSMENT**

October 2, 2014

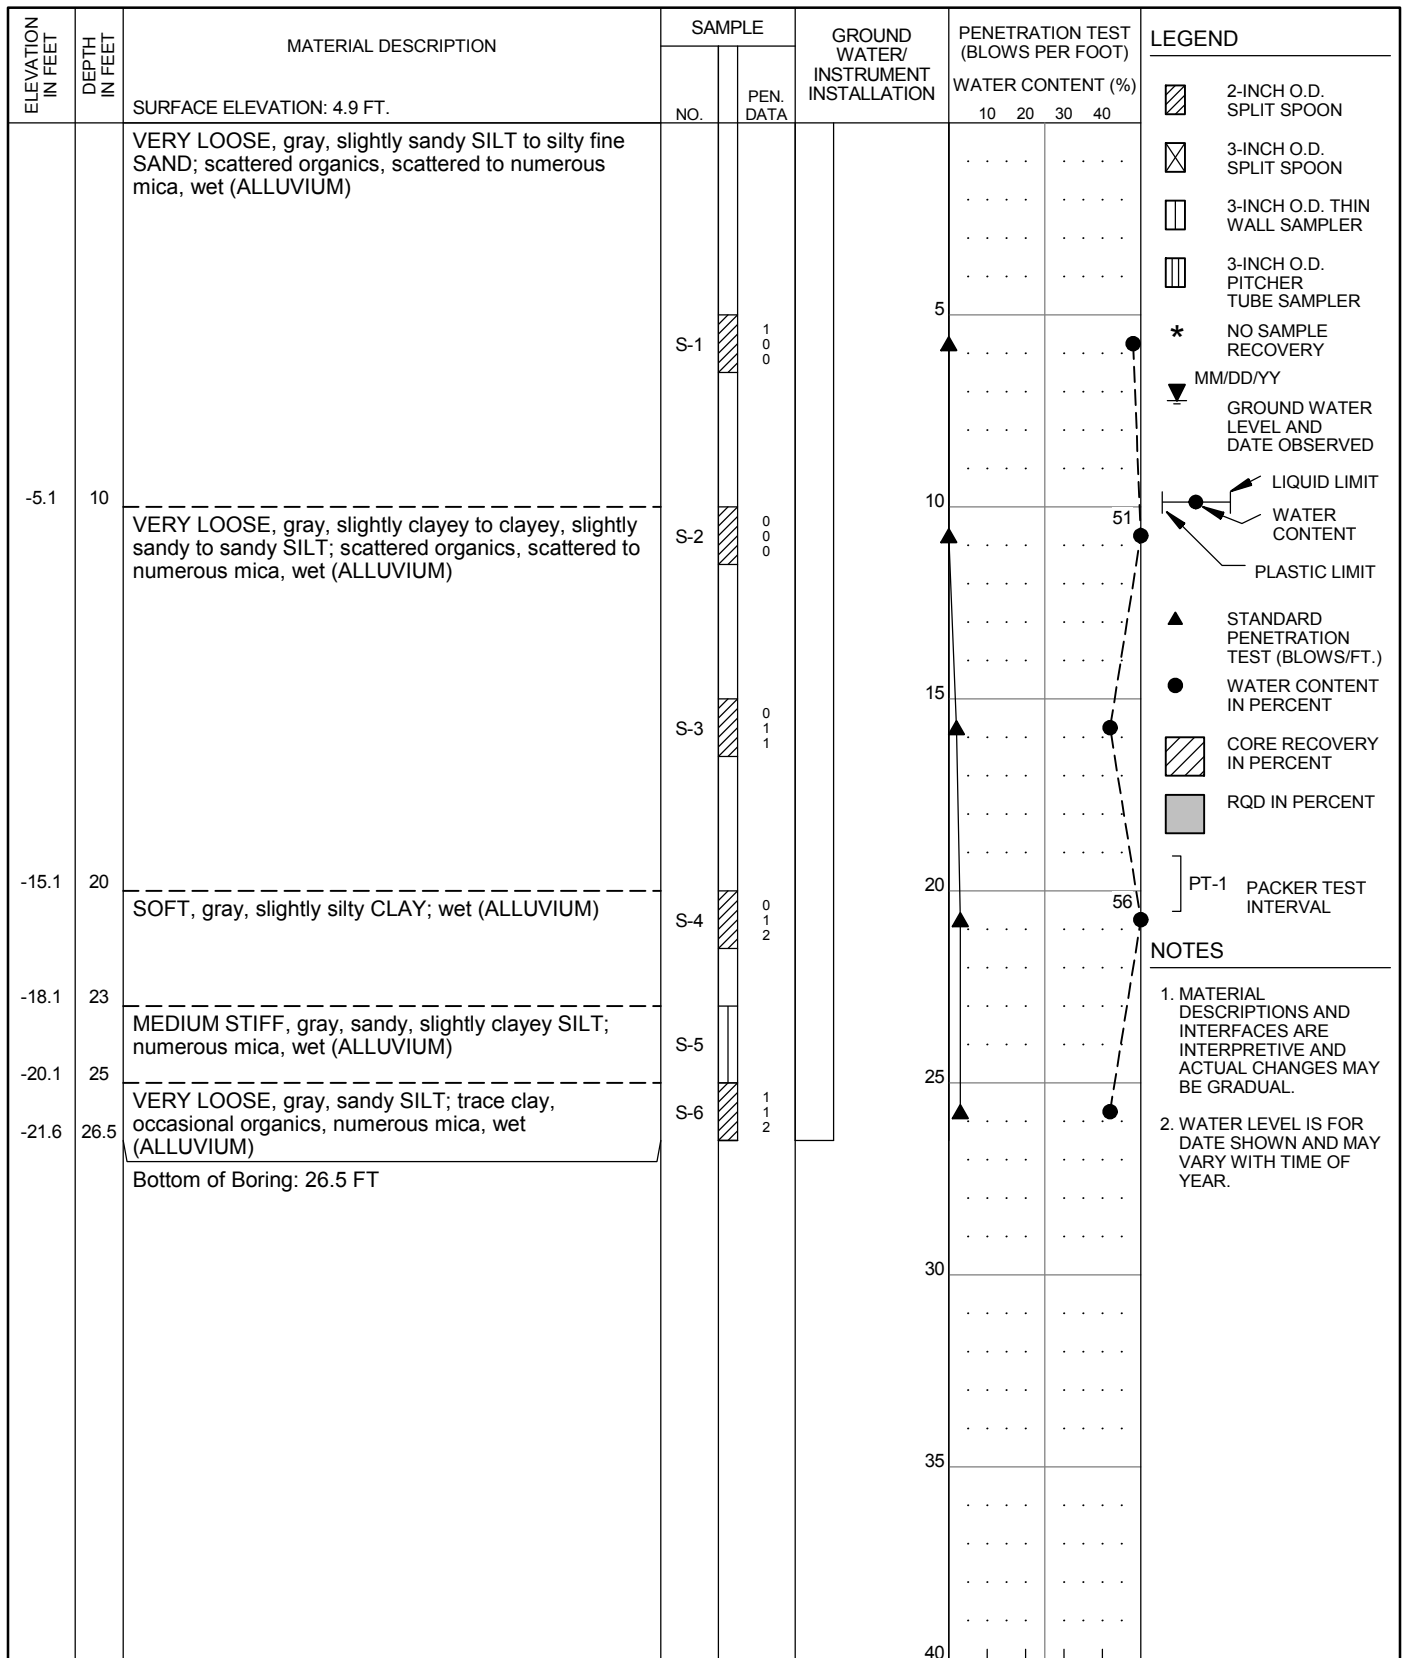
DRILLER: WESTERN STATES DATE START: 4/30/2014 FINISH: 4/30/2014 DRILLING TECHNIQUE: MUD ROTARY	CORNFORTH CONSULTANTS 10250 S.W. Greenburg Road, Suite 111 Portland, Oregon 97223 Phone 503-452-1100 Fax 503-452-1528	SUMMARY BORING LOG P2-CC-56 PENINSULA DISTRICT 2 LEVEE PORTLAND, OR	SEP 2014 PROJ 2320 FIG. A56
------------------------------------------------------------------------------------------------------	------------------------------------------------------------------------------------------------------------------------------------------	--------------------------------------------------------------------------------------------	------------------------------------------

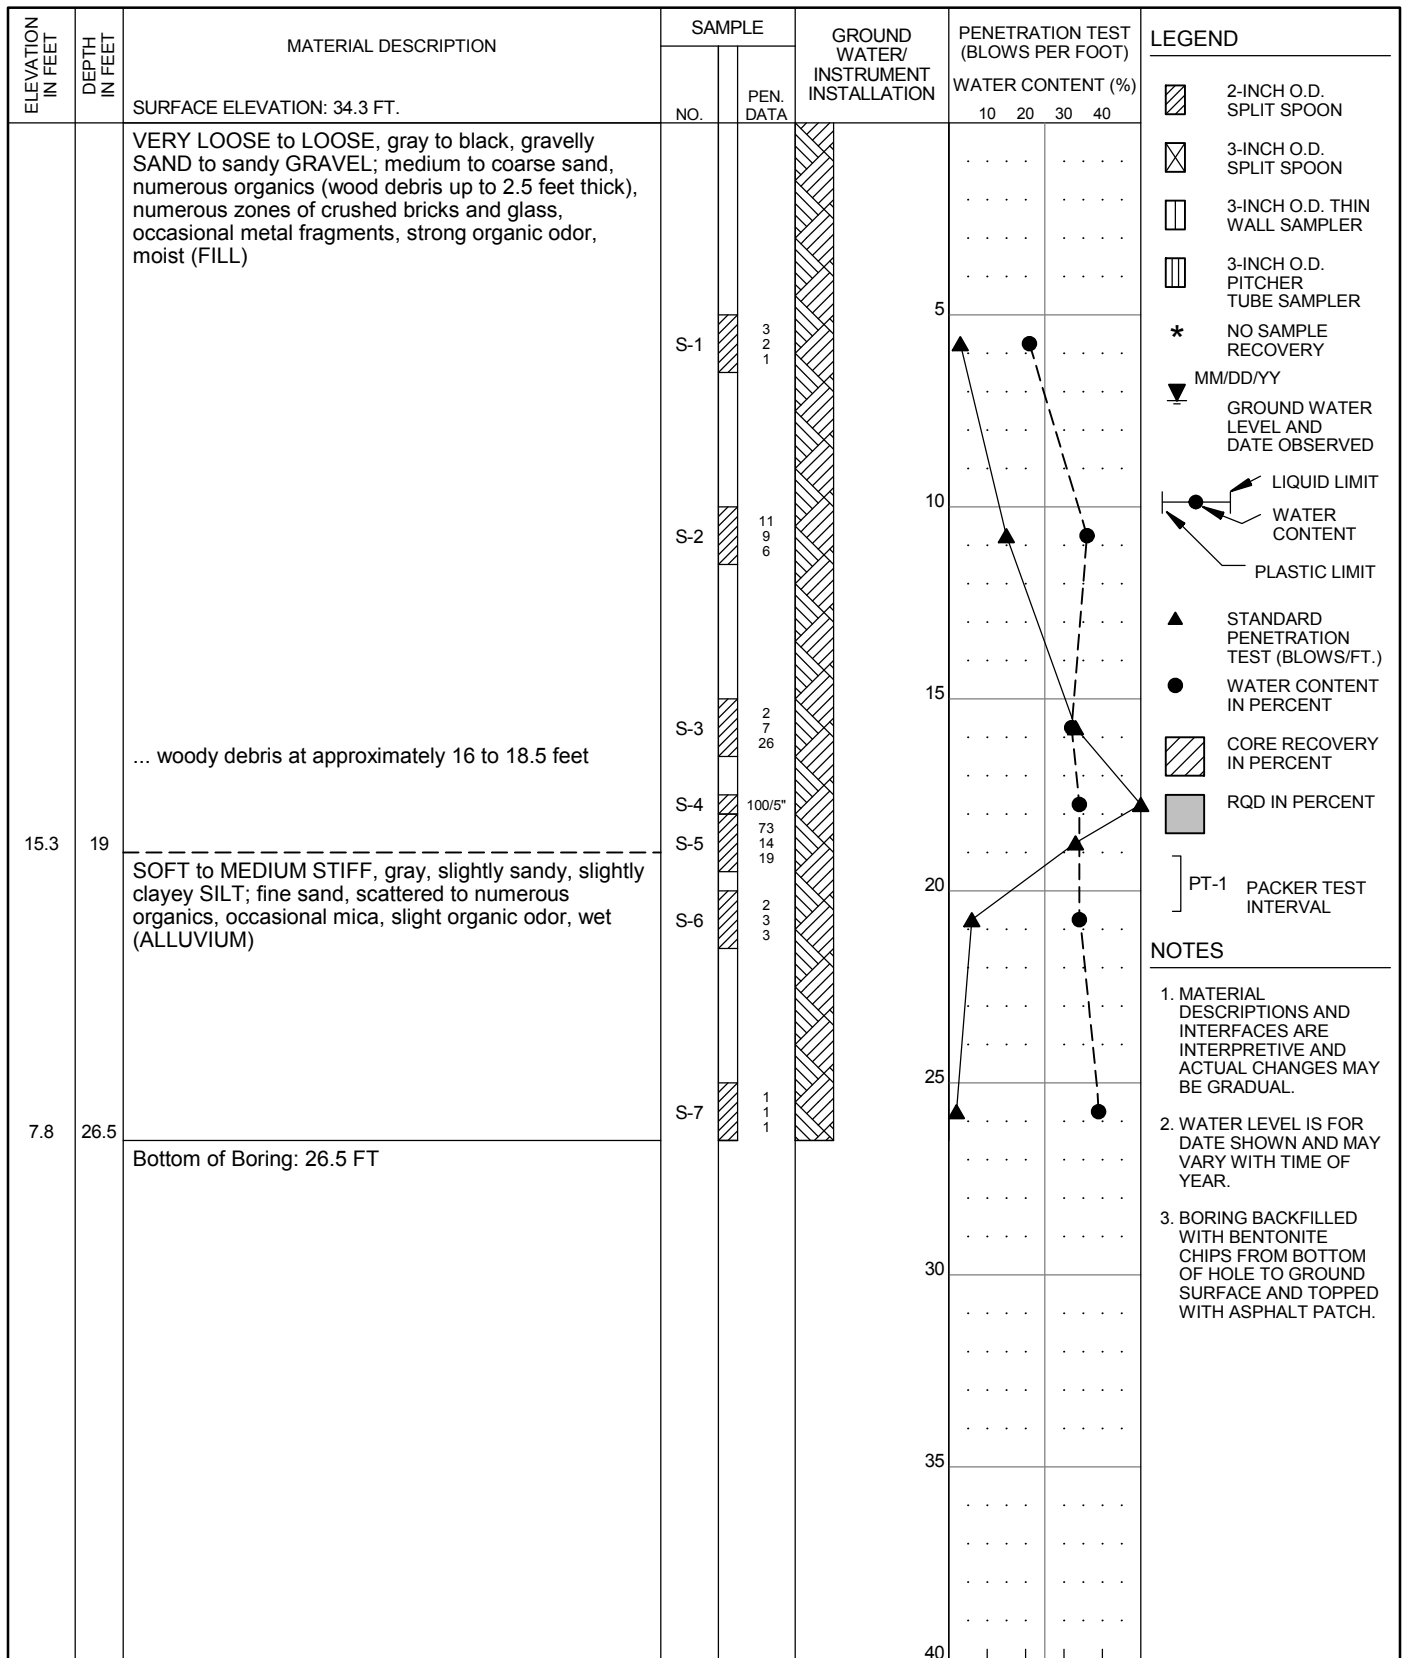
DRILLER: WESTERN STATES DATE START: 3/31/2014 FINISH: 3/31/2014 DRILLING TECHNIQUE: HOLLOW STEM AUGER	CORNFORTH CONSULTANTS 10250 S.W. Greenburg Road, Suite 111 Portland, Oregon 97223 Phone 503-452-1100 Fax 503-452-1528	SUMMARY BORING LOG P2-CC-57 PENINSULA DISTRICT 2 LEVEE PORTLAND, OR	SEP 2014 PROJ 2320 FIG. A57
----------------------------------------------------------------------------------------------------------------	------------------------------------------------------------------------------------------------------------------------------------------	--------------------------------------------------------------------------------------------	------------------------------------------

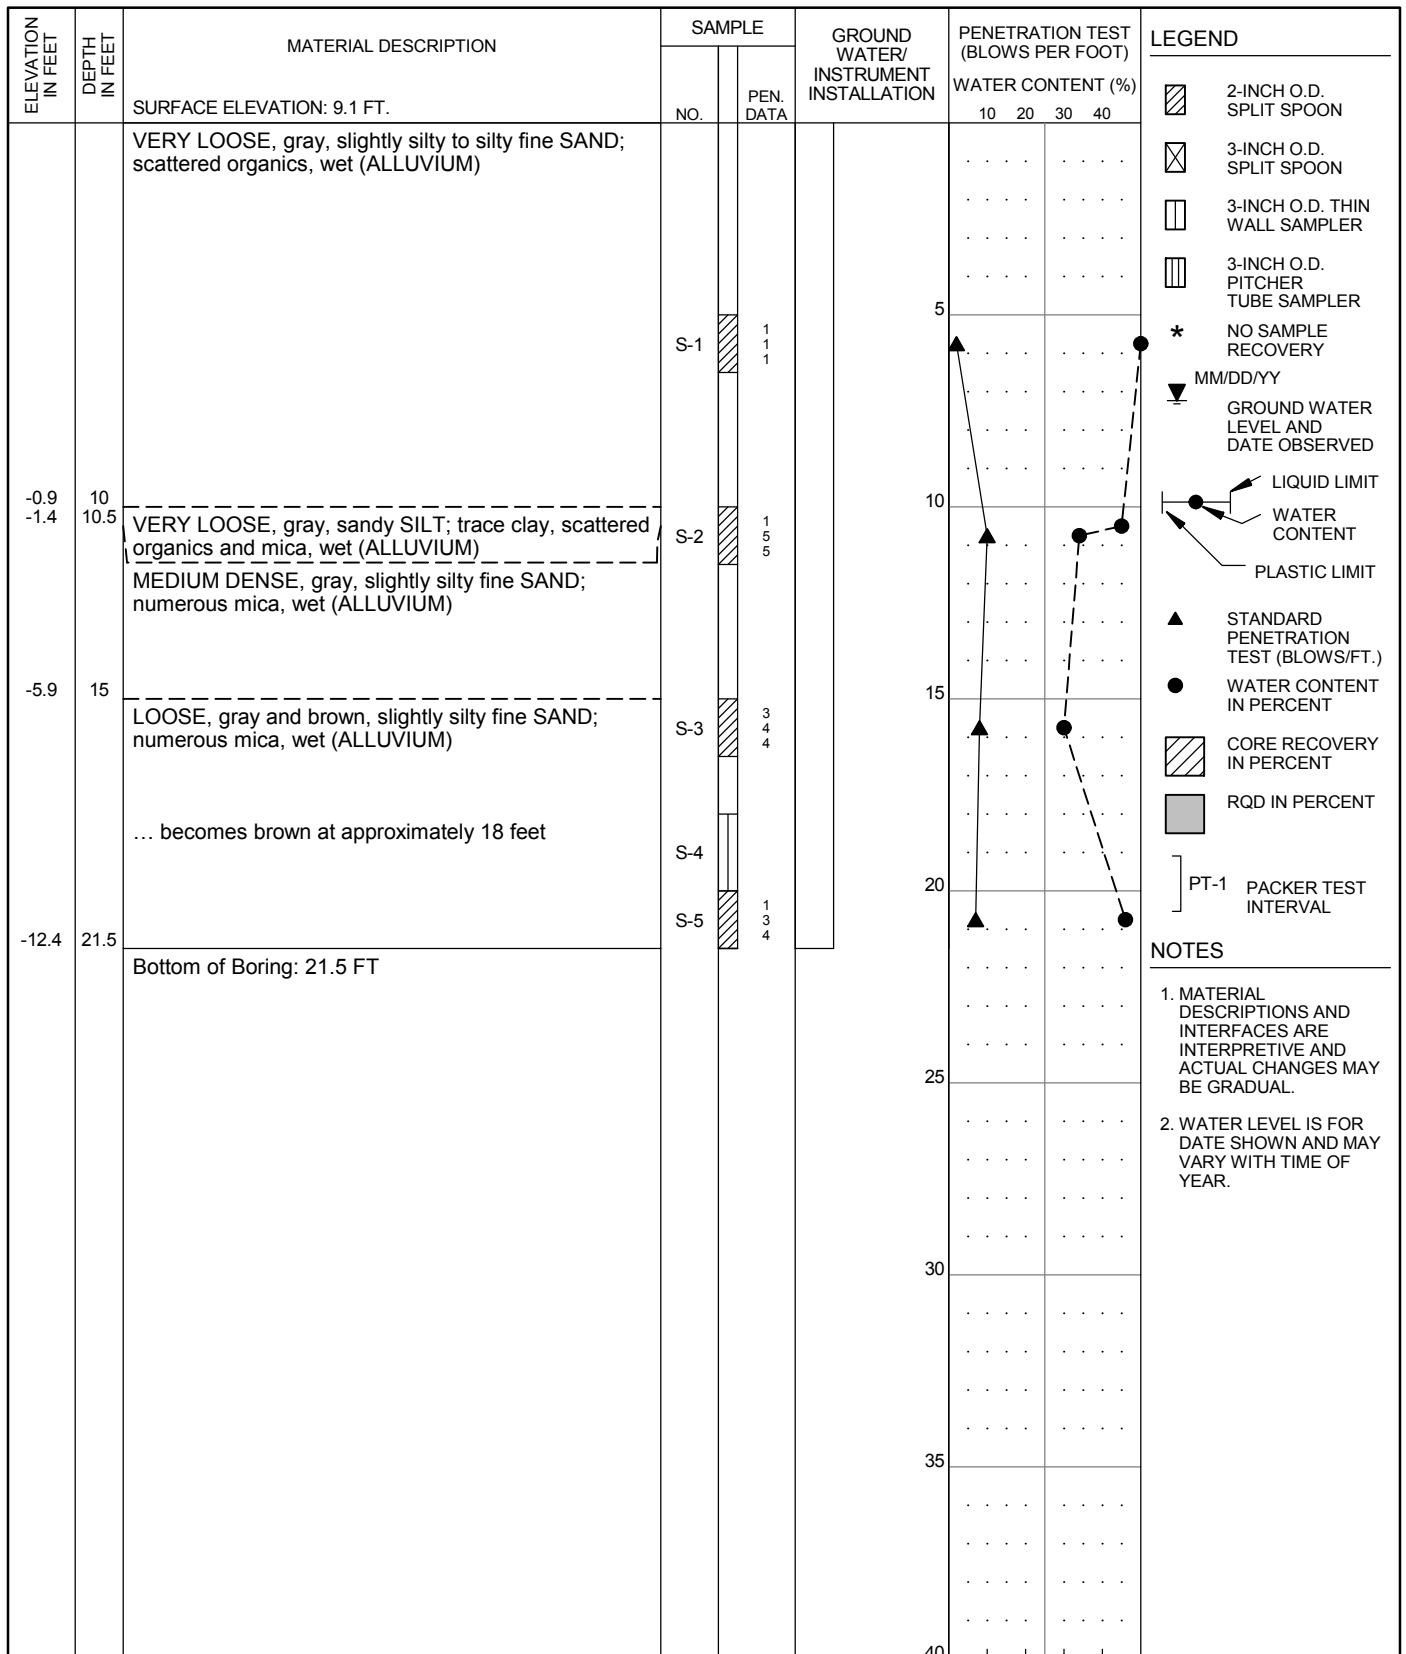
DRILLER: WESTERN STATES DATE START: 4/30/2014 FINISH: 4/30/2014 DRILLING TECHNIQUE: MUD ROTARY	 10250 S.W. Greenburg Road, Suite 111 Portland, Oregon 97223 Phone 503-452-1100 Fax 503-452-1528	SUMMARY BORING LOG P2-CC-59 PENINSULA DISTRICT 2 LEVEE PORTLAND, OR	SEP 2014
			PROJ 2320
			FIG. A59

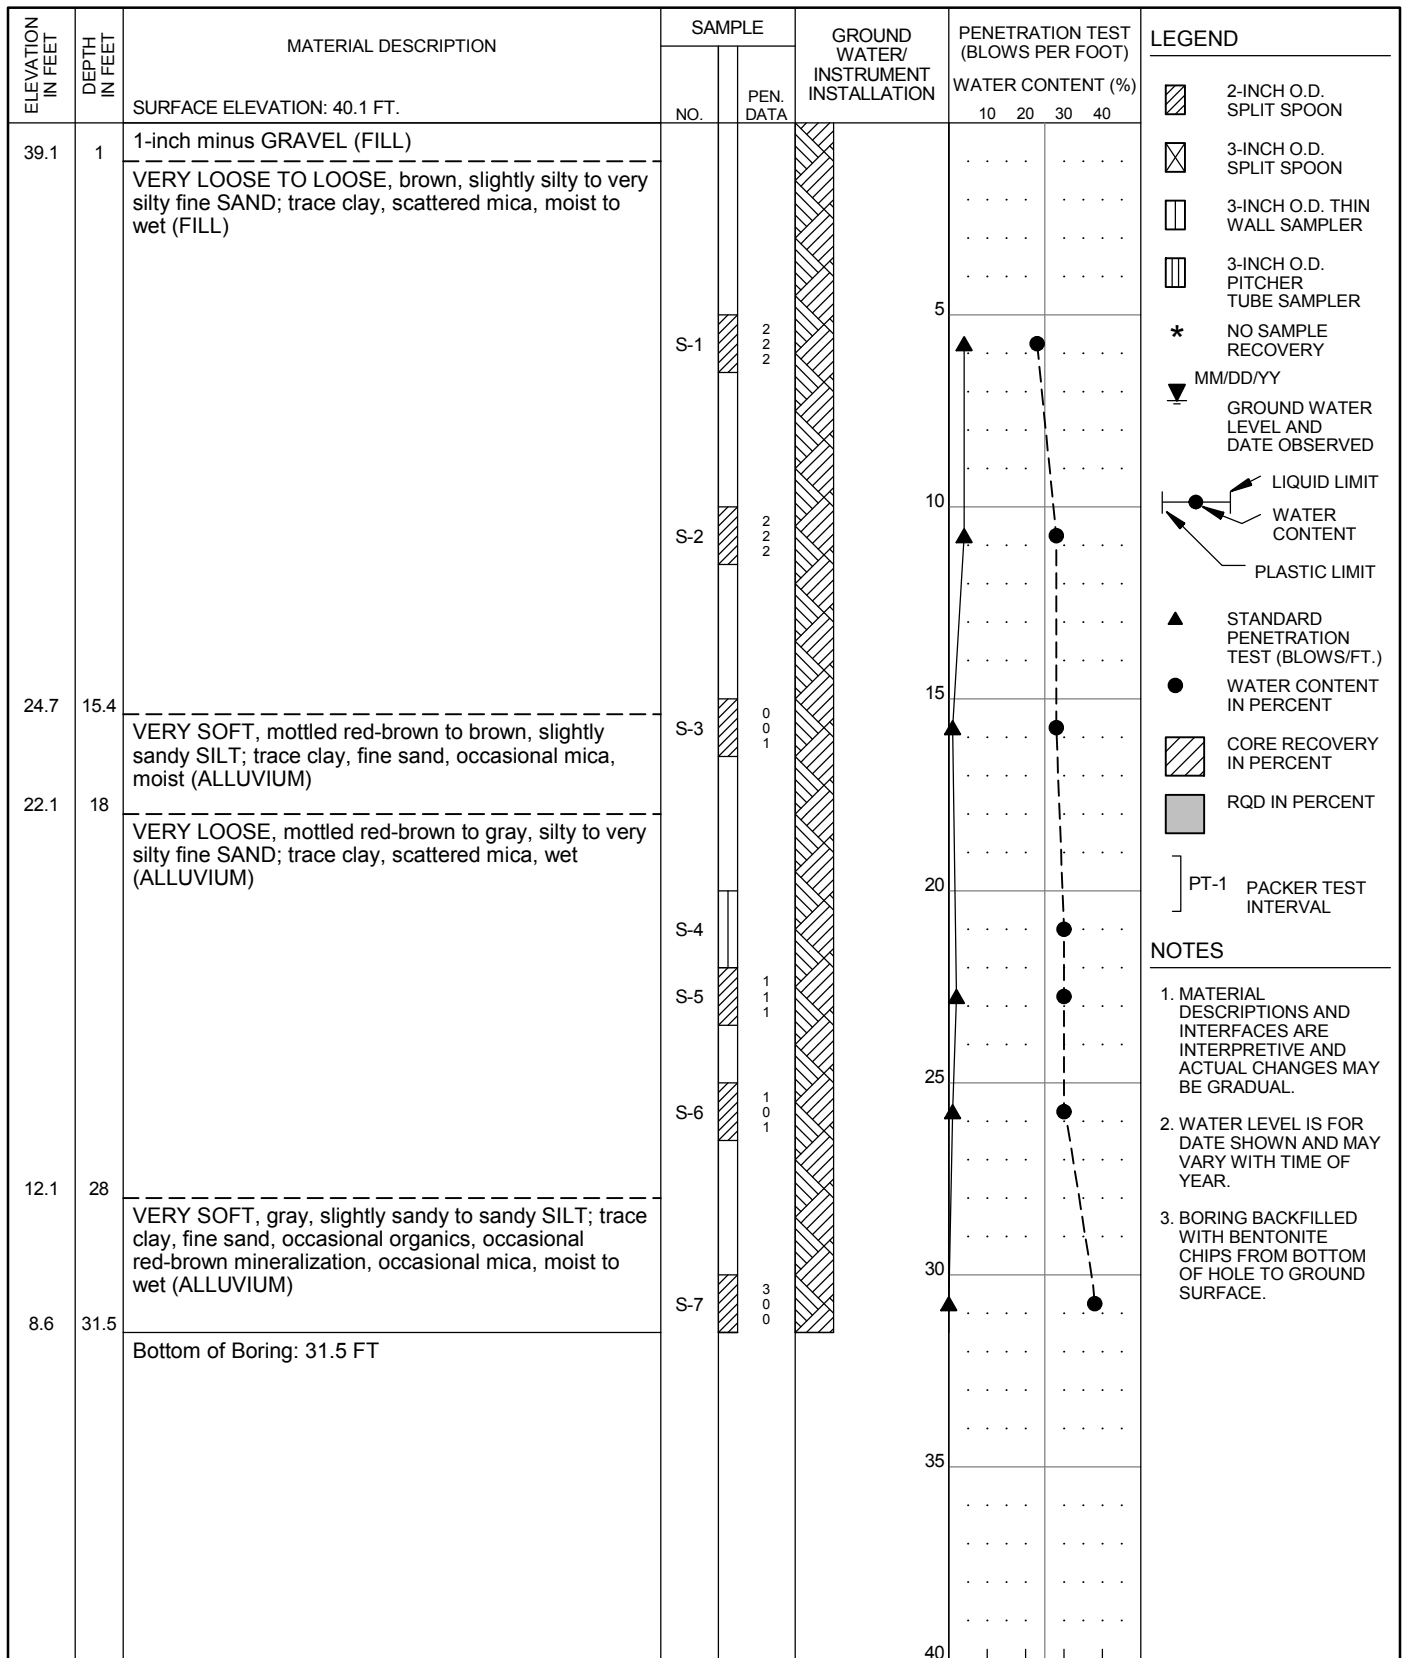
DRILLER: WESTERN STATES DATE START: 3/19/2014 FINISH: 3/19/2014 DRILLING TECHNIQUE: HOLLOW STEM AUGER	CORNFORTH CONSULTANTS 10250 S.W. Greenburg Road, Suite 111 Portland, Oregon 97223 Phone 503-452-1100 Fax 503-452-1528	SUMMARY BORING LOG P2-CC-61 PENINSULA DISTRICT 2 LEVEE PORTLAND, OR	SEP 2014 PROJ 2320 FIG. A61
-------------------------------------------------------------------------------------------------------------	------------------------------------------------------------------------------------------------------------------------------------------	--------------------------------------------------------------------------------------------	------------------------------------------

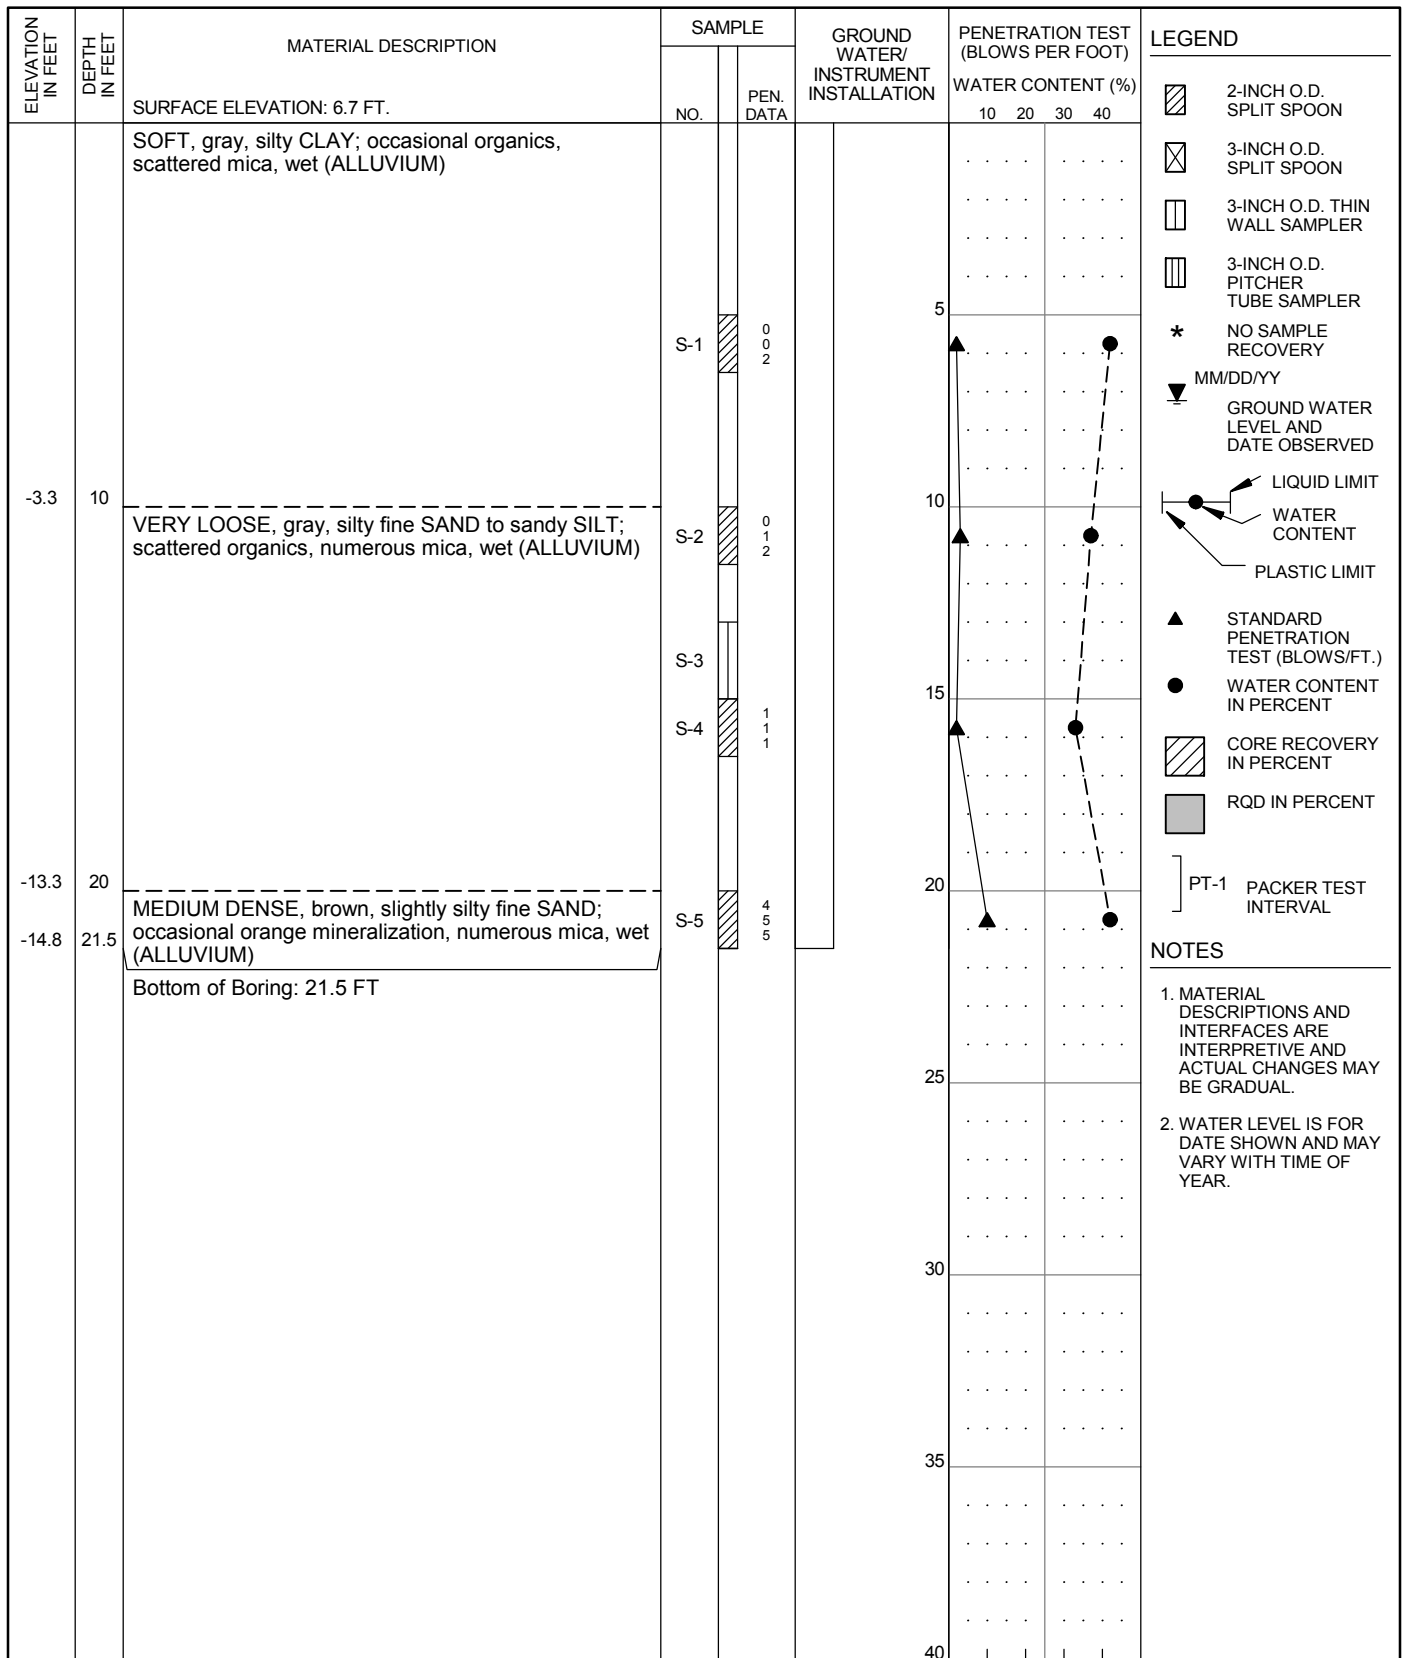
DRILLER: WESTERN STATES DATE START: 5/1/2014 FINISH: 5/1/2014 DRILLING TECHNIQUE: MUD ROTARY	CORNFORTH CONSULTANTS 10250 S.W. Greenburg Road, Suite 111 Portland, Oregon 97223 Phone 503-452-1100 Fax 503-452-1528	SUMMARY BORING LOG P2-CC-62 PENINSULA DISTRICT 2 LEVEE PORTLAND, OR	SEP 2014 PROJ 2320 FIG. A62
----------------------------------------------------------------------------------------------------	------------------------------------------------------------------------------------------------------------------------------------------	--------------------------------------------------------------------------------------------	------------------------------------------

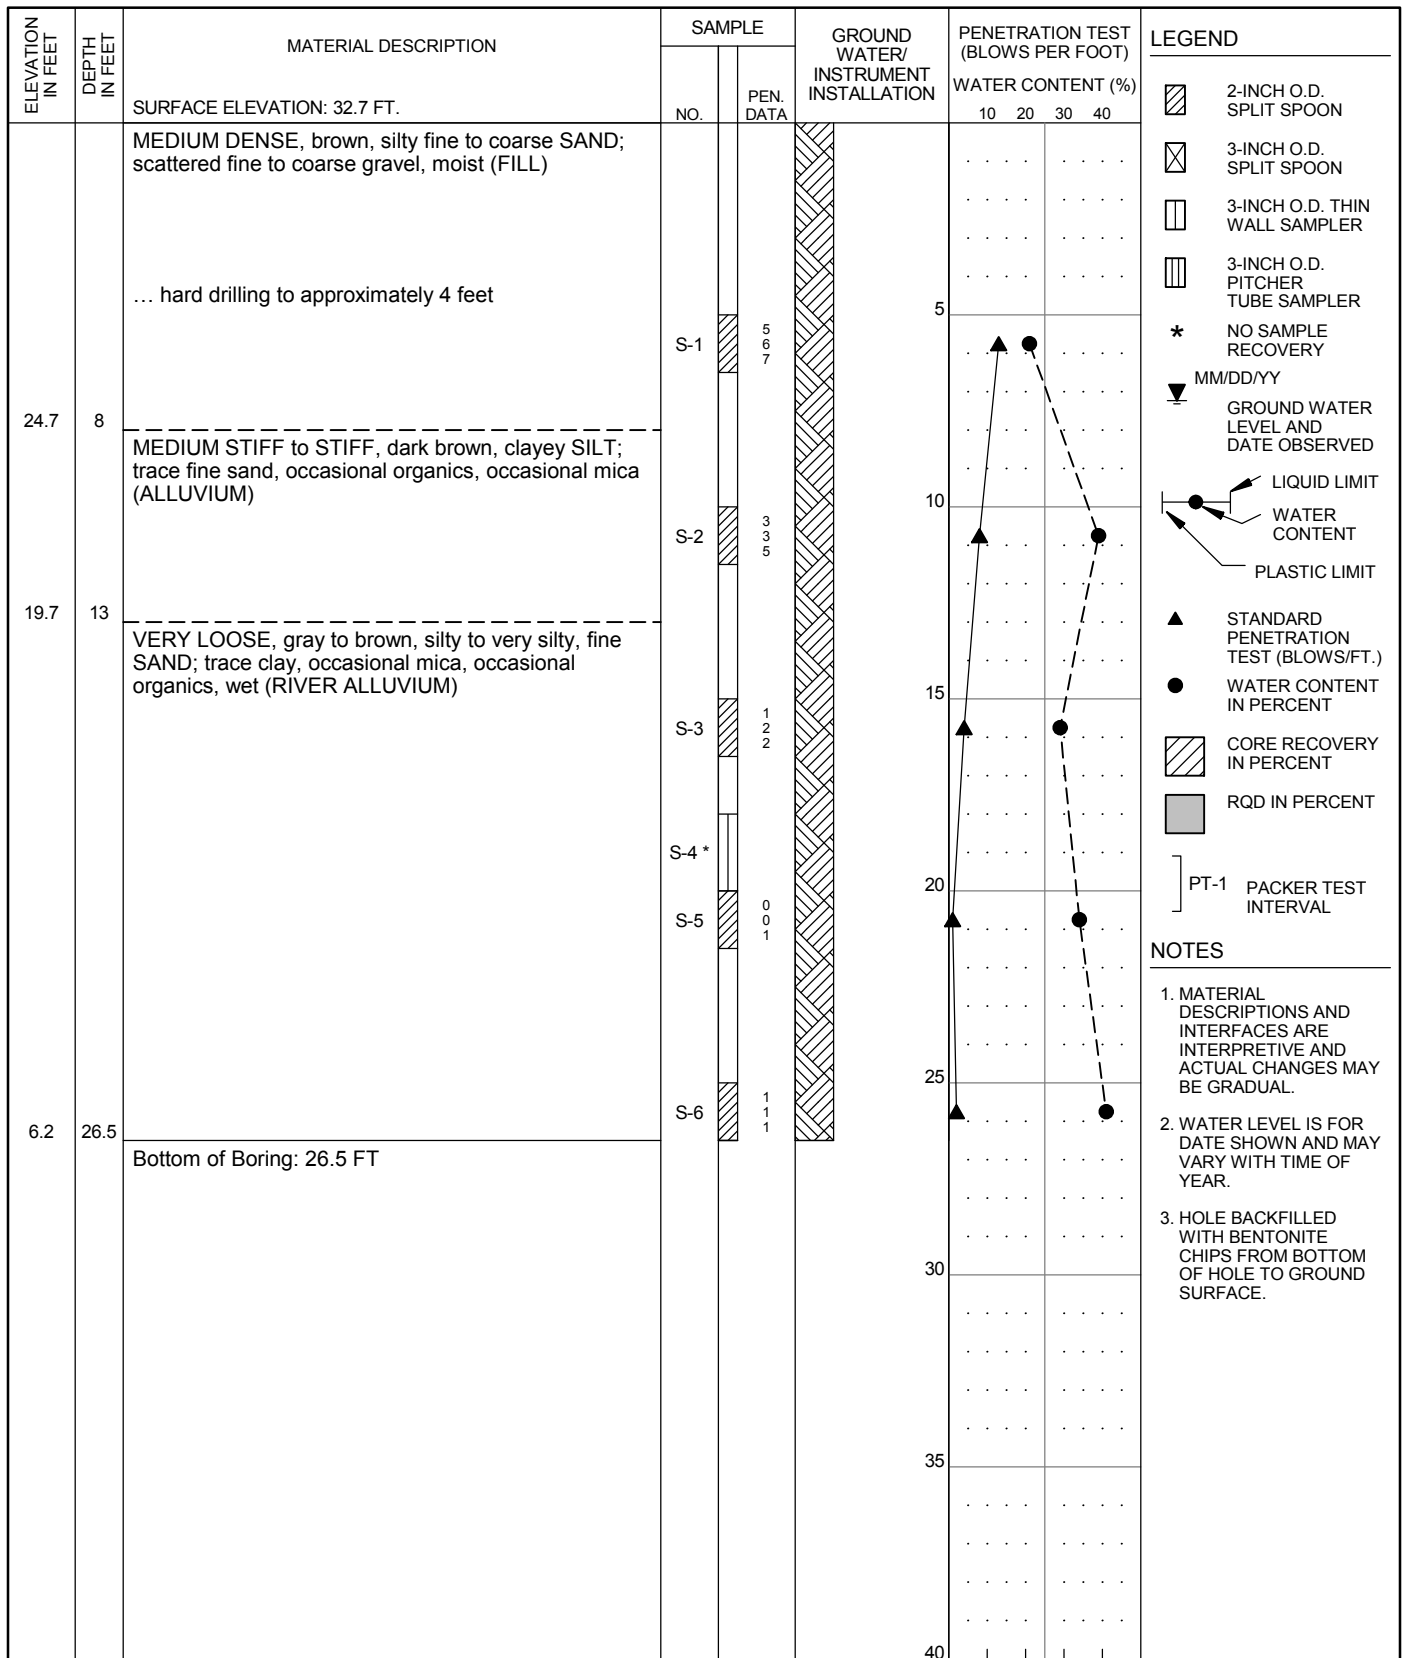
DRILLER: WESTERN STATES DATE START: 3/21/2014 FINISH: 3/21/2014 DRILLING TECHNIQUE: HOLLOW STEM AUGER	 10250 S.W. Greenburg Road, Suite 111 Portland, Oregon 97223 Phone 503-452-1100 Fax 503-452-1528	SUMMARY BORING LOG P2-CC-63 PENINSULA DISTRICT 2 LEVEE PORTLAND, OR	SEP 2014
			PROJ 2320
			FIG. A63

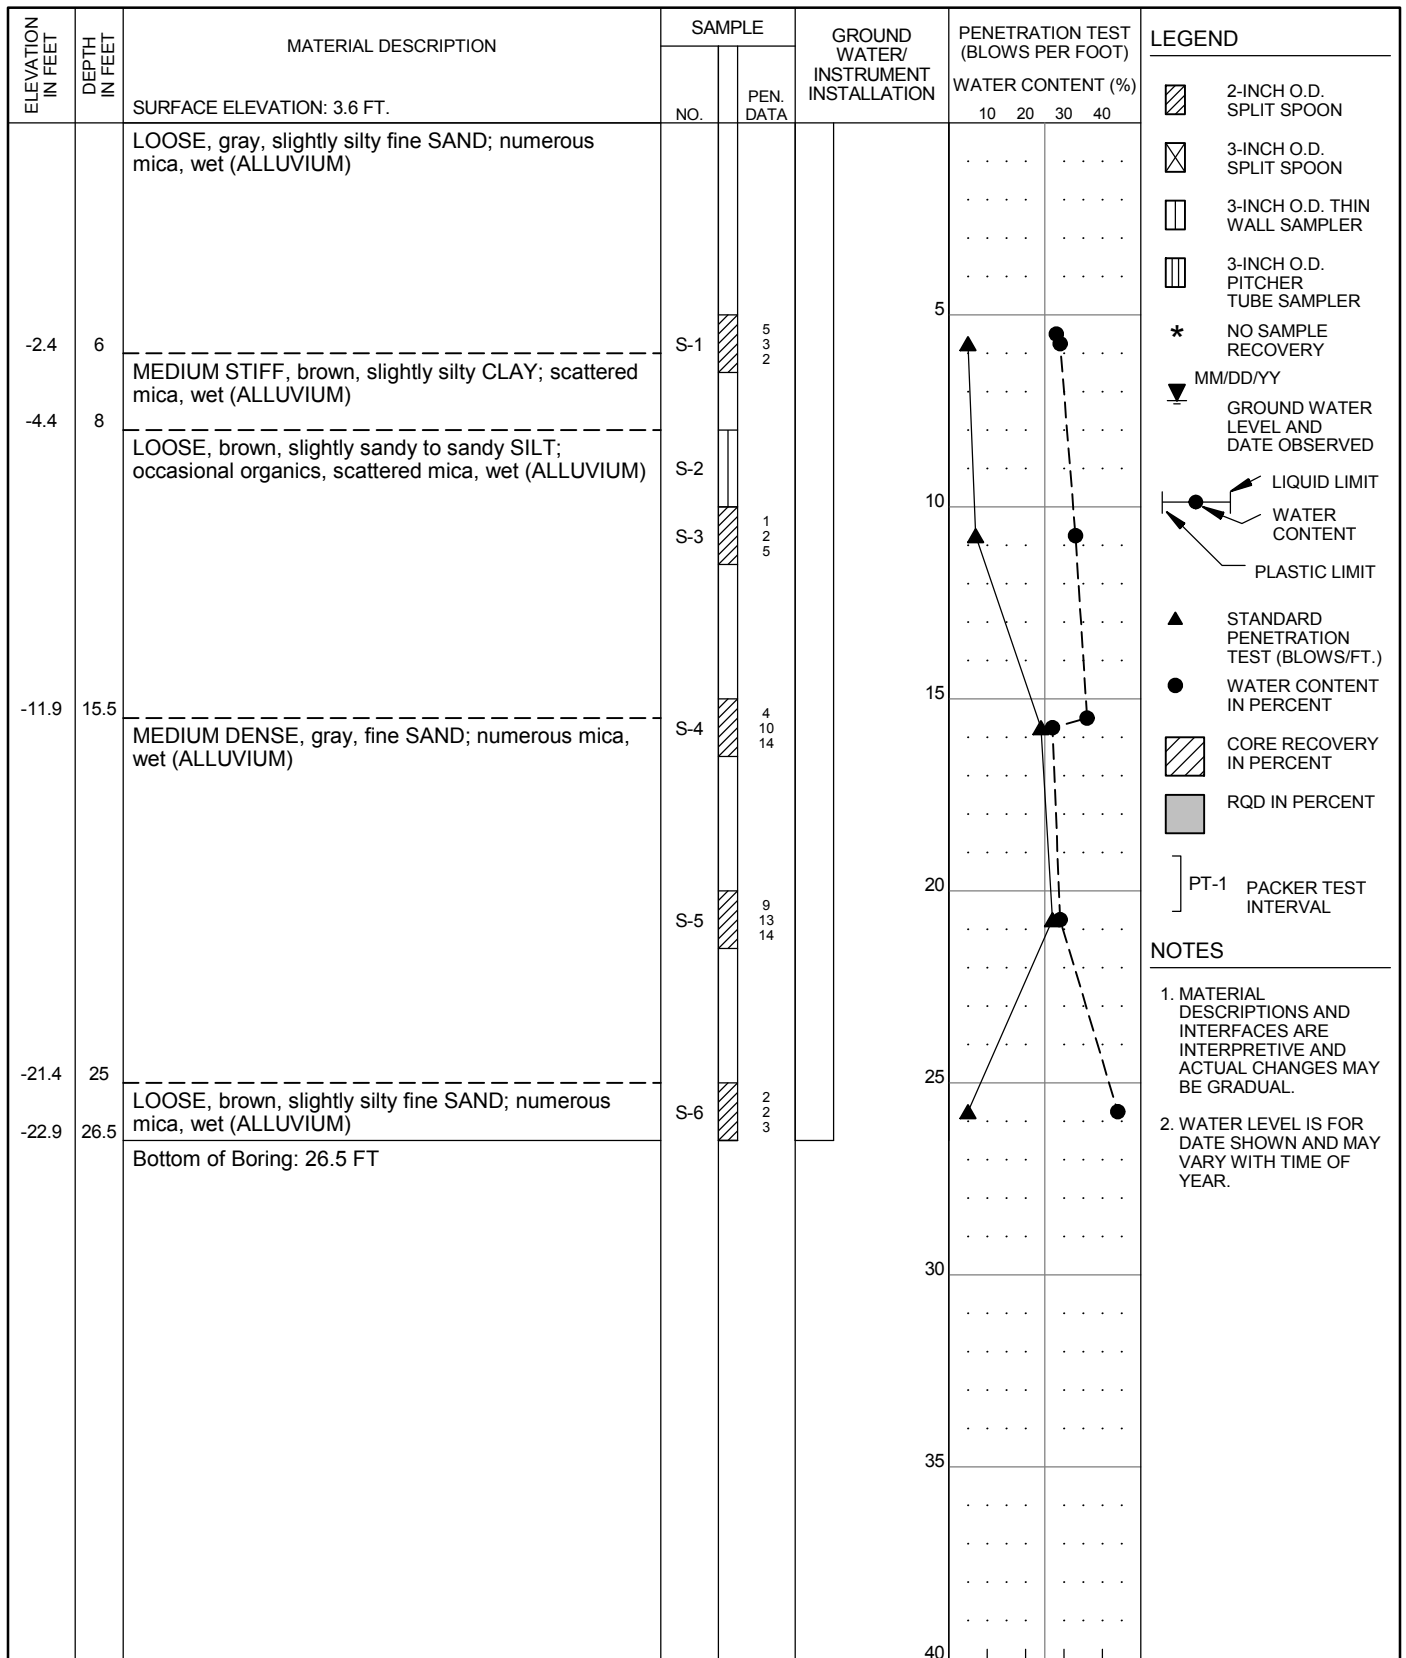
DRILLER: WESTERN STATES DATE START: 5/1/2014 FINISH: 5/1/2014 DRILLING TECHNIQUE: MUD ROTARY	CORNFORTH CONSULTANTS 10250 S.W. Greenburg Road, Suite 111 Portland, Oregon 97223 Phone 503-452-1100 Fax 503-452-1528	SUMMARY BORING LOG P2-CC-65 PENINSULA DISTRICT 2 LEVEE PORTLAND, OR	SEP 2014 PROJ 2320 FIG. A65
----------------------------------------------------------------------------------------------------	------------------------------------------------------------------------------------------------------------------------------------------	--------------------------------------------------------------------------------------------	------------------------------------------

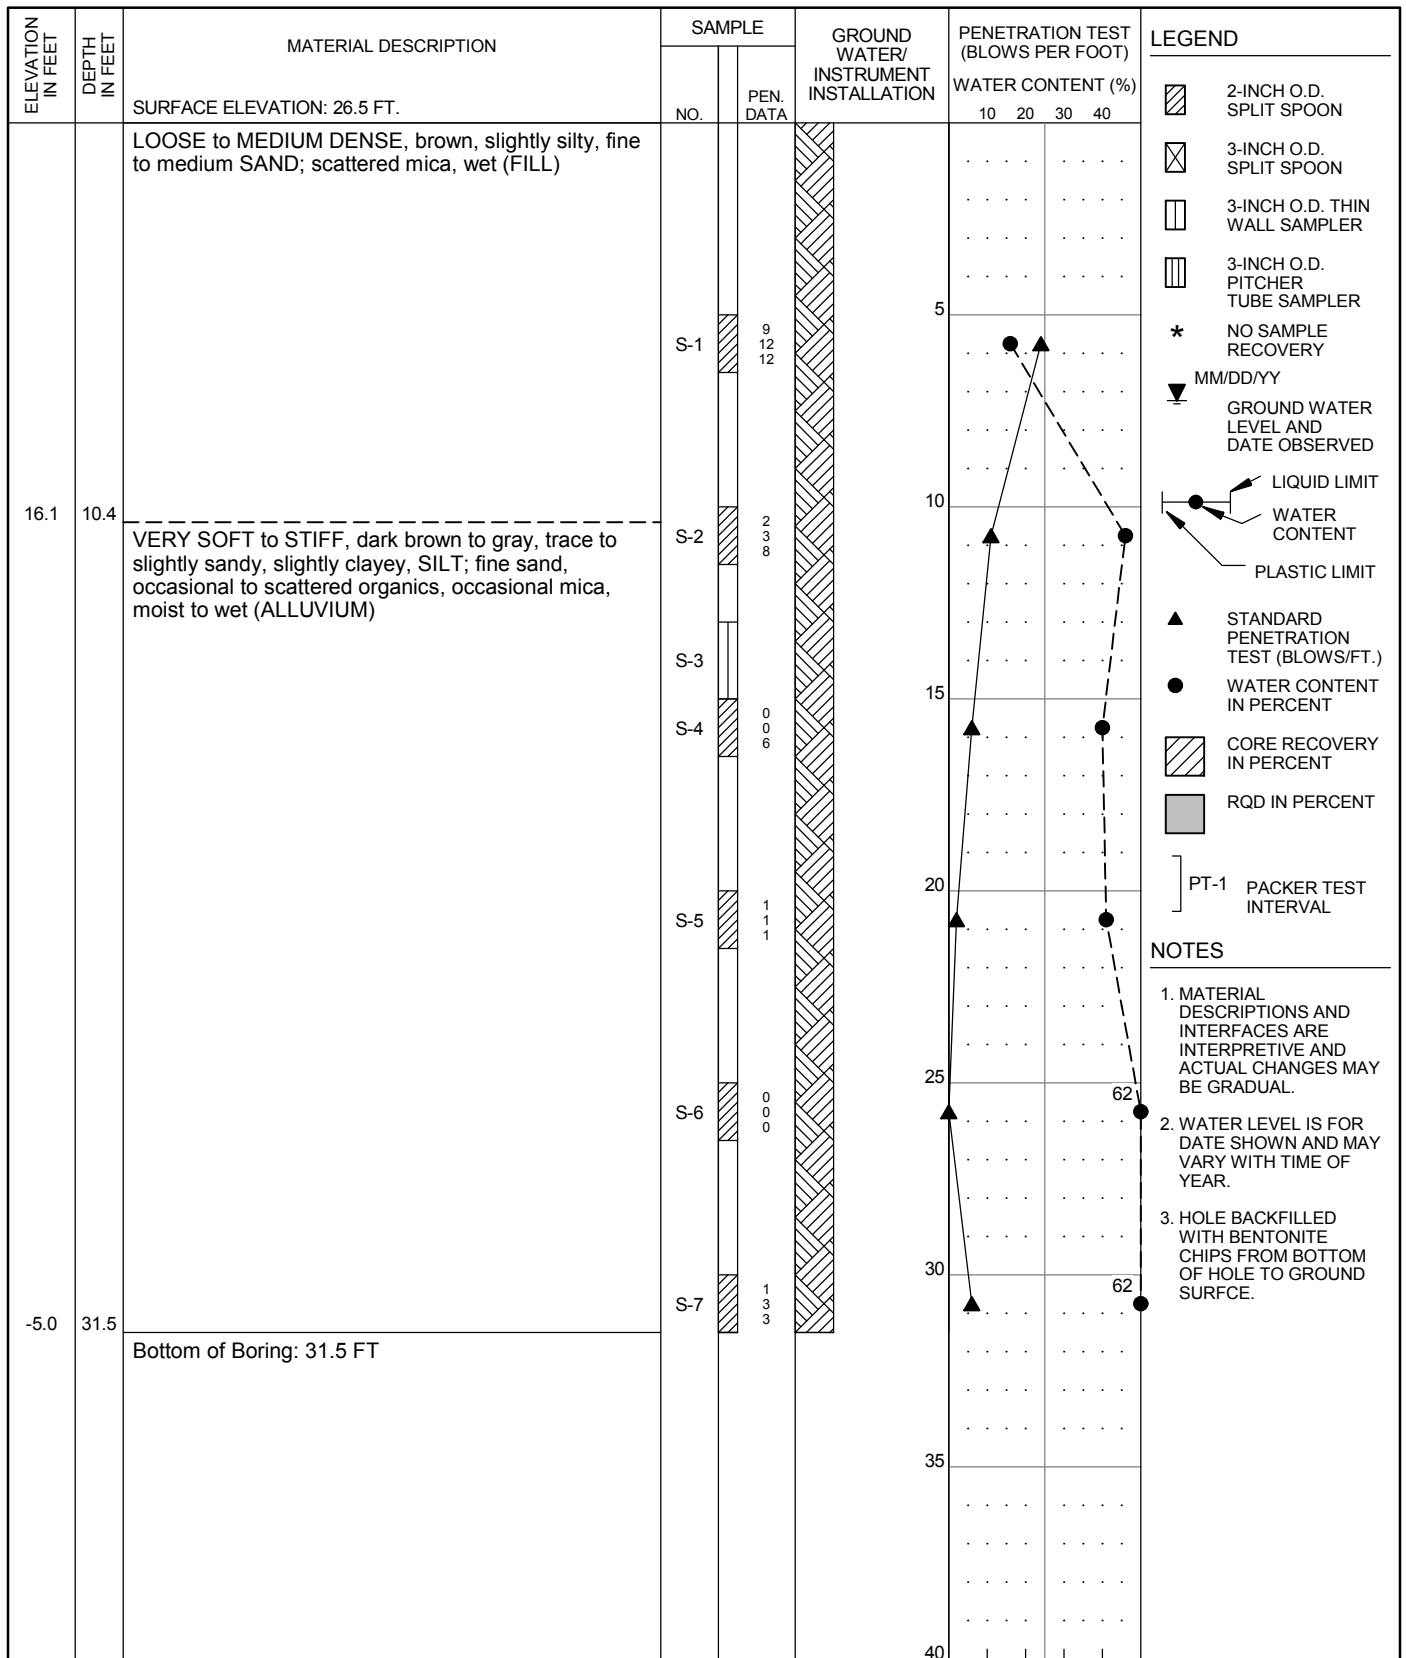
DRILLER: WESTERN STATES DATE START: 3/21/2014 FINISH: 3/21/2014 DRILLING TECHNIQUE: HOLLOW STEM AUGER	CORNFORTH CONSULTANTS 10250 S.W. Greenburg Road, Suite 111 Portland, Oregon 97223 Phone 503-452-1100 Fax 503-452-1528	SUMMARY BORING LOG P2-CC-66 PENINSULA DISTRICT 2 LEVEE PORTLAND, OR	SEP 2014
			PROJ 2320
			FIG. A66

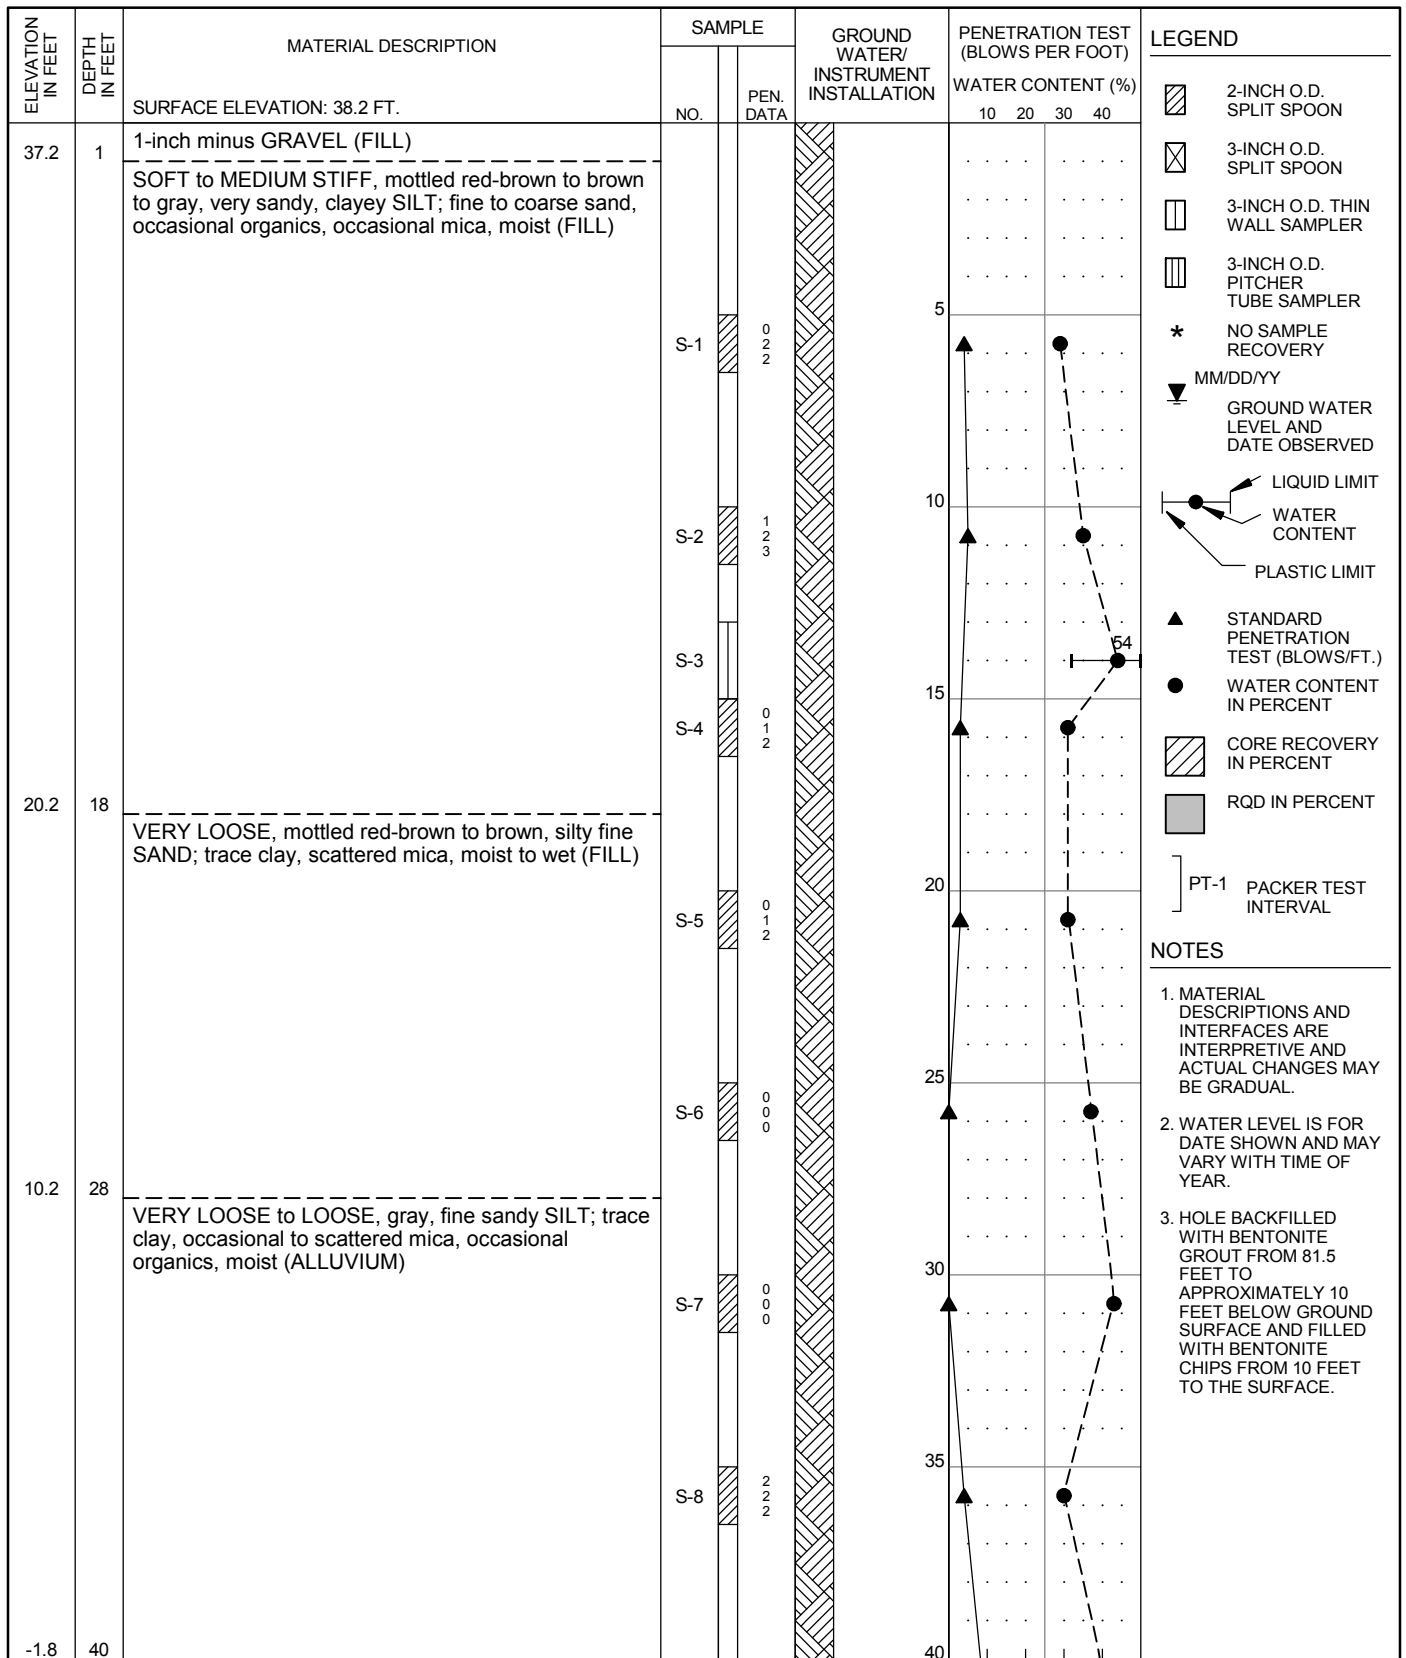
DRILLER: WESTERN STATES DATE START: 3/20/2014 FINISH: 3/20/2014 DRILLING TECHNIQUE: HOLLOW STEM AUGER	 10250 S.W. Greenburg Road, Suite 111 Portland, Oregon 97223 Phone 503-452-1100 Fax 503-452-1528	SUMMARY BORING LOG P2-CC-70 (1 of 3) PENINSULA DISTRICT 2 LEVEE PORTLAND, OR	SEP 2014
			PROJ 2320
			FIG. A70
