Peninsula Drainage District No. 2

Levee Engineering Assessment

**PENINSULA DRAINAGE DISTRICT NO. 2
LEVEE ENGINEERING ASSESSMENT**

October 2, 2014

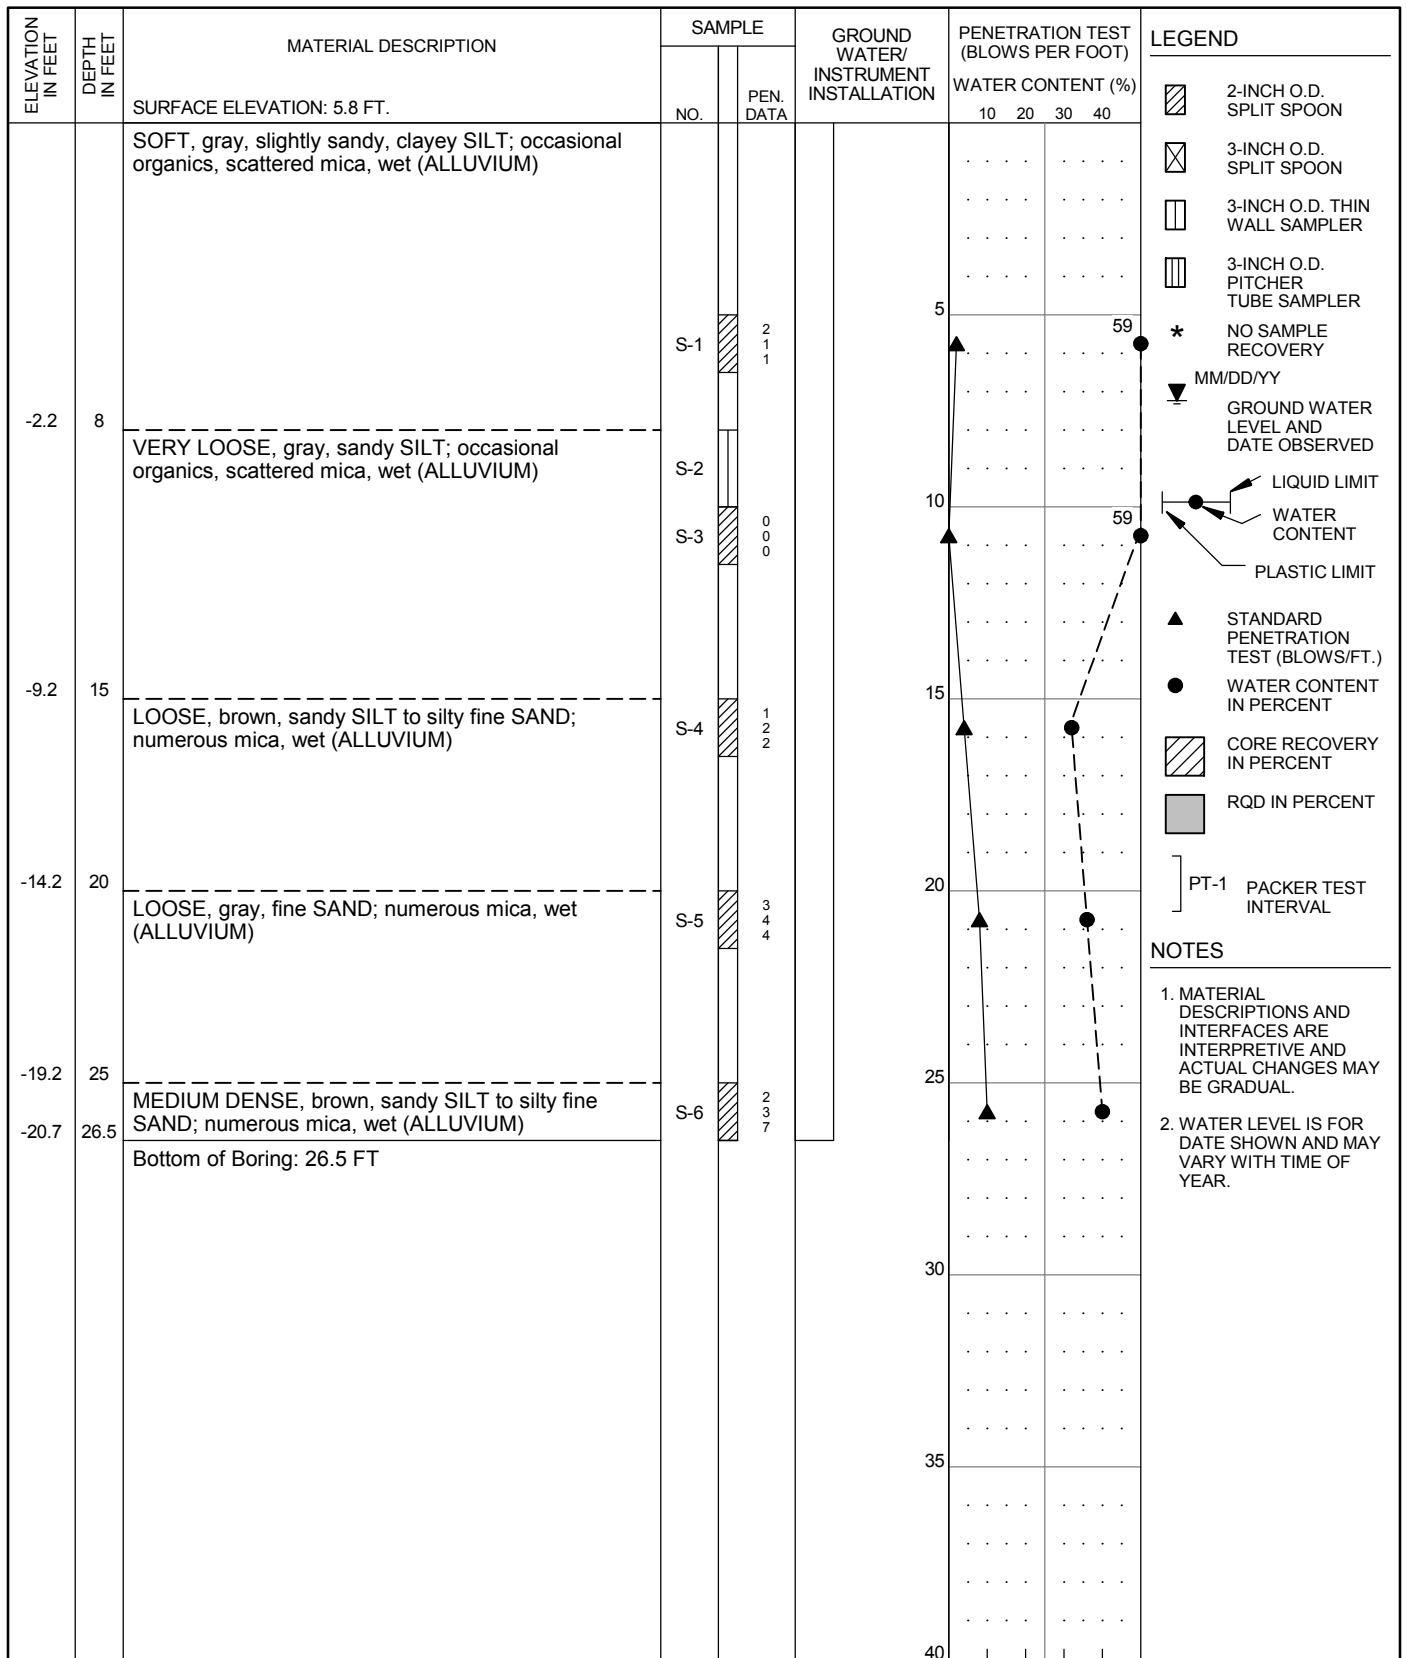
DRILLER: WESTERN STATES DATE START: 5/2/2014 FINISH: 5/2/2018 DRILLING TECHNIQUE: MUD ROTARY	  CORNFORTH CONSULTANTS 10250 S.W. Greenburg Road, Suite 111 Portland, Oregon 97223 Phone 503-452-1100 Fax 503-452-1528	SUMMARY BORING LOG P2-CC-71 PENINSULA DISTRICT 2 LEVEE PORTLAND, OR	SEP 2014 PROJ 2320 FIG. A71
----------------------------------------------------------------------------------------------------	------------------------------------------------------------------------------------------------------------------------------------------------------------------------------------------------------------------------------	--------------------------------------------------------------------------------------------	------------------------------------------

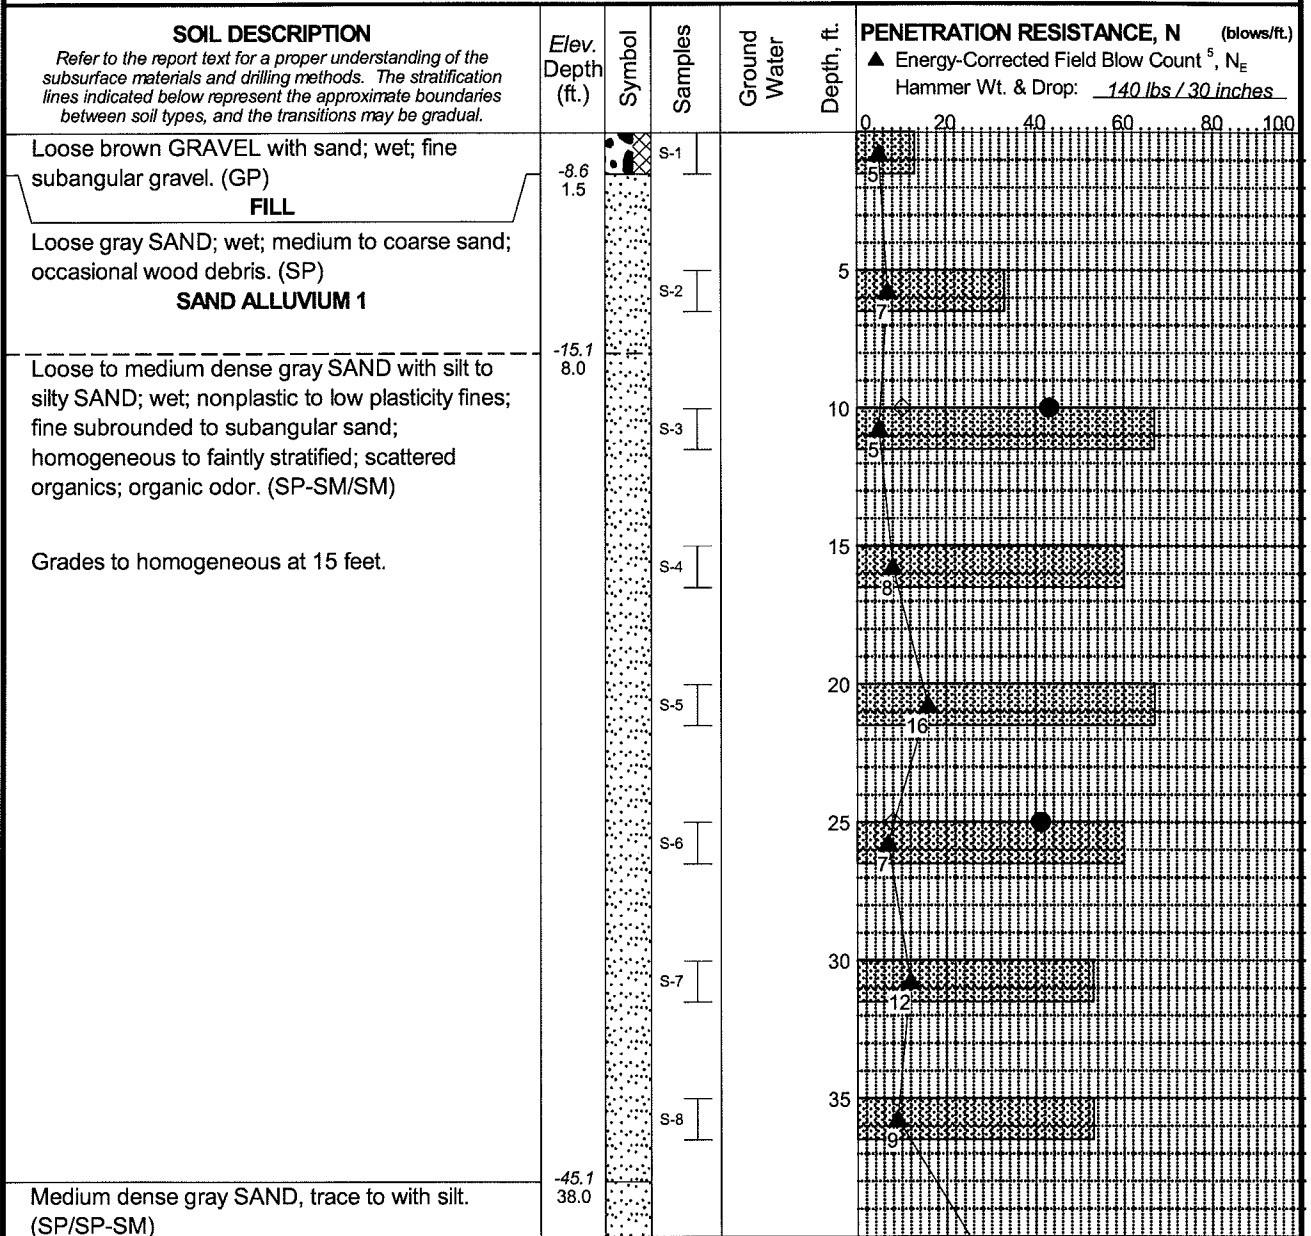
Total Depth: 189.7 ft. Northing: 107,311 ft. Drilling Method: Mud Rotary Hole Diam.: 4 7/8 in.
 Top Elevation: -7.1 ft. Easting: 1,082,186 ft. Drilling Company: Hardcore Drilling Rod Type: NWJ
 Vert. Datum: NAVD88 Station: _____ Drill Rig Equipment: CME 75 (YEAA627) Hammer Type: Automatic
 Horiz. Datum: CRC Project Offset: _____ Other Comments: _____

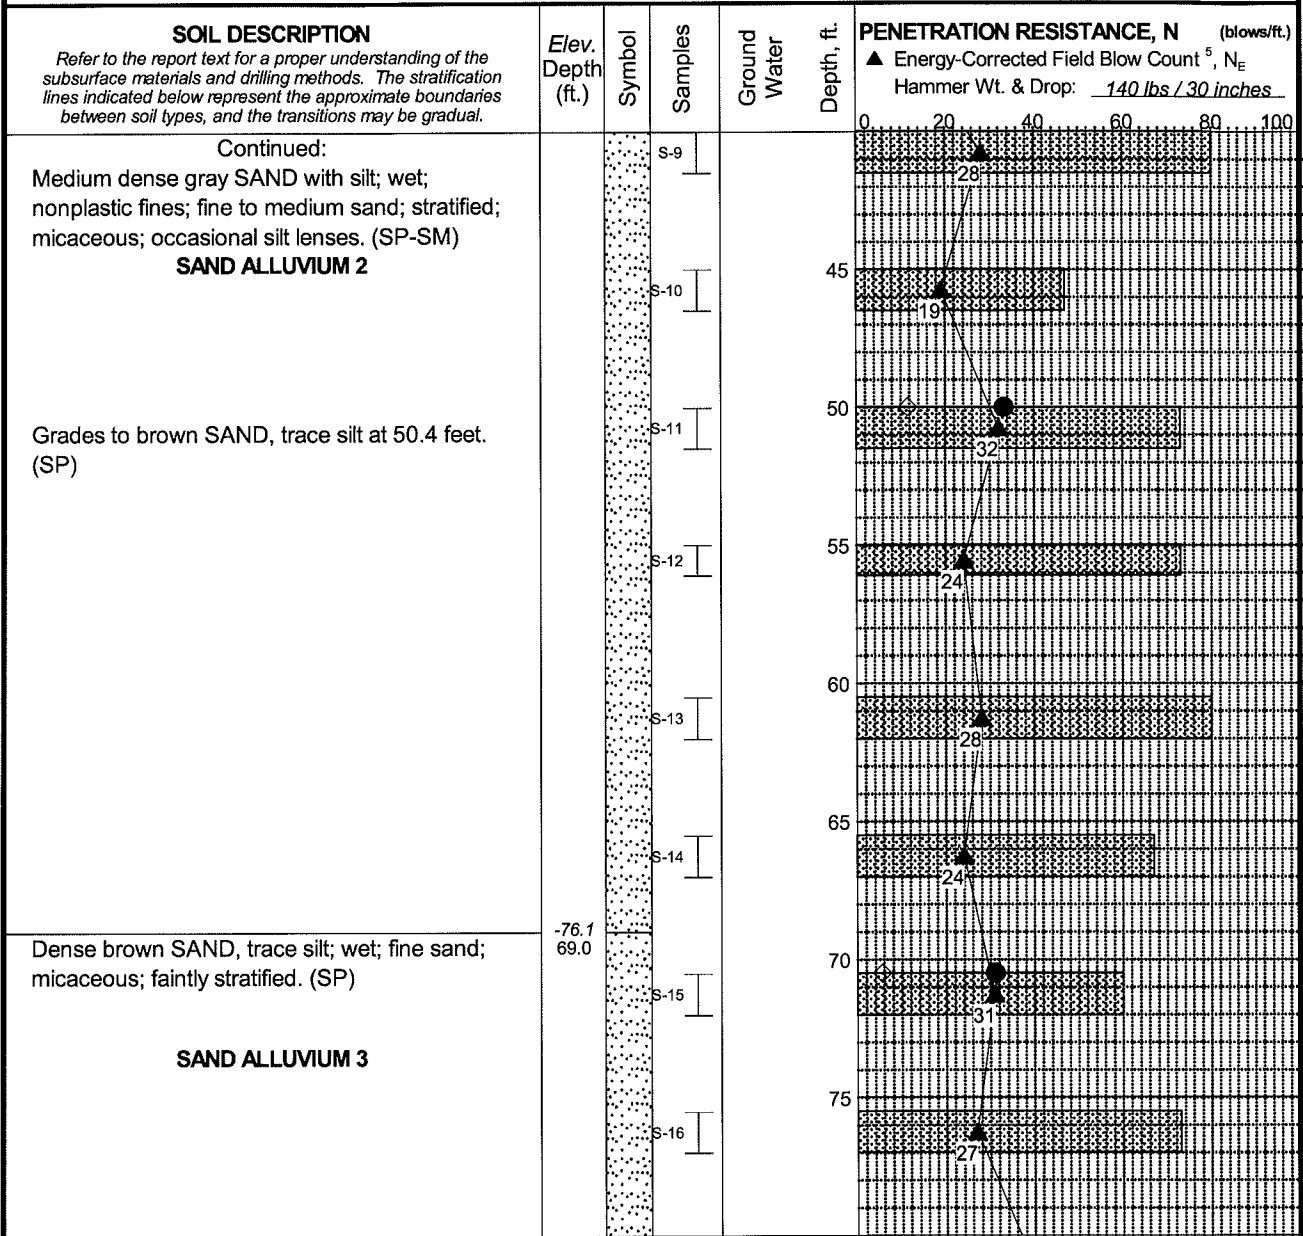
FIG. A22
 Sheet 1 of 5

Total Depth: 189.7 ft. Northing: 107,311 ft. Drilling Method: Mud Rotary Hole Diam.: 4 7/8 in.
 Top Elevation: -7.1 ft. Easting: 1,082,186 ft. Drilling Company: Hardcore Drilling Rod Type: NWJ
 Vert. Datum: NAVD88 Station: _____ Drill Rig Equipment: CME 75 (YEAA627) Hammer Type: Automatic
 Horiz. Datum: CRC Project Offset: _____ Other Comments: _____

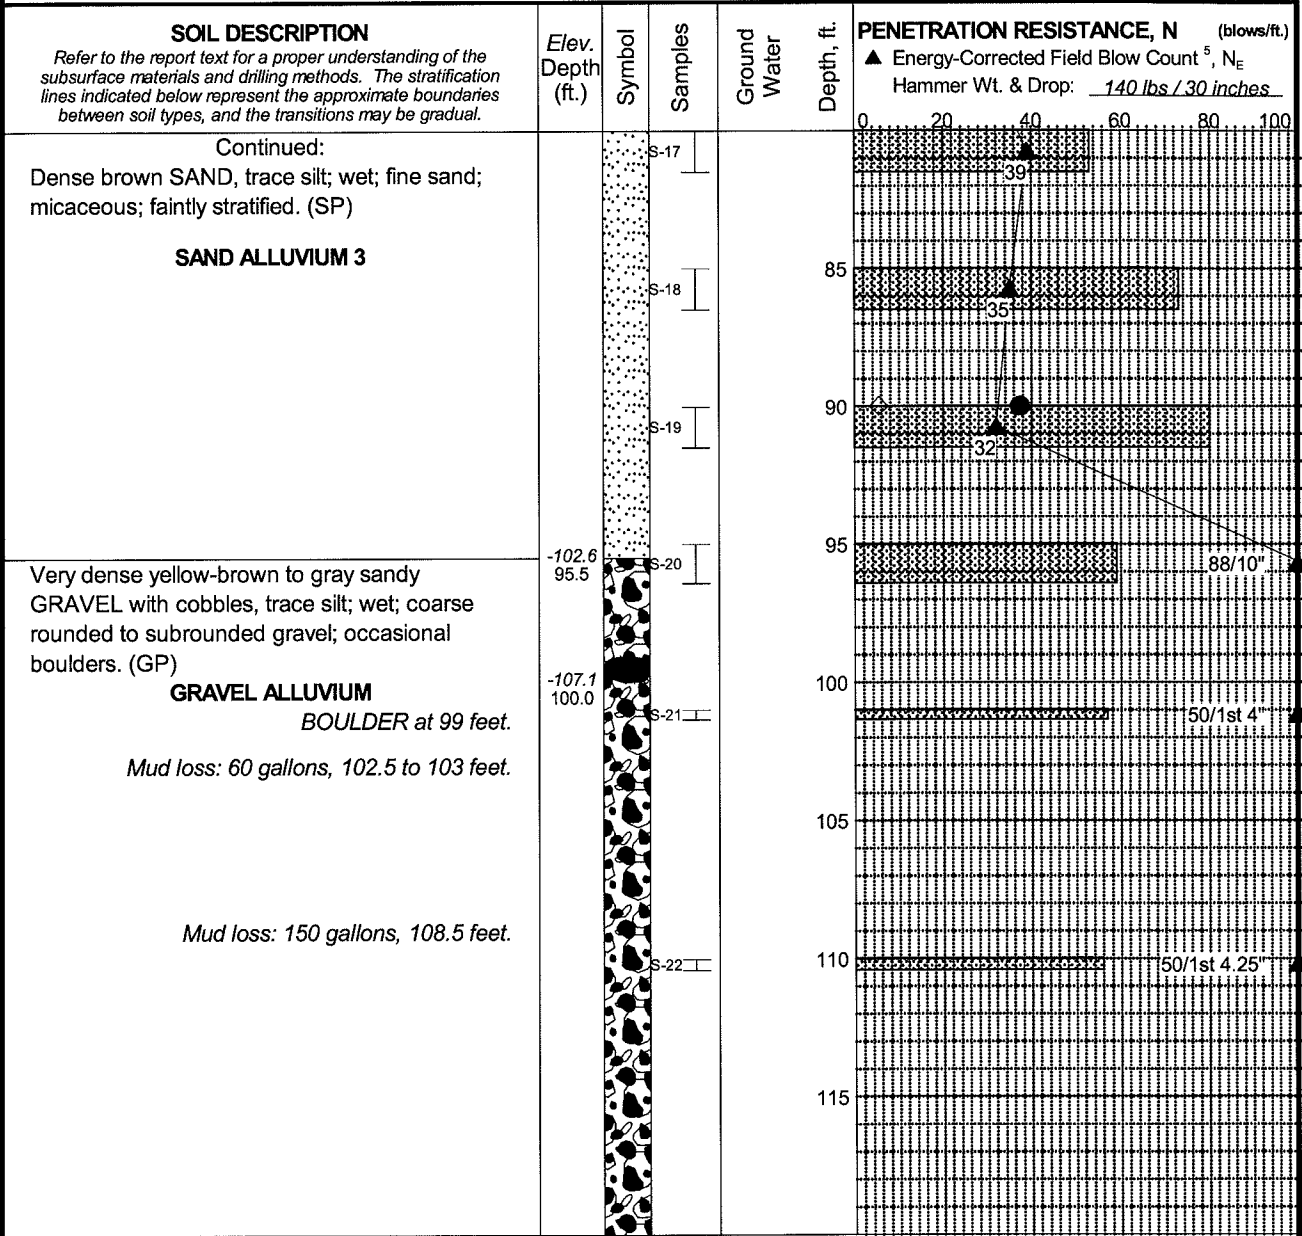
FIG. A22
 Sheet 2 of 5

Total Depth: 189.7 ft. Northing: 107,311 ft. Drilling Method: Mud Rotary Hole Diam.: 4 7/8 in.
 Top Elevation: -7.1 ft. Easting: 1,082,186 ft. Drilling Company: Hardcore Drilling Rod Type: NWJ
 Vert. Datum: NAVD88 Station: _____ Drill Rig Equipment: CME 75 (YEAA627) Hammer Type: Automatic
 Horiz. Datum: CRC Project Offset: _____ Other Comments: _____

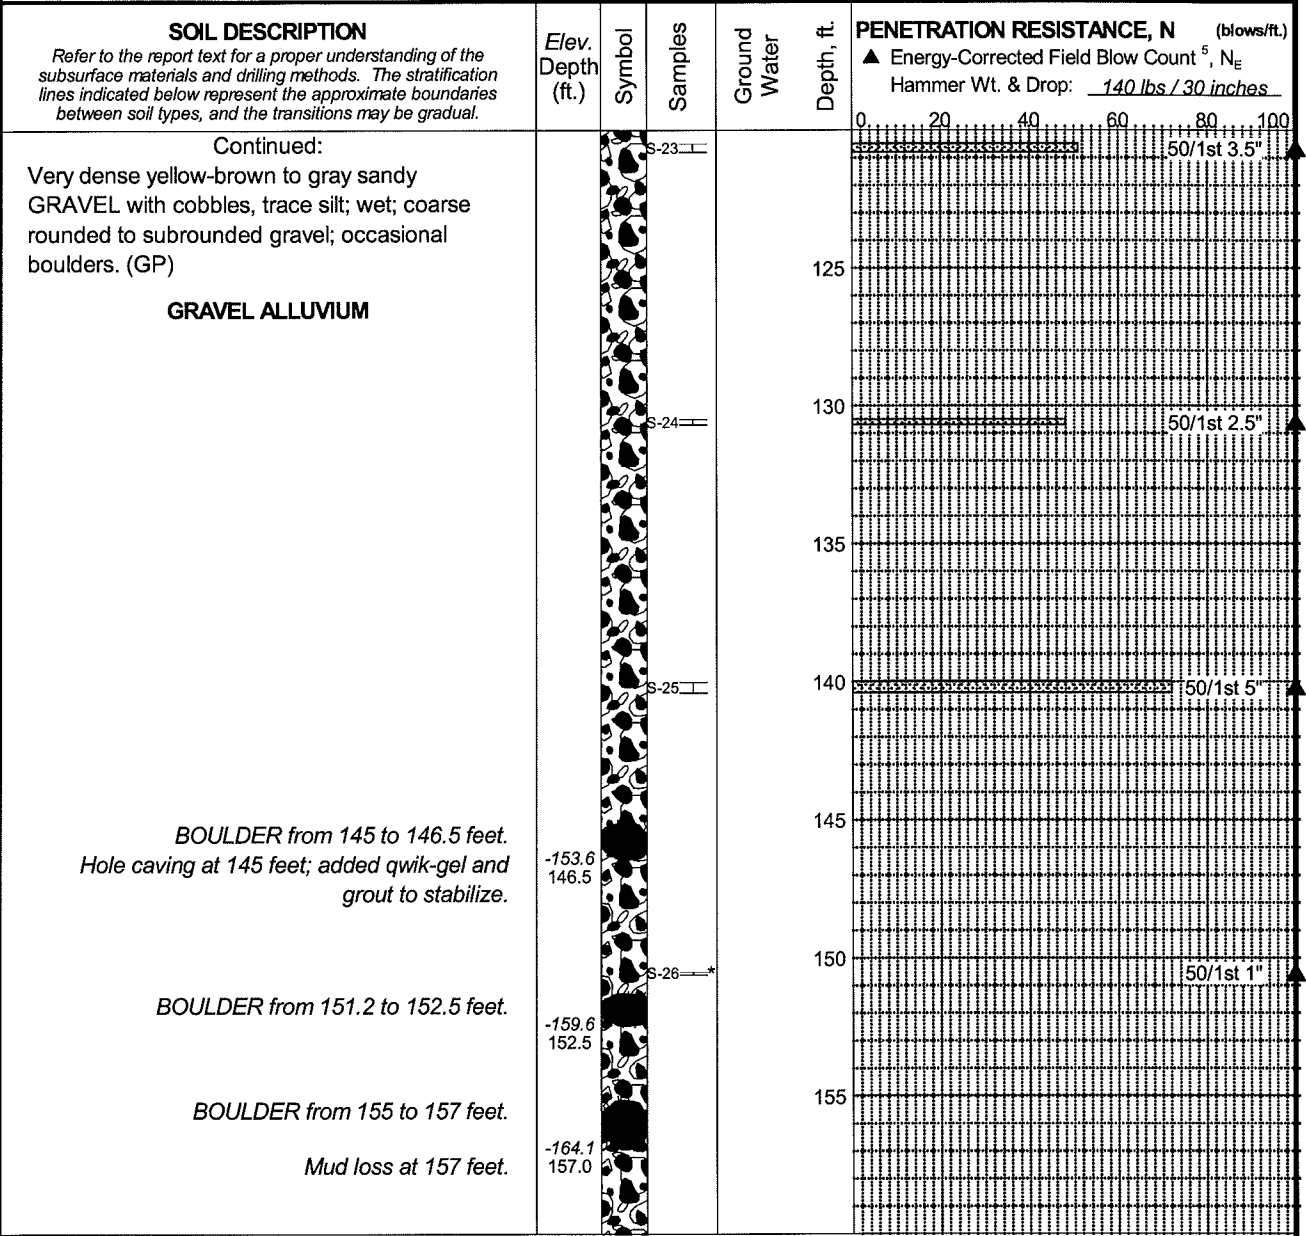
FIG. A22
 Sheet 3 of 5

Total Depth: 189.7 ft. Northing: 107,311 ft. Drilling Method: Mud Rotary Hole Diam.: 4 7/8 in.
 Top Elevation: -7.1 ft. Easting: 1,082,186 ft. Drilling Company: Hardcore Drilling Rod Type: NWJ
 Vert. Datum: NAVD88 Station: _____ Drill Rig Equipment: CME 75 (YEA627) Hammer Type: Automatic
 Horiz. Datum: CRC Project Offset: _____ Other Comments: _____

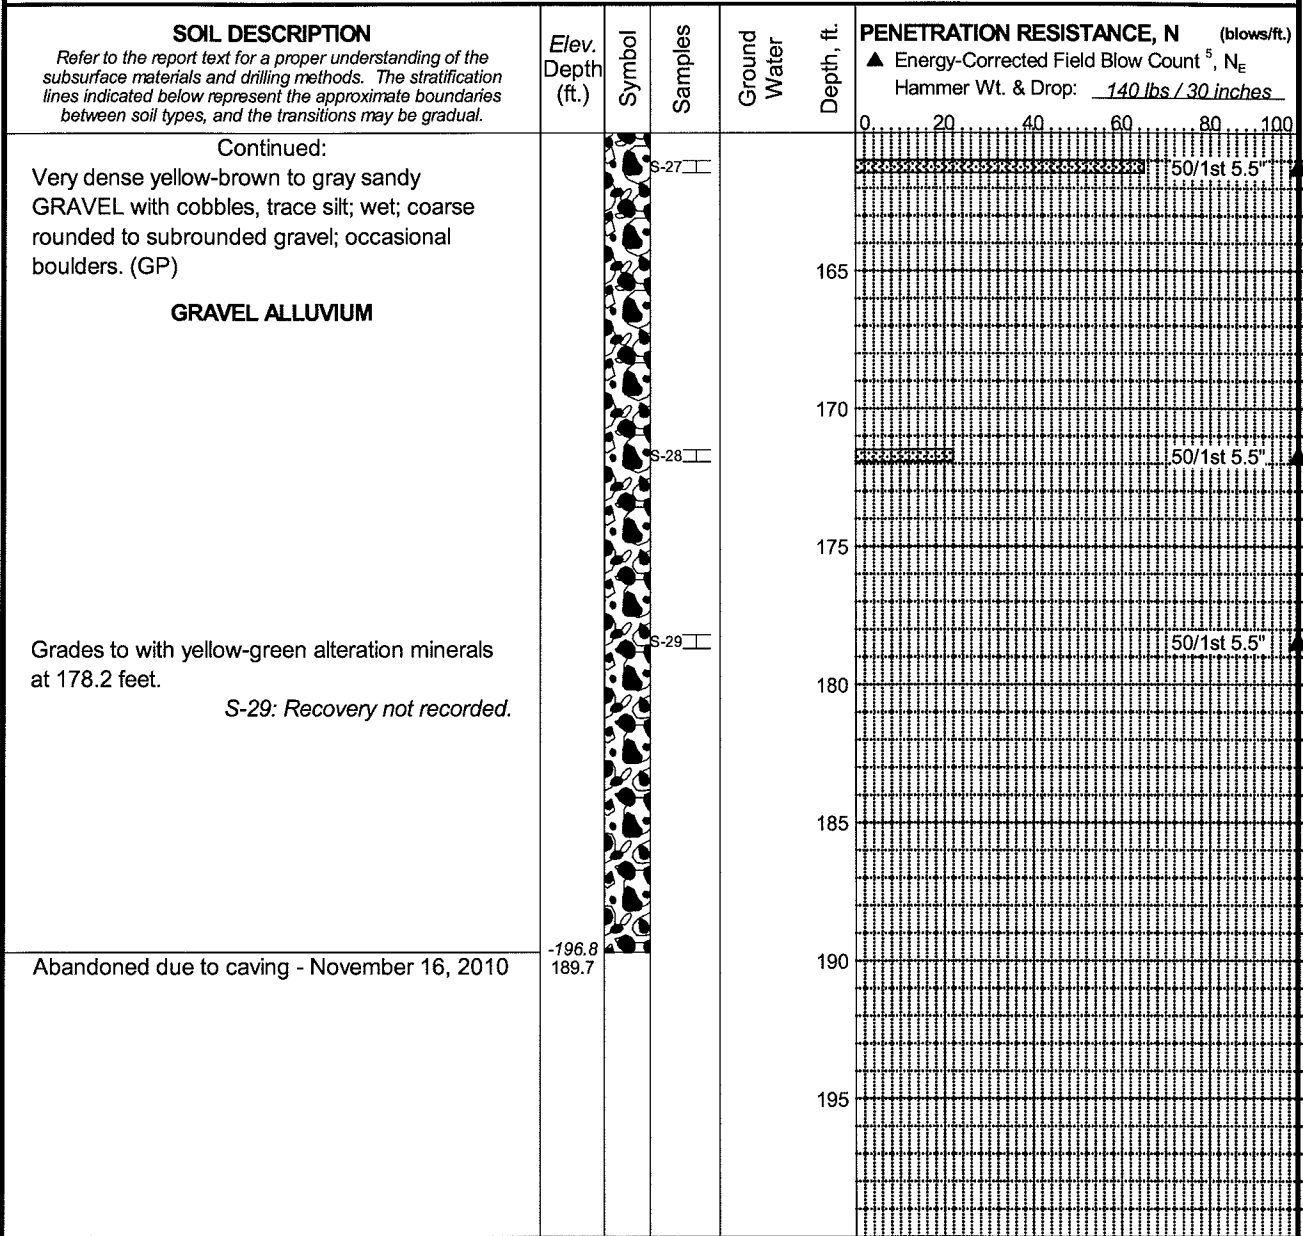
FIG. A22
 Sheet 4 of 5

Total Depth: 189.7 ft. Northing: 107,311 ft. Drilling Method: Mud Rotary Hole Diam.: 4 7/8 in.
 Top Elevation: -7.1 ft. Easting: 1,082,186 ft. Drilling Company: Hardcore Drilling Rod Type: NWJ
 Vert. Datum: NAVD88 Station: _____ Drill Rig Equipment: CME 75 (YEAA627) Hammer Type: Automatic
 Horiz. Datum: CRC Project Offset: _____ Other Comments: _____

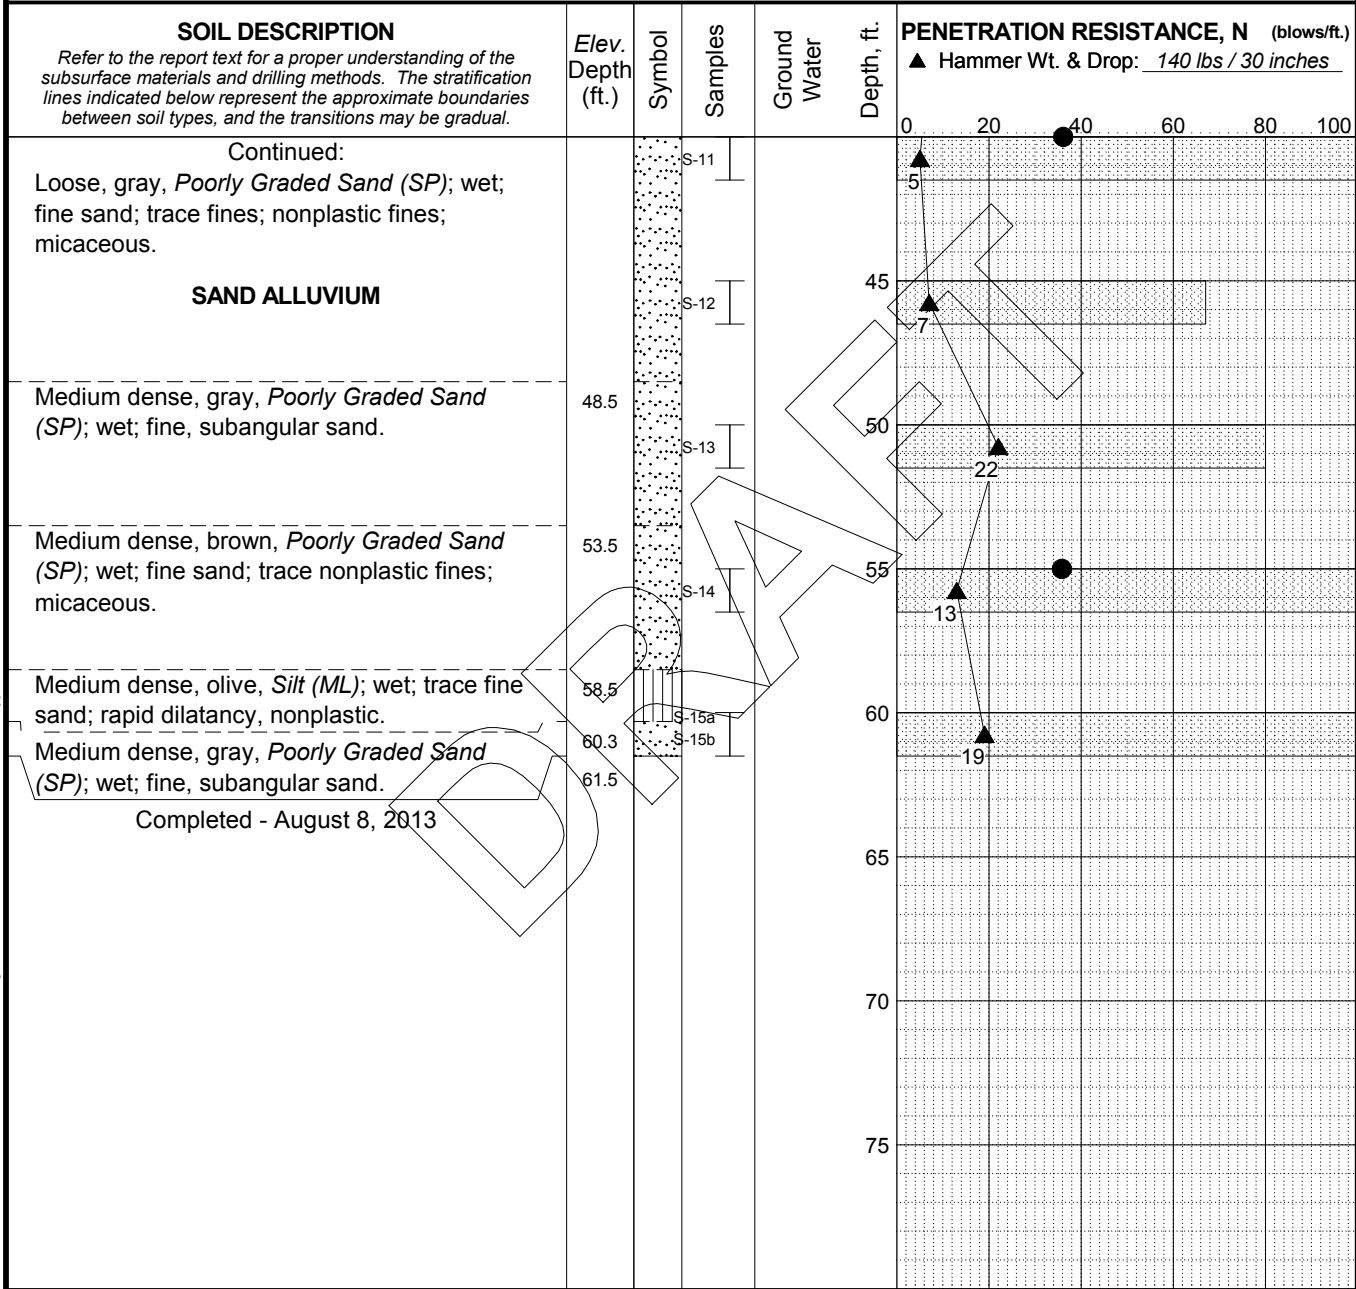
FIG. B2
 Sheet 1 of 2

Total Depth: 61.5 ft. Northing: ~ Drilling Method: Mud Rotary Hole Diam.: 4 in.
 Top Elevation: ~ Easting: ~ Drilling Company: Subsurface Technologies Rod Type: NWJ
 Vert. Datum: ~ Station: ~ Drill Rig Equipment: Diedrich D-50 Track Hammer Type: Automatic
 Horiz. Datum: ~ Offset: ~ Other Comments: Hammer Efficiency = 70.9%

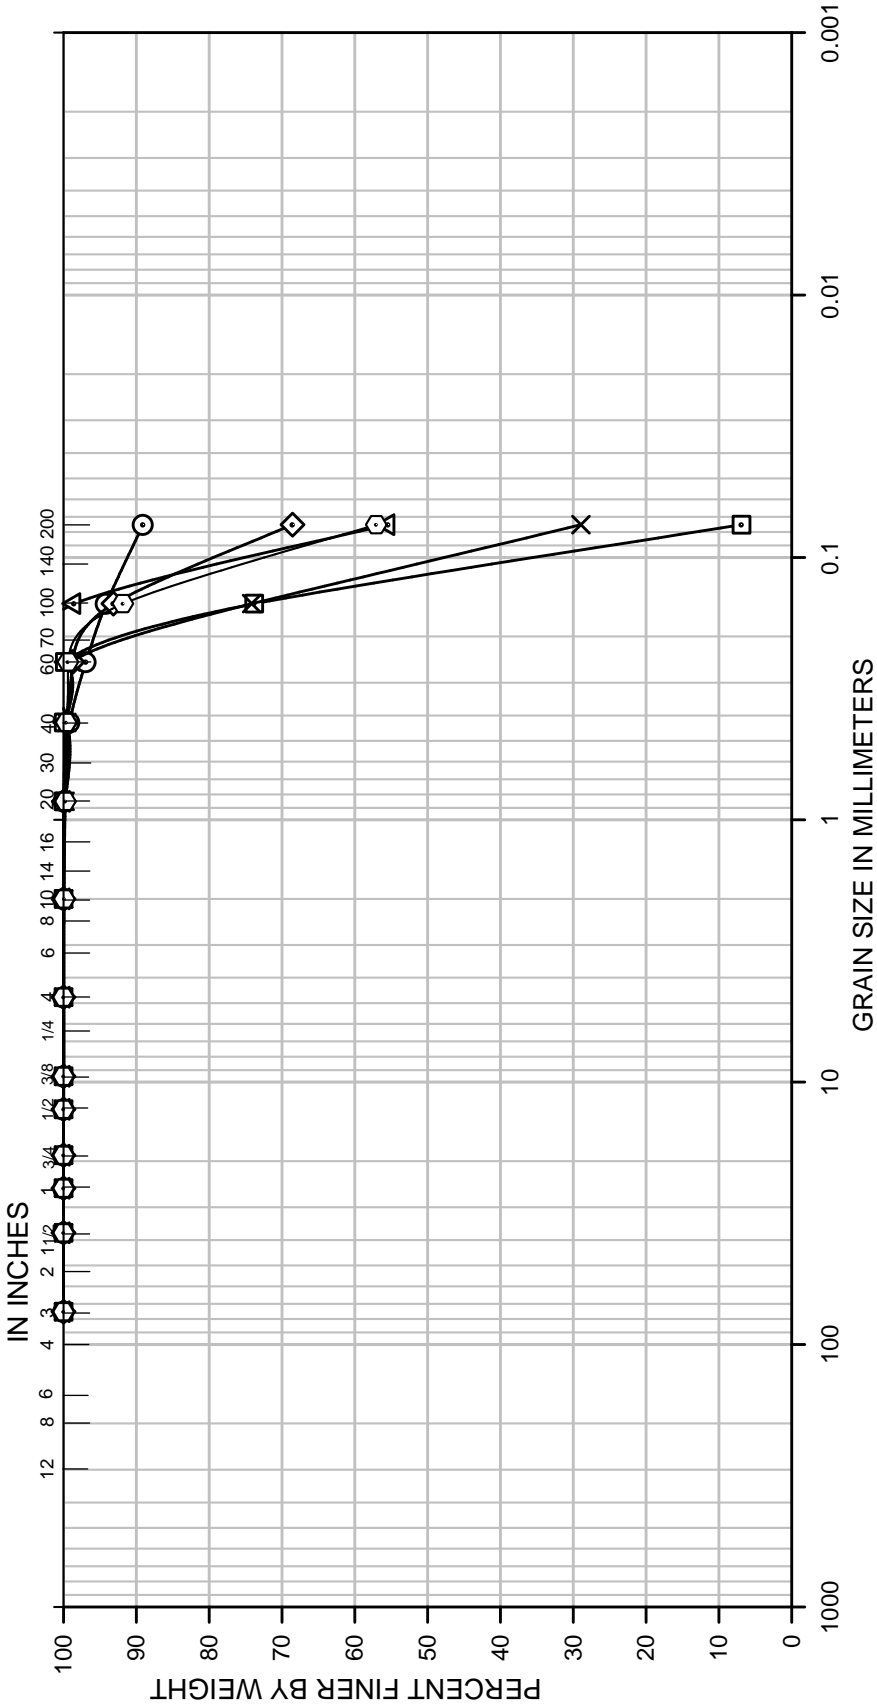
Boring No.	Sample No	Depth, Ft.	Classification	Nat W%	LL	PL	PI
⊙ P2-CC-03	S-3	15	slightly sandy, clayey SILT	38	40	27	13
△ P2-CC-19	S-4	20	very sandy SILT	26	--	--	--
◻ P2-CC-28	S-7	35	slightly silty fine SAND	32	--	--	--
◇ P2-CC-32	S-4	20	sandy, slightly clayey SILT	41	37	30	7
× P2-CC-52	S-11	50	silty fine SAND	38	--	--	--
◊ P2-CC-55	S-6	30	very sandy SILT	35	--	--	--

**GRADATION GRAPH
FOUNDATION (1 of 3)**

Figure No.	Description
C1	Gradation Graph – Embankment (1 of 2) (Mechanical Only)
C2	Gradation Graph – Embankment (2 of 2) (Mechanical/Hydrometer)
C3	Gradation Graph – Foundation (1 of 3) (Mechanical Only)
C4	Gradation Graph – Foundation (2 of 3) (Mechanical Only)
C5	Gradation Graph – Foundation (3 of 3) (Mechanical/Hydrometer)
C6	Plasticity Chart – Embankment Samples
C7	Plasticity Chart – Foundation Samples
C8	Consolidation Test
C9	Consolidation Test
C10	Consolidation Test
C11	Consolidated Undrained Triaxial Test Data Plots
C12	Consolidated Undrained Triaxial Test Data Plots
C13	Consolidated Undrained Triaxial Test Data Plots
C14	Consolidated Undrained Triaxial Test Data Plots
C15	Consolidated Undrained Triaxial Test Data Plots
C16	Consolidated Undrained Triaxial Test Data Plots
C17	Consolidated Undrained Triaxial Test Data Plots
C18	Consolidated Undrained Triaxial Test Data Plots
C19	Consolidated Undrained Triaxial Test Data Plots

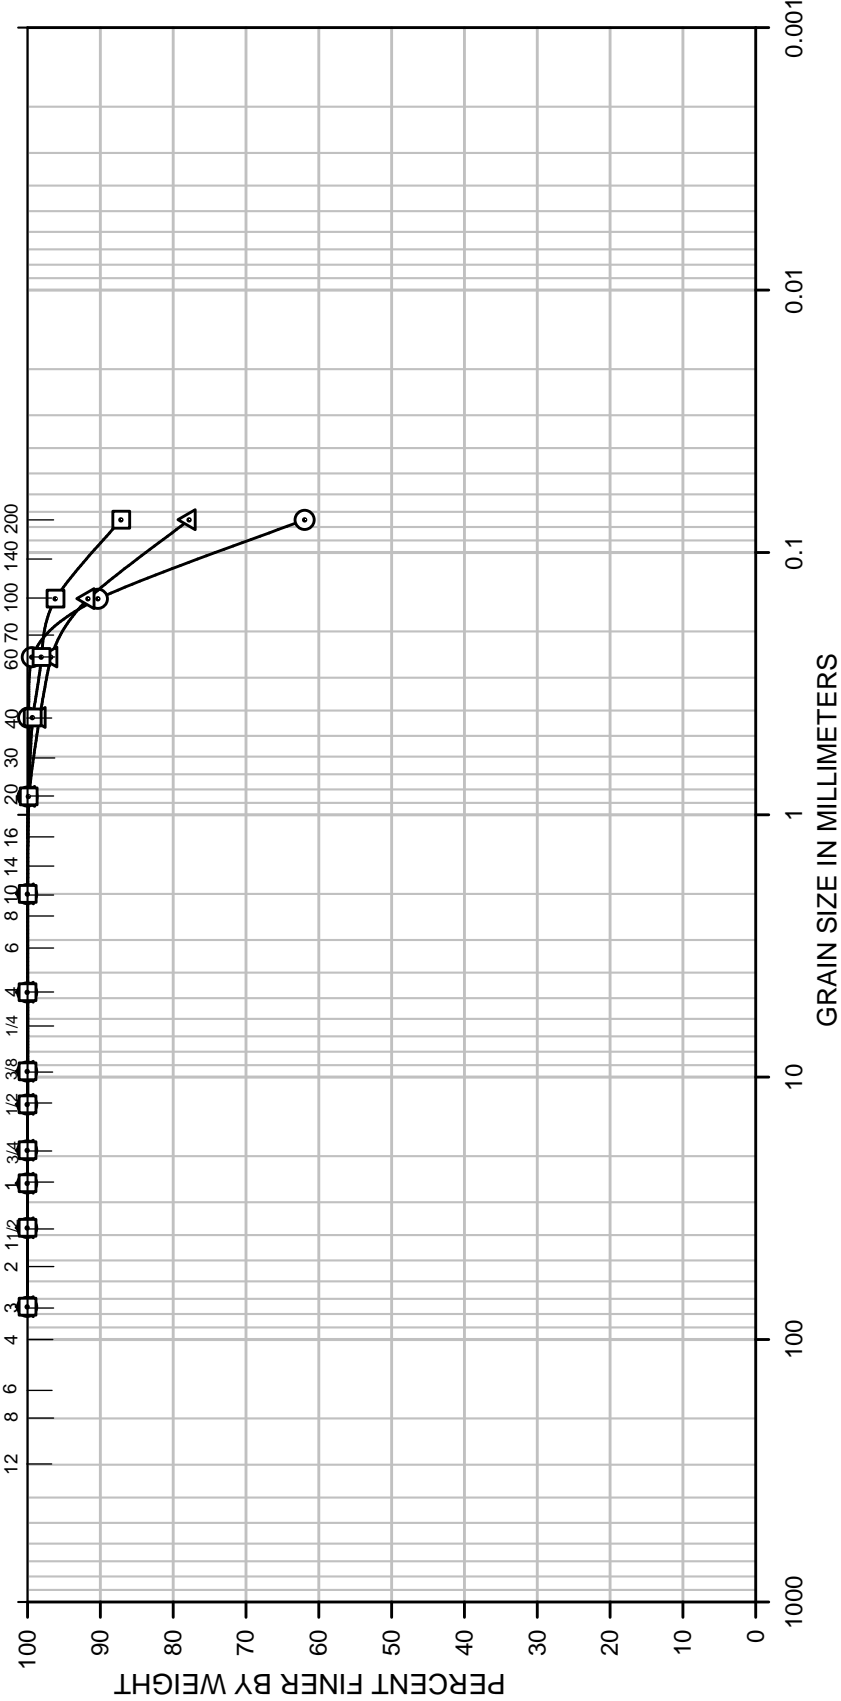
Boring No.	Sample No	Depth, Ft.	Classification	Nat W%	LL	PL	PI
⊙ P2-CC-58	S-5	25	slightly clayey, very sandy SILT	33	32	26	6
△ P2-CC-64	S-8	40	sandy, slightly clayey SILT	73	58	46	12
□ P2-CC-67	S-7	35	sandy, clayey SILT	71	75	42	33

**GRADATION GRAPH
FOUNDATION (2 of 3)**
PENINSULA 2 LEVEE EVALUATION
PORTLAND, OR

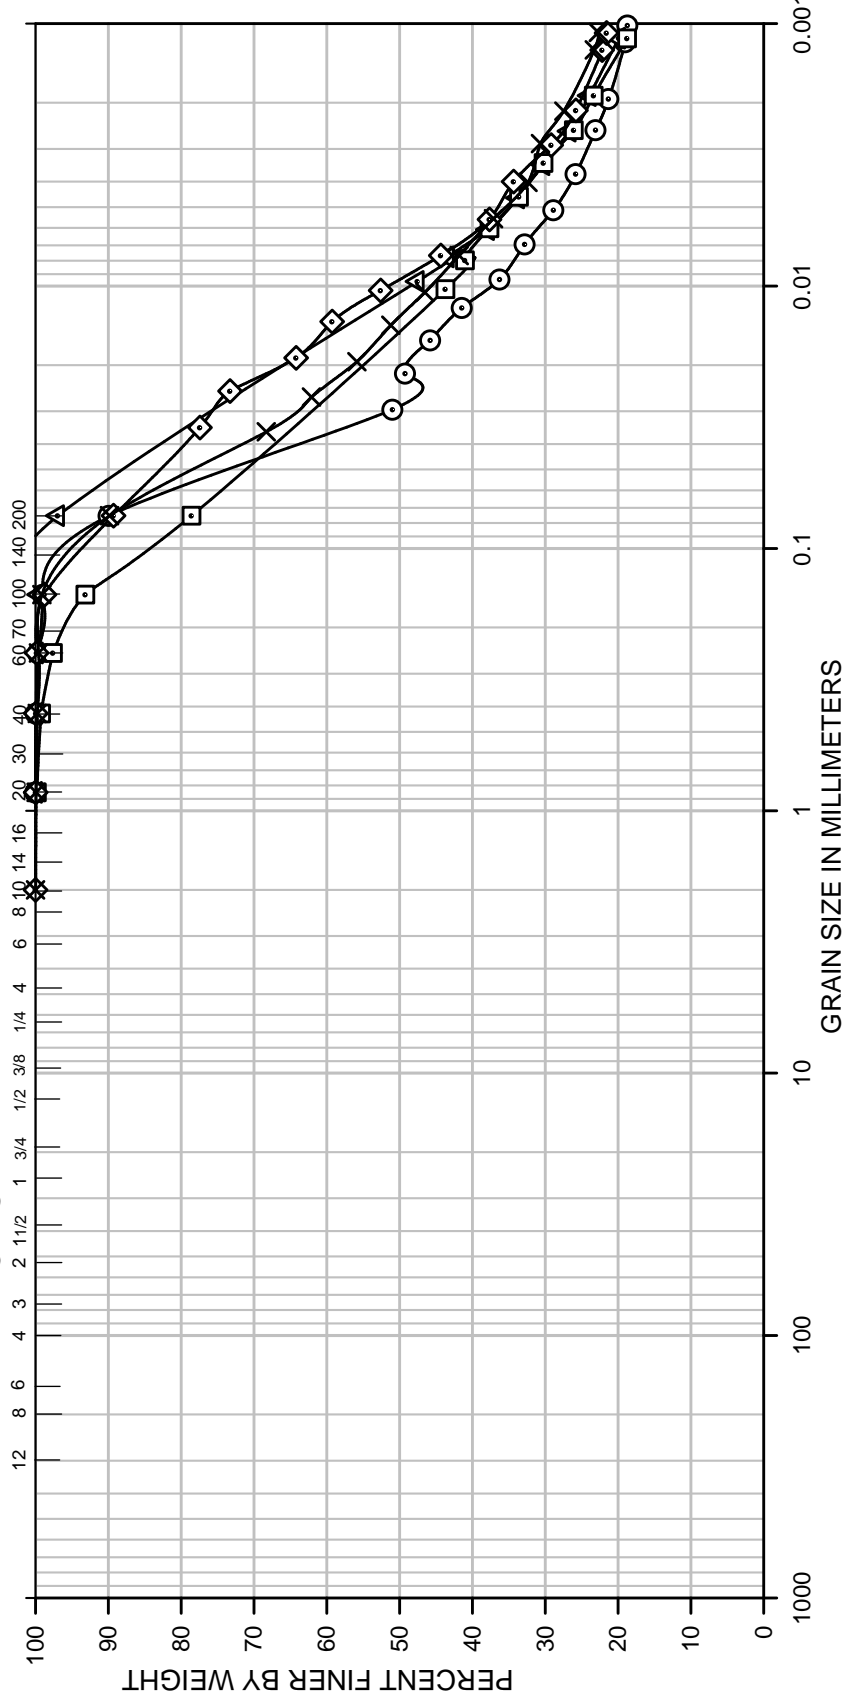
SEP 2014
PROJ. 2320
FIG. **C5**

Boring No.	Sample No	Depth, Ft.	Classification	Nat W%	LL	PL	PI
⊙ P2-CC-15	S-3	15	slightly sandy, clayey SILT	37	38	24	14
△ P2-CC-22	S-4	20	slightly sandy, clayey SILT	45	42	26	16
□ P2-CC-37	S-4	20	sandy, clayey SILT	33	38	26	12
◇ P2-CC-49	S-5	25	slightly sandy, clayey SILT	36	43	25	18
× P2-CC-73	S-8	35	sandy, clayey SILT	53	54	33	21

**GRADATION GRAPH
FOUNDATION (3 of 3)**

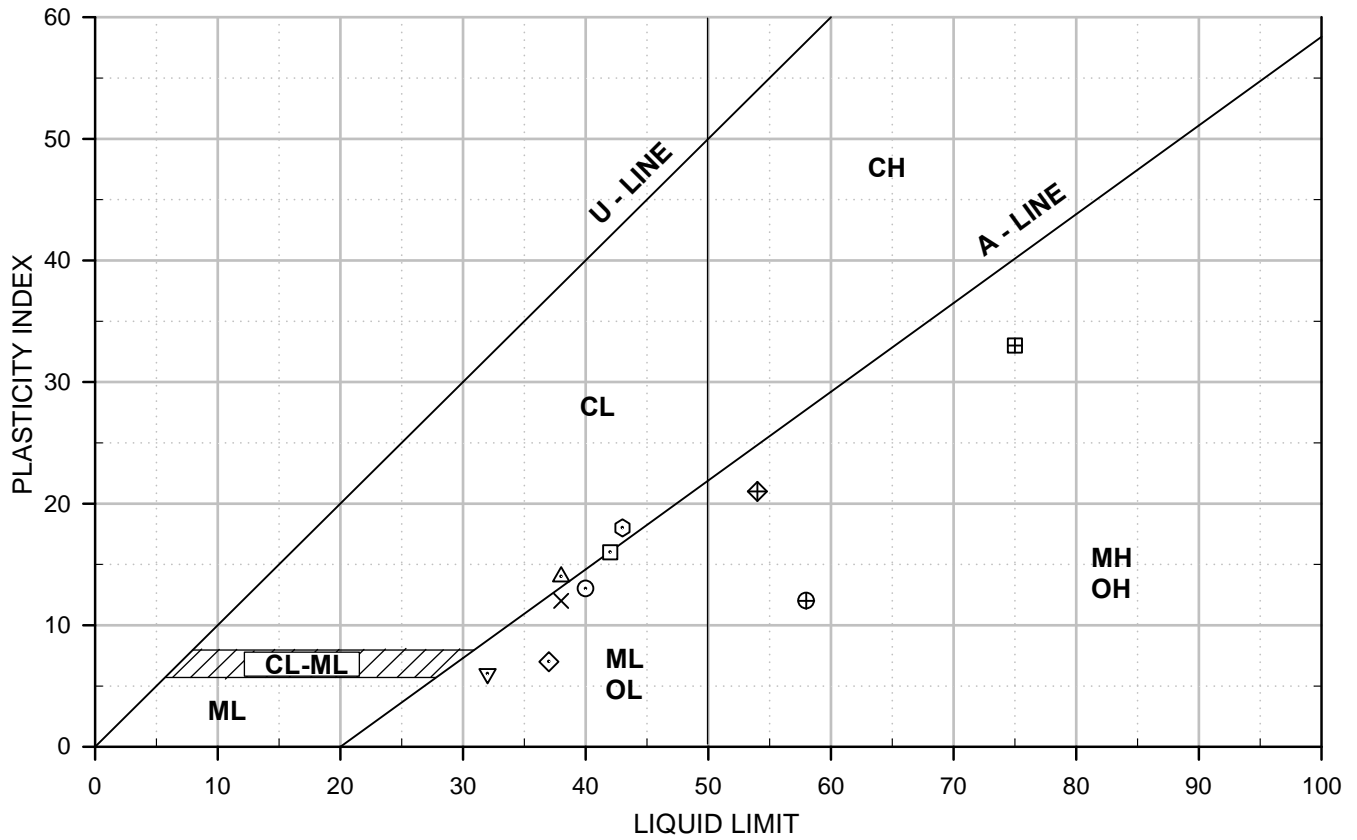
FIG. C6

○	P2-CC-03	S-3	15
△	P2-CC-15	S-3	15
□	P2-CC-22	S-4	20
◇	P2-CC-32	S-4	20
×	P2-CC-37	S-4	20
⊙	P2-CC-49	S-5	25
▽	P2-CC-58	S-5	25
⊕	P2-CC-64	S-8	40
⊞	P2-CC-67	S-7	35
⊠	P2-CC-73	S-8	35

PLASTICITY CHART FOUNDATION SAMPLES

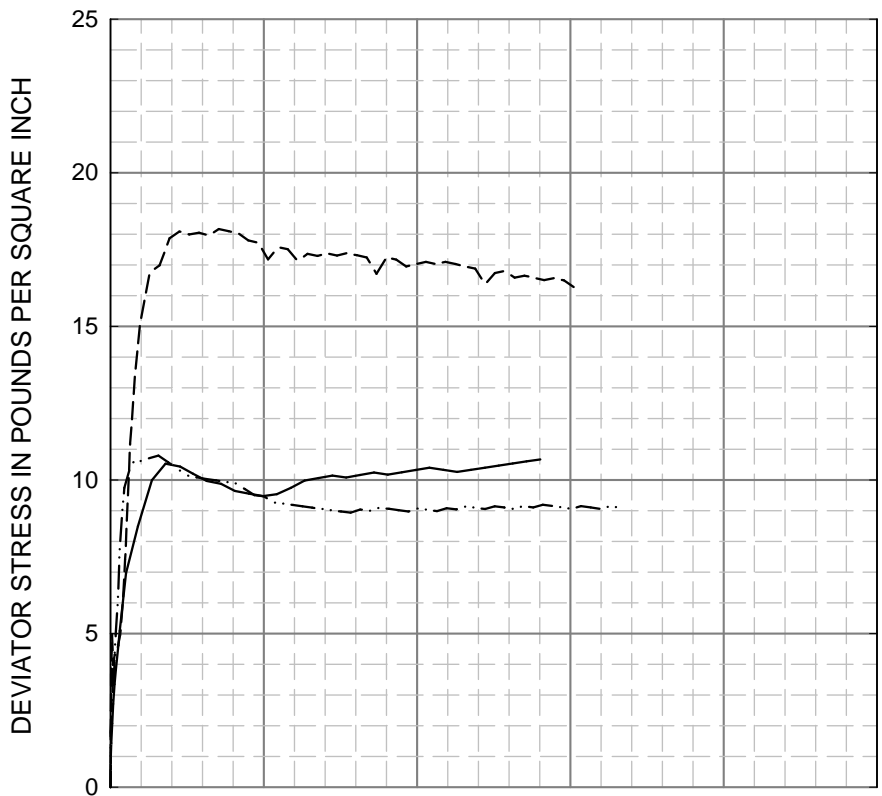
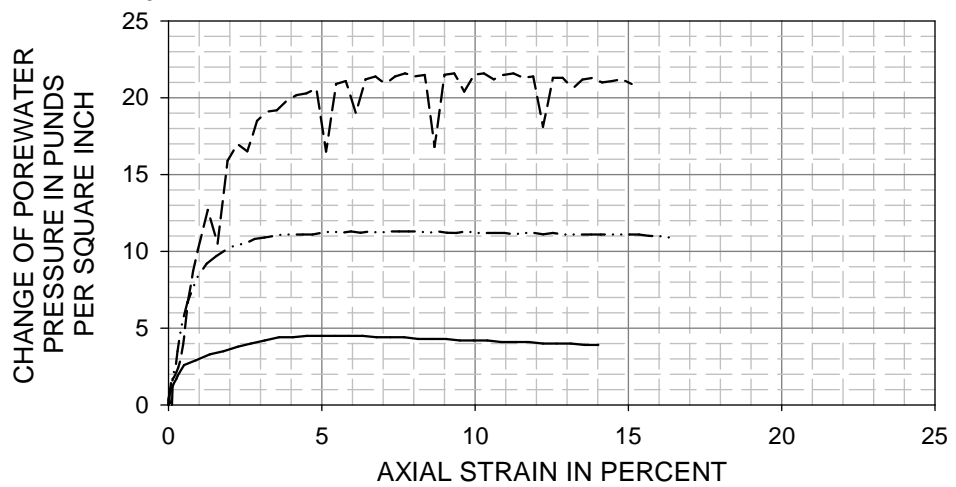
Boring No. P2-CC-15

Depth of Sample 13 - 15 ft.

Soil Description: VERY SOFT, brown, slightly sandy, clayey SILT; fine sand, numerous mica, wet (ALLUVIUM)

Confining Stress σ'	Length (in)	Diameter (in)	Strain Rate (%/hr)	w_c (%)	Wet Density (pcf)	Peak Stress (psi)
7	6.00	2.83	0.95	33	112.2	10.5
14	5.79	2.83	0.99	34	107.8	10.8
28	5.71	2.83	0.96	32	108.0	18.2

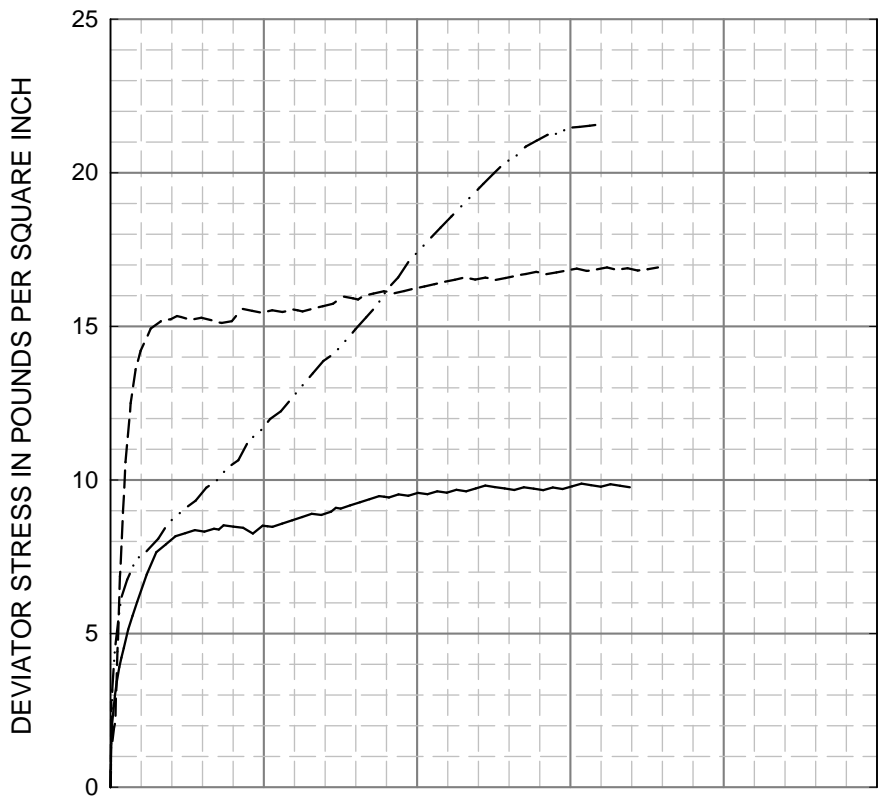
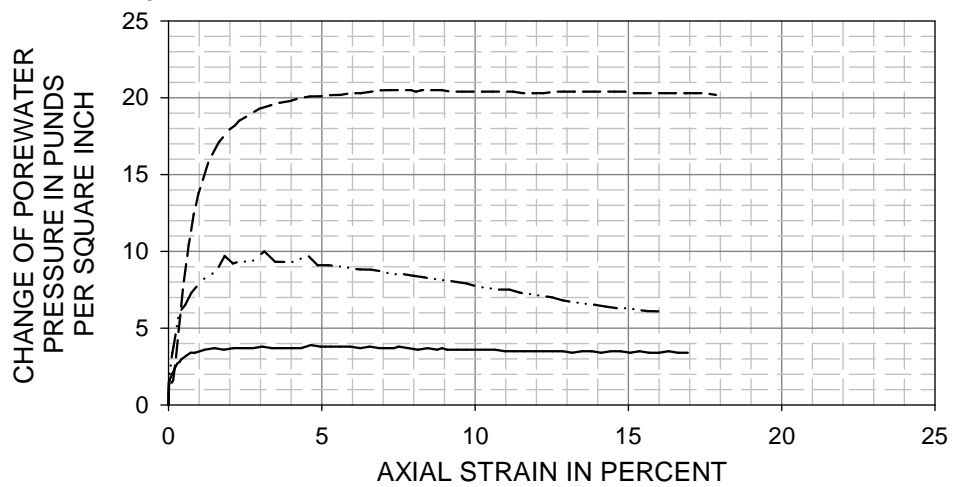
Boring No. P2-CC-25 Sample No. S-3 Depth of Sample 13 to 15 ft.

Soil Description: MEDIUM STIFF, brown, slightly sandy, slightly clayey SILT; trace clay,
fine sand, numerous mica, moist (FILL)

Confining Stress σ'	Length (in)	Diameter (in)	Strain Rate (%/hr)	w_c (%)	Wet Density (pcf)	Peak Stress (psi)
—	7	5.74	2.85	0.99	33	112.0	8.4
- · -	14	5.23	2.79	1.09	31	116.3	10.0
- - -	28	5.52	2.83	1.04	32	111.8	15.6

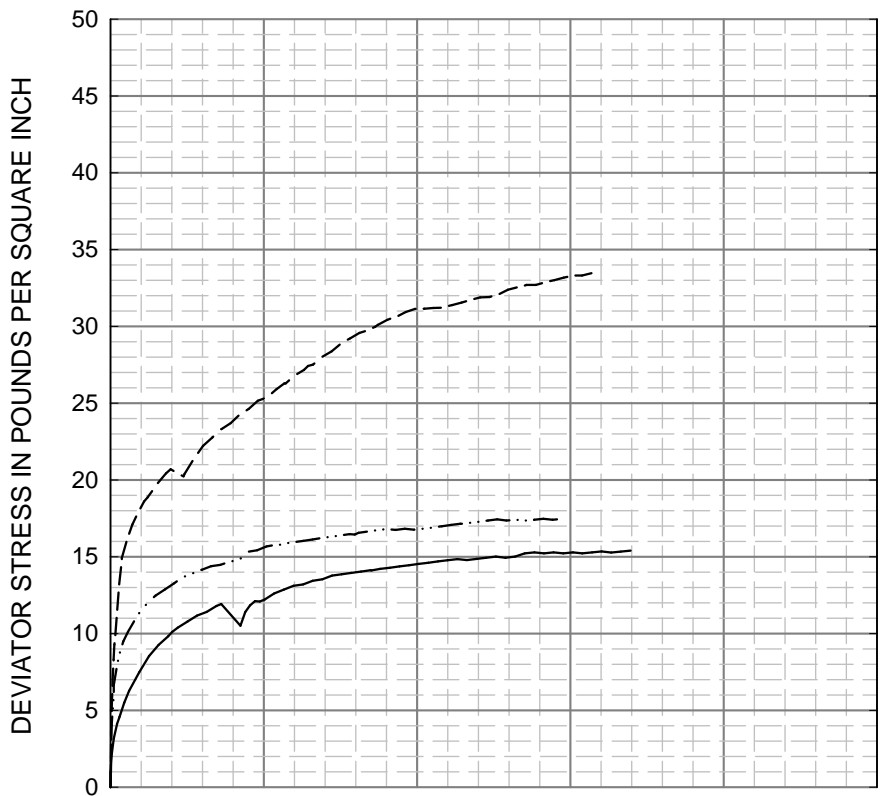
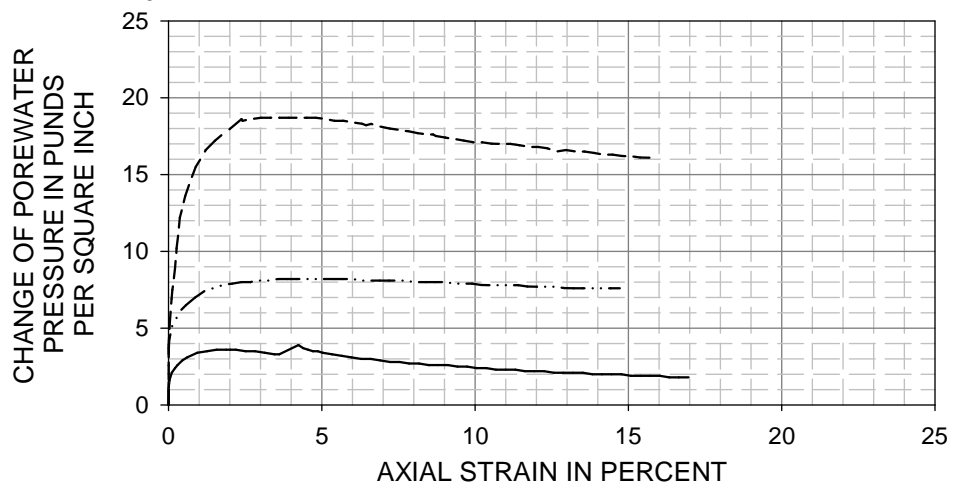
Boring No. P2-CC-70 Sample No. S-3 Depth of Sample 13 to 15 ft.

Soil Description: SOFT to MEDIUM STIFF, mottled red-brown to gray, very sandy, clayey SILT; fine to coarse sand, occasional organics, occasional mica, moist (FILL)

Confining Stress σ'	Length (in)	Diameter (in)	Strain Rate (%/hr)	w_c (%)	Wet Density (pcf)	Peak Stress (psi)
—	7	5.77	2.85	0.99	44	109.5	10.1
- · -	14	6.04	2.83	0.95	37	112.3	14.8
- - -	28	6.02	2.83	0.95	33	115.3	23.7
