Peninsula Drainage District No. 2

Levee Engineering Assessment

**PENINSULA DRAINAGE DISTRICT NO. 2
LEVEE ENGINEERING ASSESSMENT**

October 2, 2014

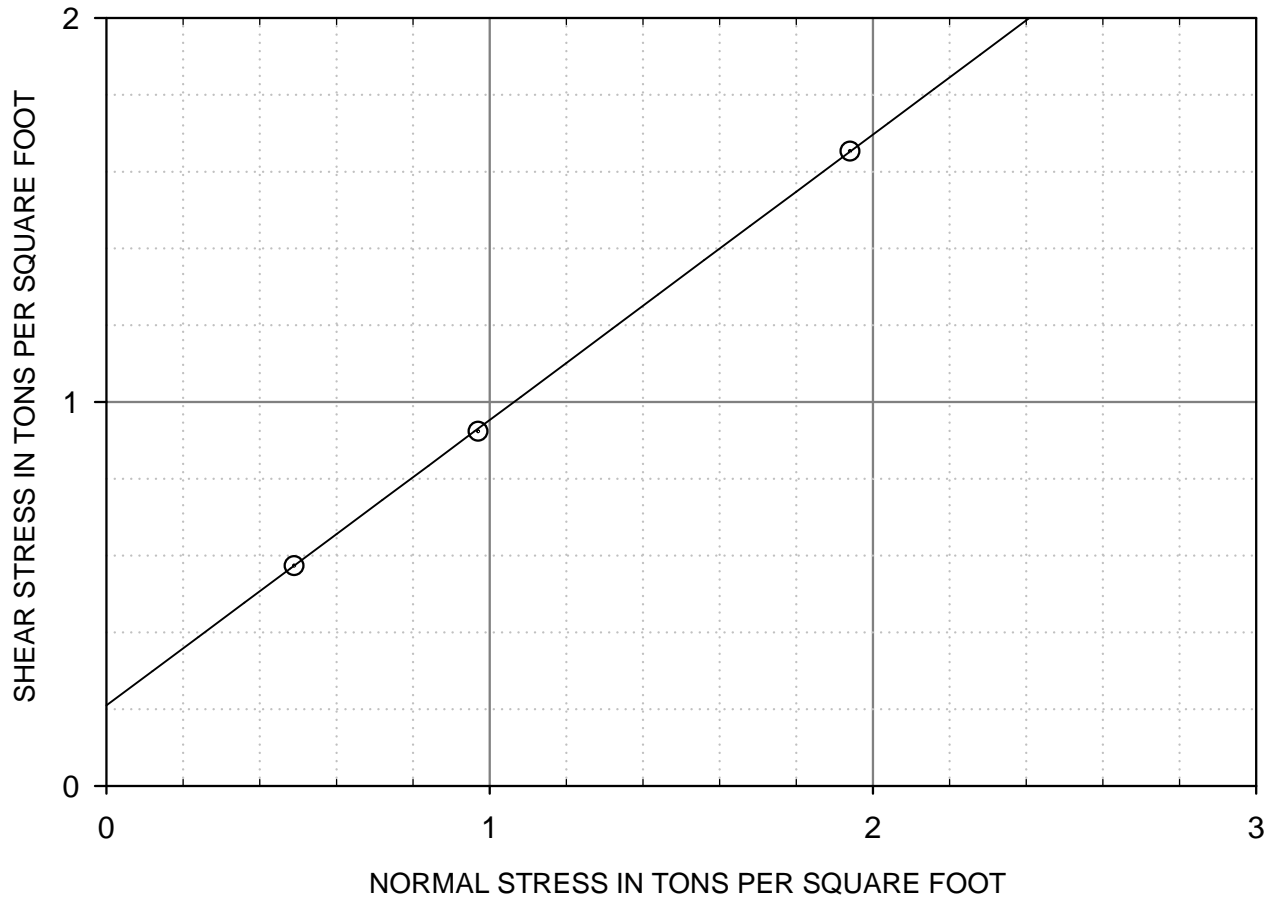
FIG. C19

Boring No. P2-CC-32 Sample No. S-4 Depth of Sample 18.5 to 19.1 ft.

Soil Description: SOFT, gray, sandy, slightly clayey SILT; fine sand, occasional organics, scattered mica, wet (ALLUVIUM)
