**Subject: Final Submittal, Willamette Falls Locks Engineering Study
Large Scale Capital Costs**

Name of Project: Willamette Falls Locks Engineering Study
INCA Job No.: 07-013

Willamette Falls Lock Engineering Study
Large Scale Capital Costs
Final Submittal

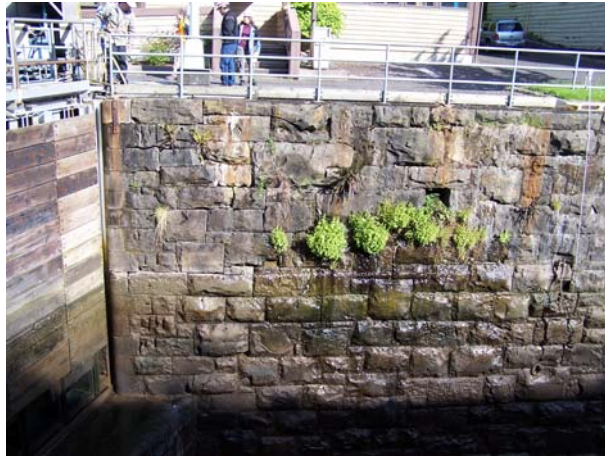
Photo 3-4 Through Wall Leakage (Landside) / Prior to Filling Upstream Chamber

The vegetative growth, loss of ashlar masonry stones, and open joints in the masonry are likely the result of water moving through the miter gate monolith.

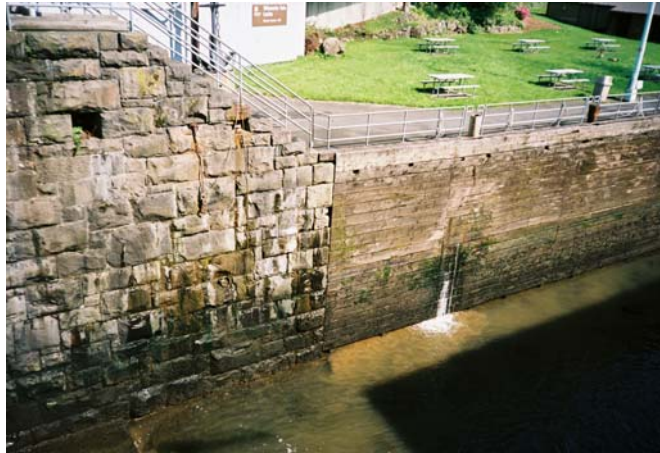
Photo 3-6 Through Wall Leakage (Landside)
(Flow path extends beyond masonry)

This photograph highlights the different consequences of through wall leakage on the landside versus the riverside. As the leak path propagates beyond the masonry miter gate monolith, it encounters the general lock chamber wall construction. The chamber wall construction has multiple designs, including a timber lined excavated rock face, a timber lined excavated rock face with soil and concrete fill, and a combination of timber and concrete faced rock cut. Each of these designs is shown below.

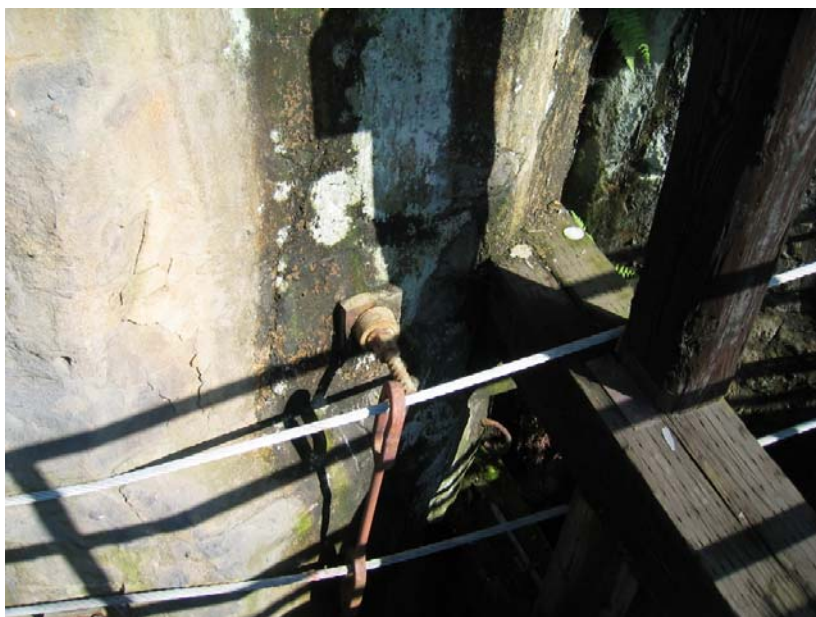
Photo 3-14 Land Side - Chamber 1 Rock Bolt

In addition to the rock anchors installed during the original construction of the lock walls, there have been rock bolts installed for what appears to be stability issues; either the stability of the cut rock face or stability of the gate monoliths. The following photograph shows a rock anchor used to support the rock slope.

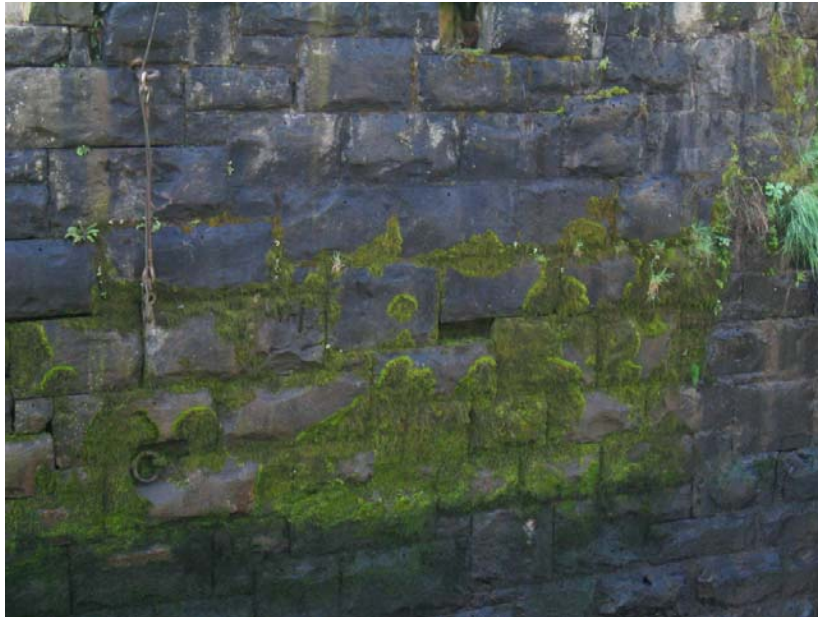
Photo 3-16 **Riverside Wall**

One of the signature features of the Willamette Falls Locks is the ashlar masonry gate monoliths and chamber walls. The masonry, made from locally quarried stones, was placed without mortar. In a number of places, the surface stones have become displaced. We did not note any locations where two adjacent stones have become displaced, an indication of imminent failure. All missing stones appeared to be individual occurrences. A portion of these instances are shown below.

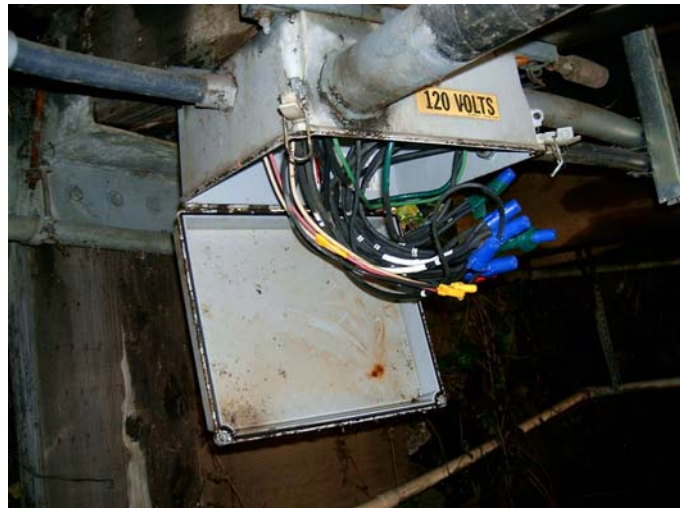
A number of junction boxes were opened during the April 19, 2007 site observation, and with the exception of a small accumulation of water in one box, the wiring was found to be in very good condition.

Photo 4-2 Junction Box Contained Water When Opened

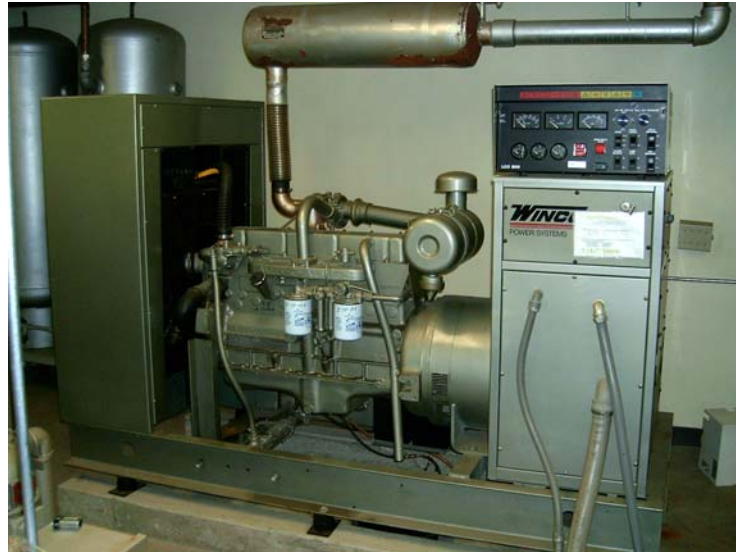
Photo 4-3 75kVA Diesel Engine Standby Generator

There is a 75kVA standby diesel-engine generator set, located in the Lockmaster's Office. The primary purpose of this generator is to provide power for operation of the gates and lighting. This generator, and its automatic transfer switch, appears to be in good repair.

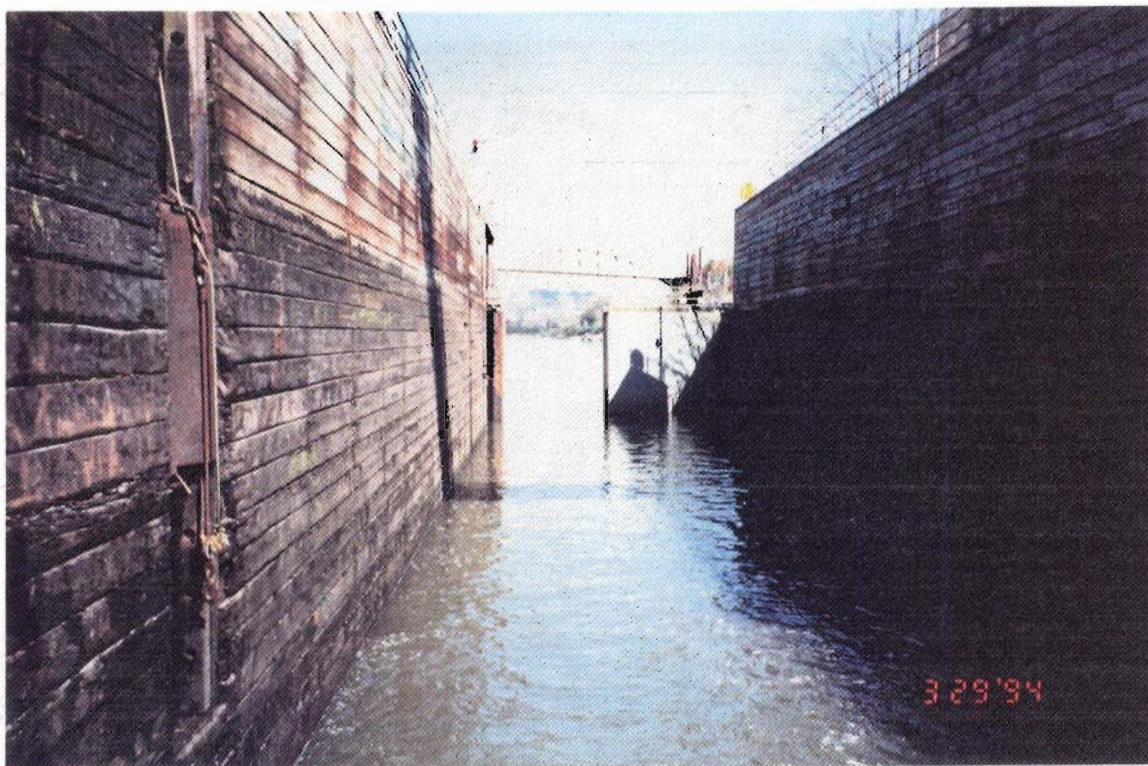
1. Lock chamber 1, left wall looking downstream.

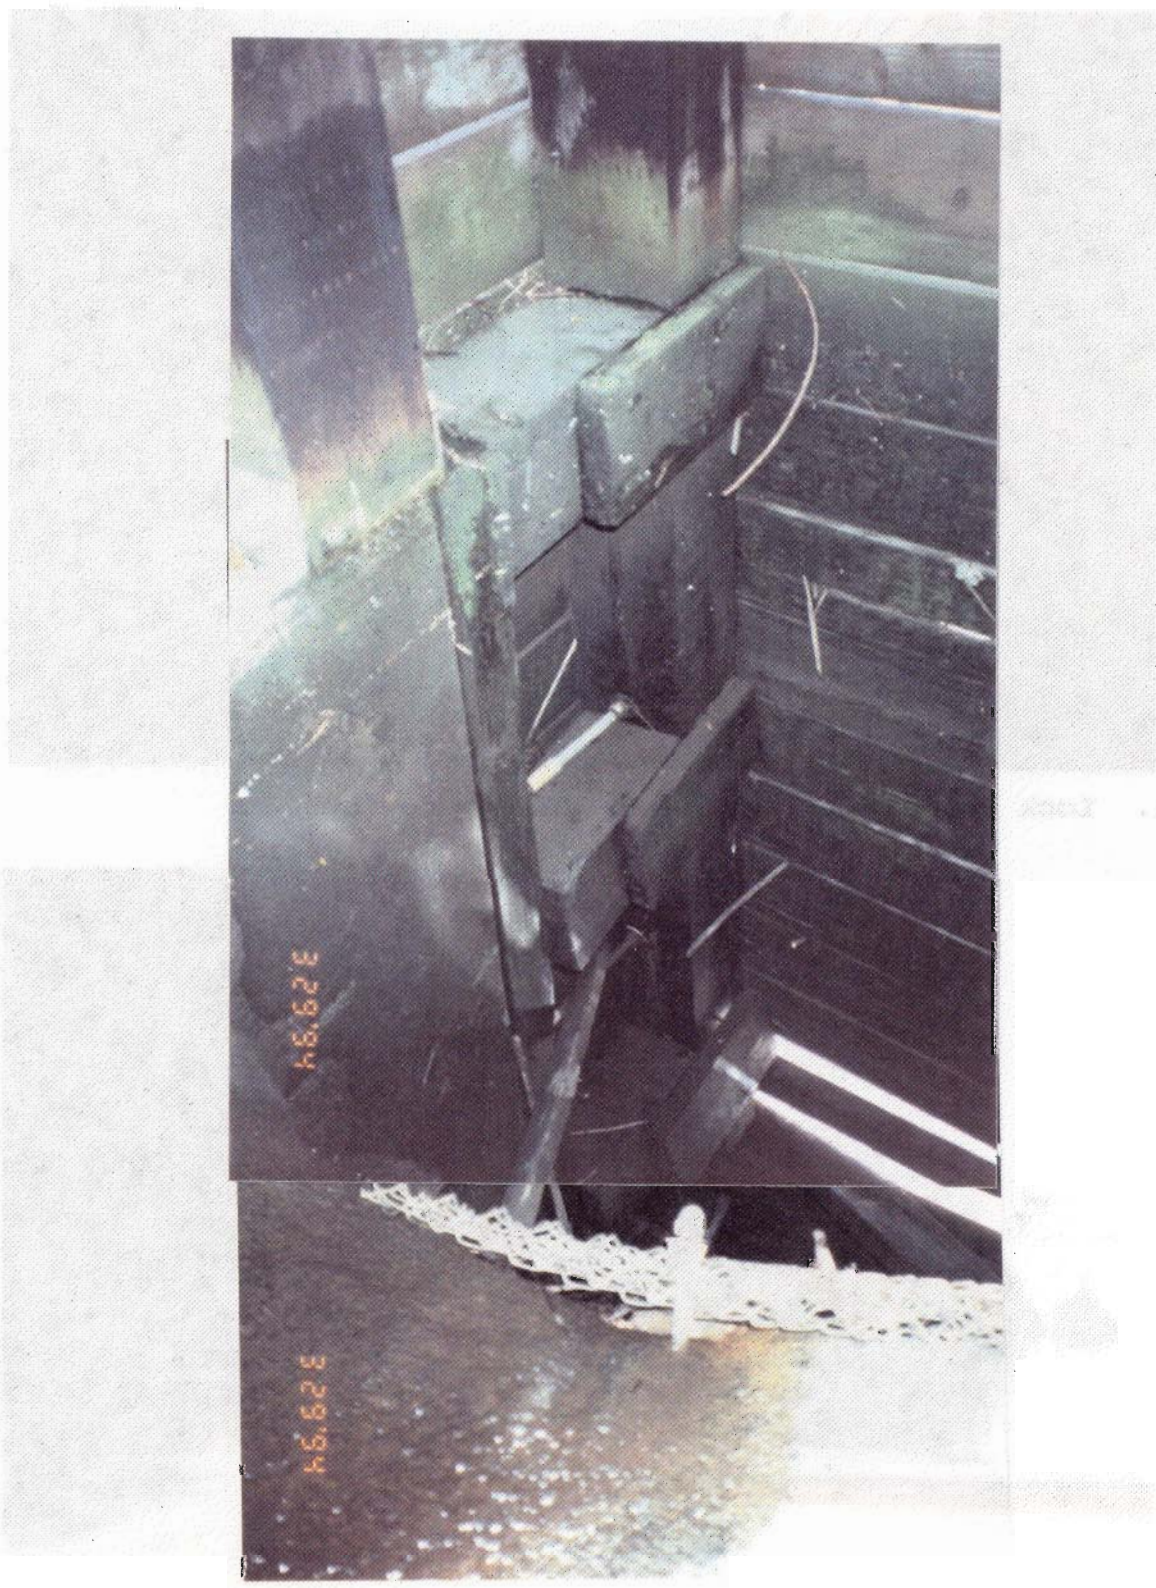
3. Split timber in lock 1, corner post upstream of gate 1, left side.

Inspection Summary. The lock structure was generally in good condition. Project staff replaces approximately 100 timbers every year on the lock gates and walls as a continuing maintenance item. The sills at each lock gate receive a lot of abuse from barge traffic, due to the maneuvering needed to fit the barge and tug combinations into each chamber. Some of the sills have worn back into the stonework to an extent that repairs are recommended. Also, there are several masonry stones missing from various places in the sills and lock walls. The stones should be replaced or the gaps filled with concrete to prevent further loosening of adjacent stones. The miter gates appeared to be in generally good condition, although the timber lagging on the downstream faces prevented a thorough inspection of the main structural members. Problems noted with many of the gates included loose gudgeon anchors, loose gate operating cylinder anchors and pins, worn guide plates for the slide gates, and wear of the miter posts due to tugs bumping and rubbing on the miter posts. See paragraph 3 of Appendix C for recommended gate repairs. A 12x12 timber column corner post in the west wall near gate 1 has been broken and bisected by a vertical split. The timber should be replaced or clamped back together.

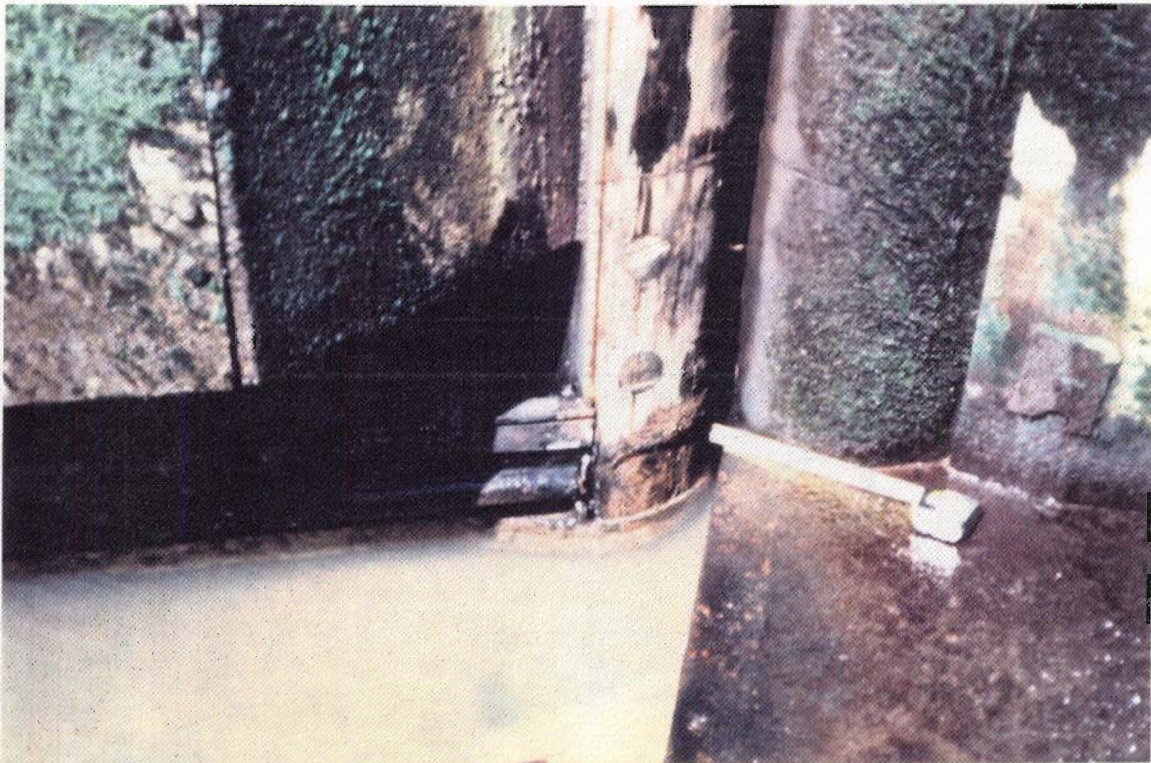
5. Gate 2, left side, gouge in quoin post (end of tape).

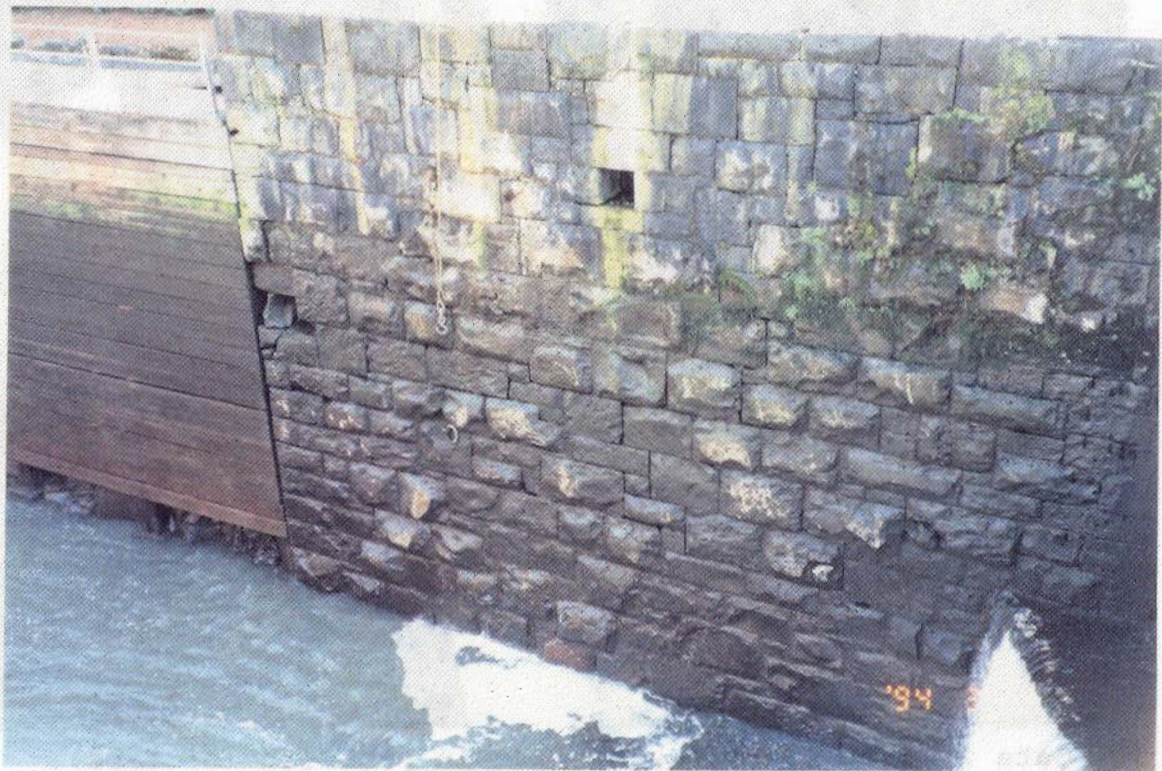
7. Chamber 2, right wall, upstream end near sill 3.

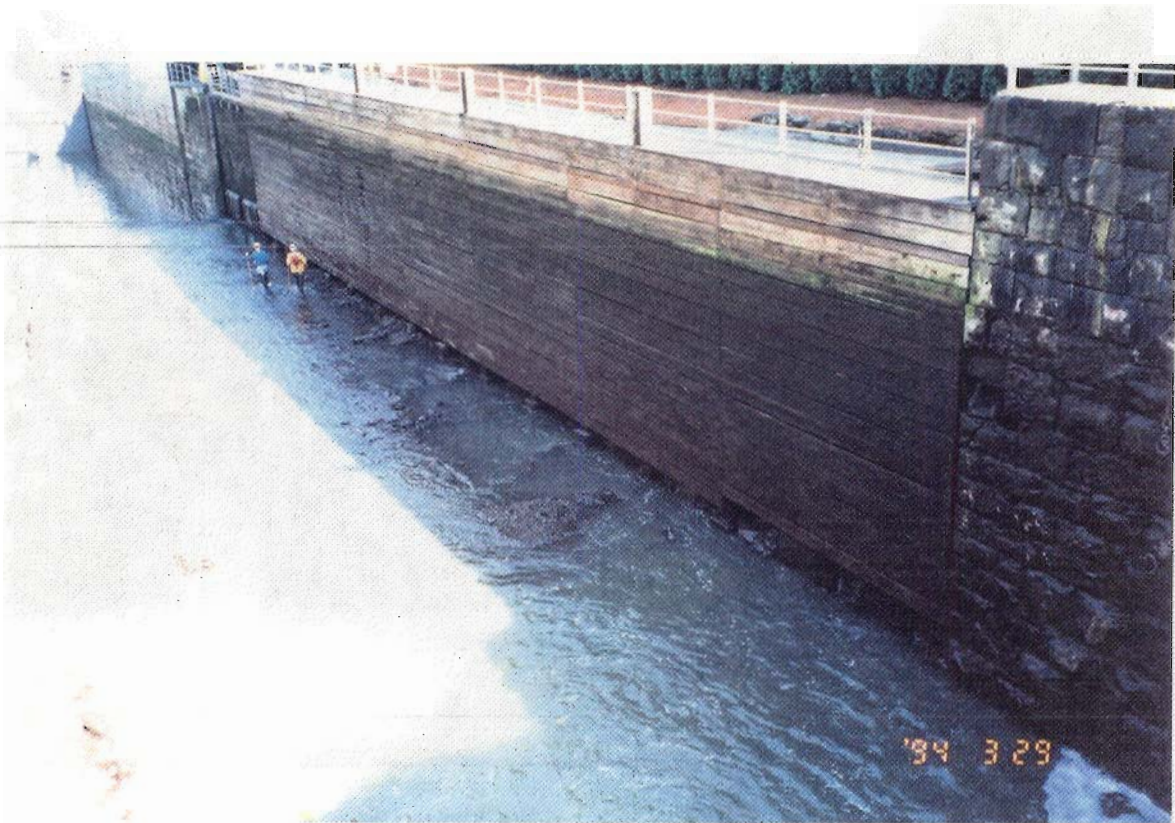
8. Chamber 2, right wall, looking downstream.

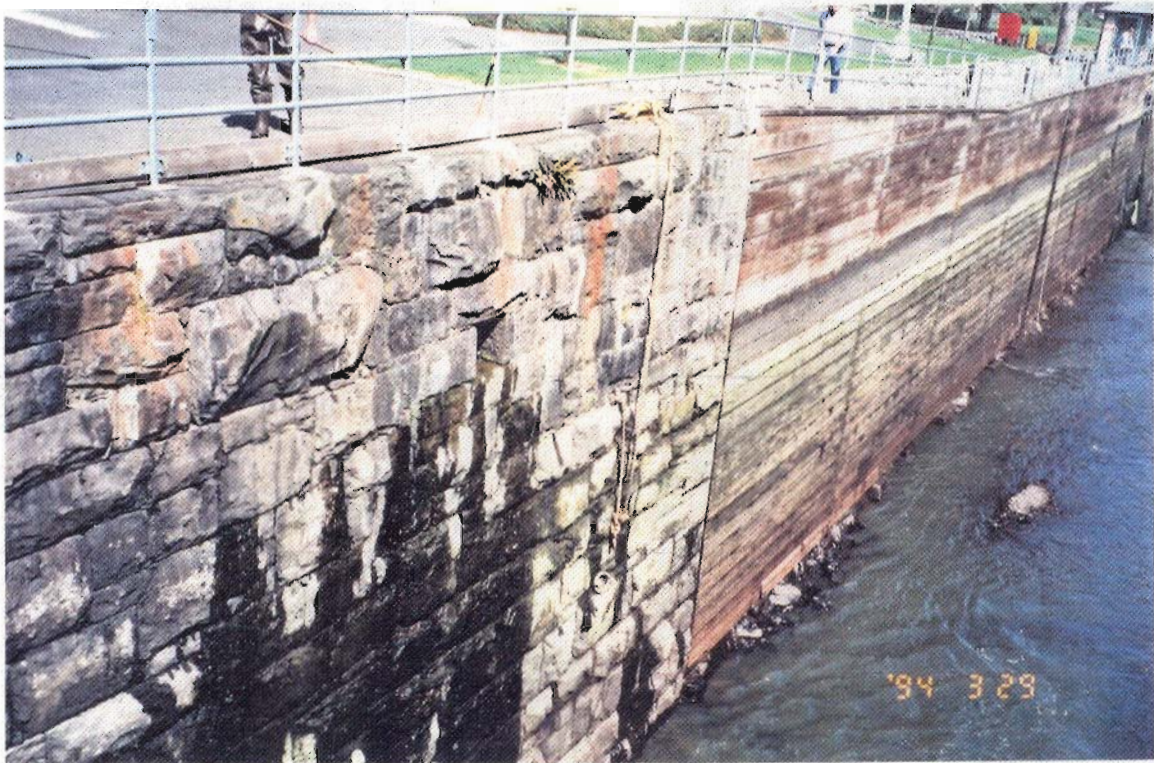
9. Chamber 2, left wall, looking downstream.

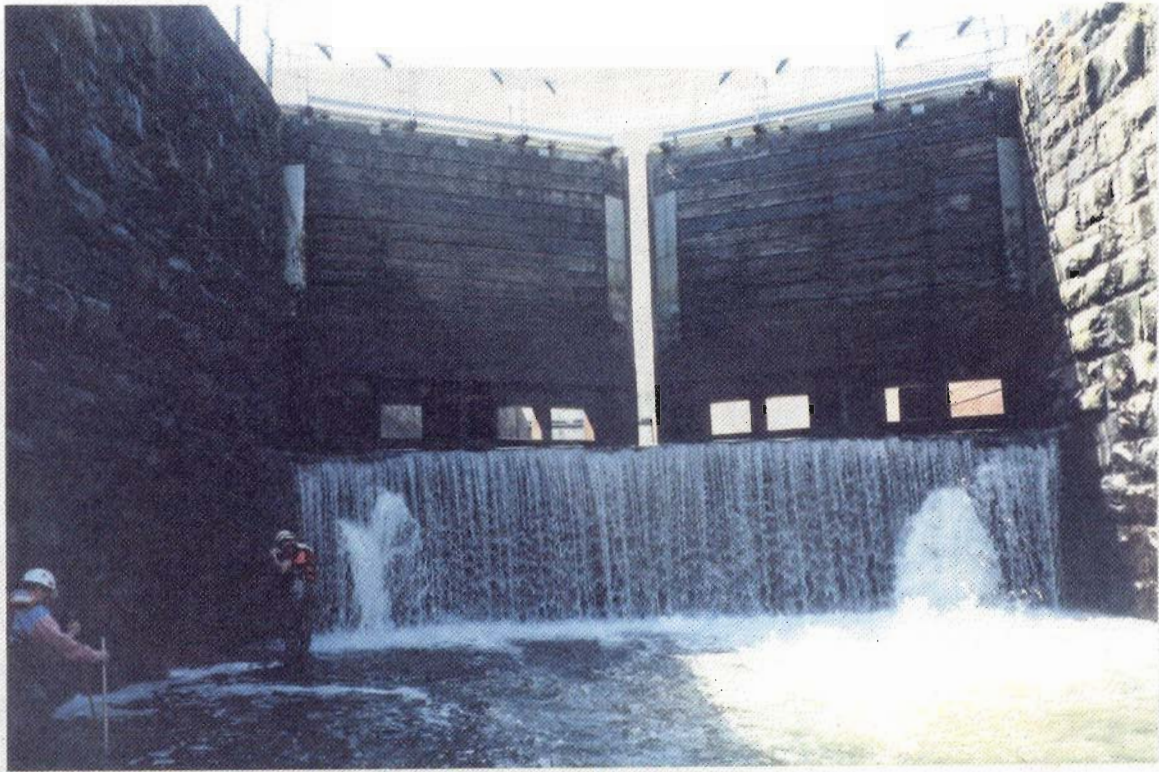
10. Looking u/s at gate sill 3, before gate closed.

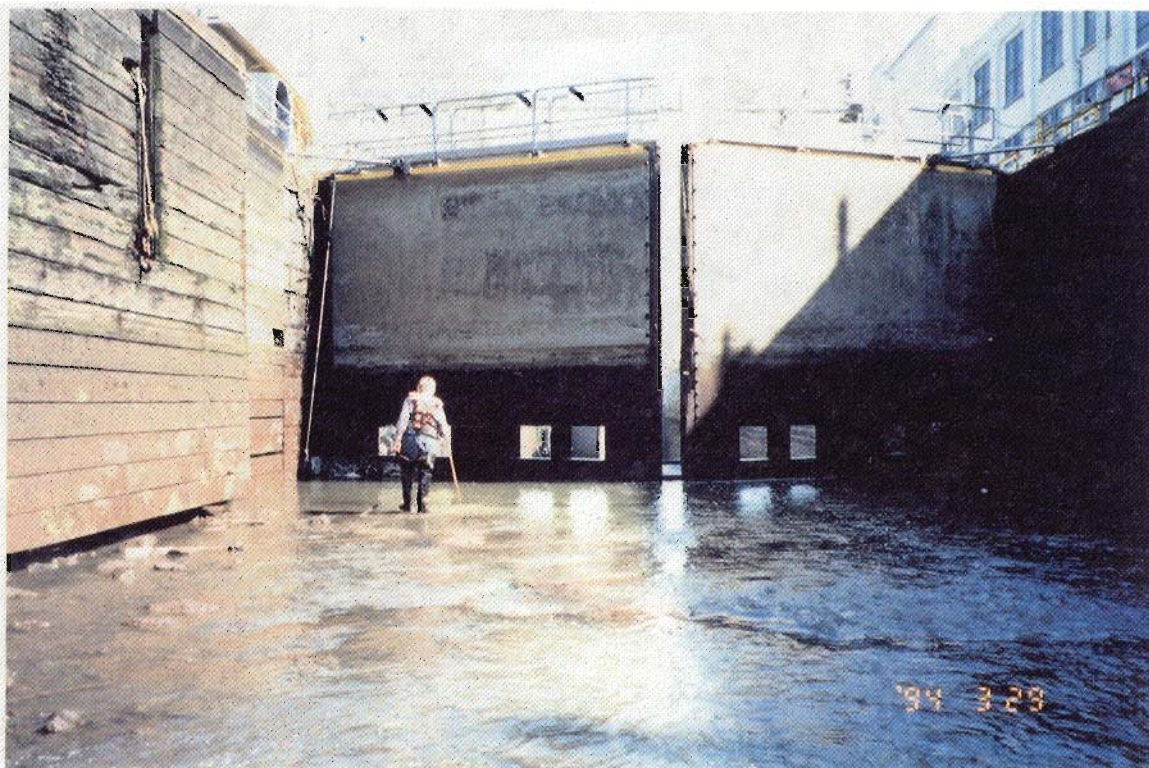
14. Gate 3, upstream side.

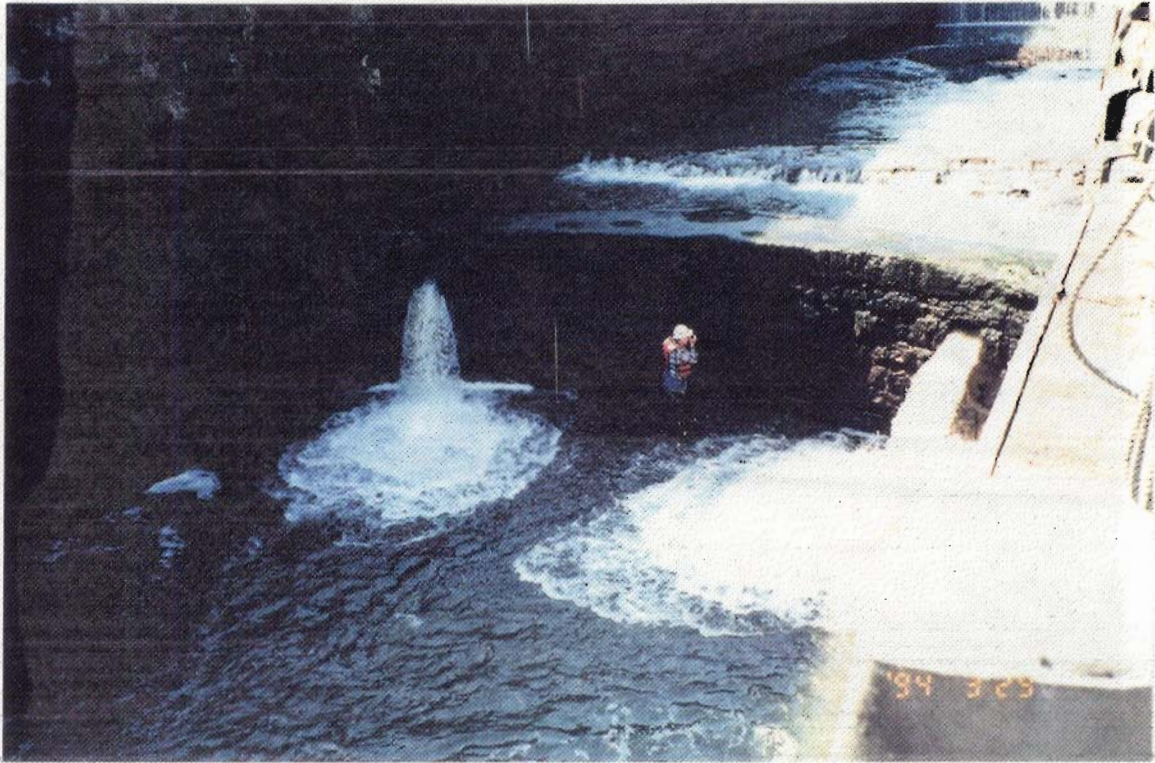
16. Gate 4 sill, view from deck.

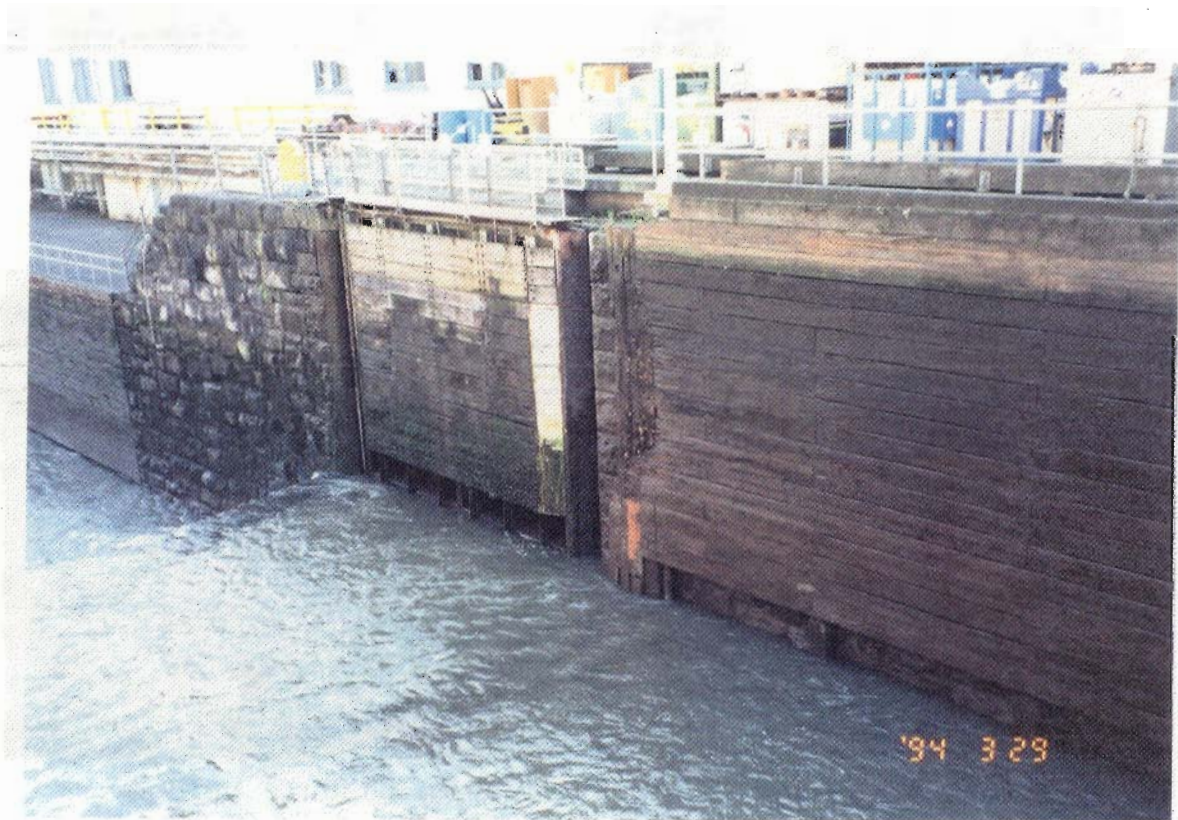
21. Gate 4 (open) and d/s right wall of chamber 4.

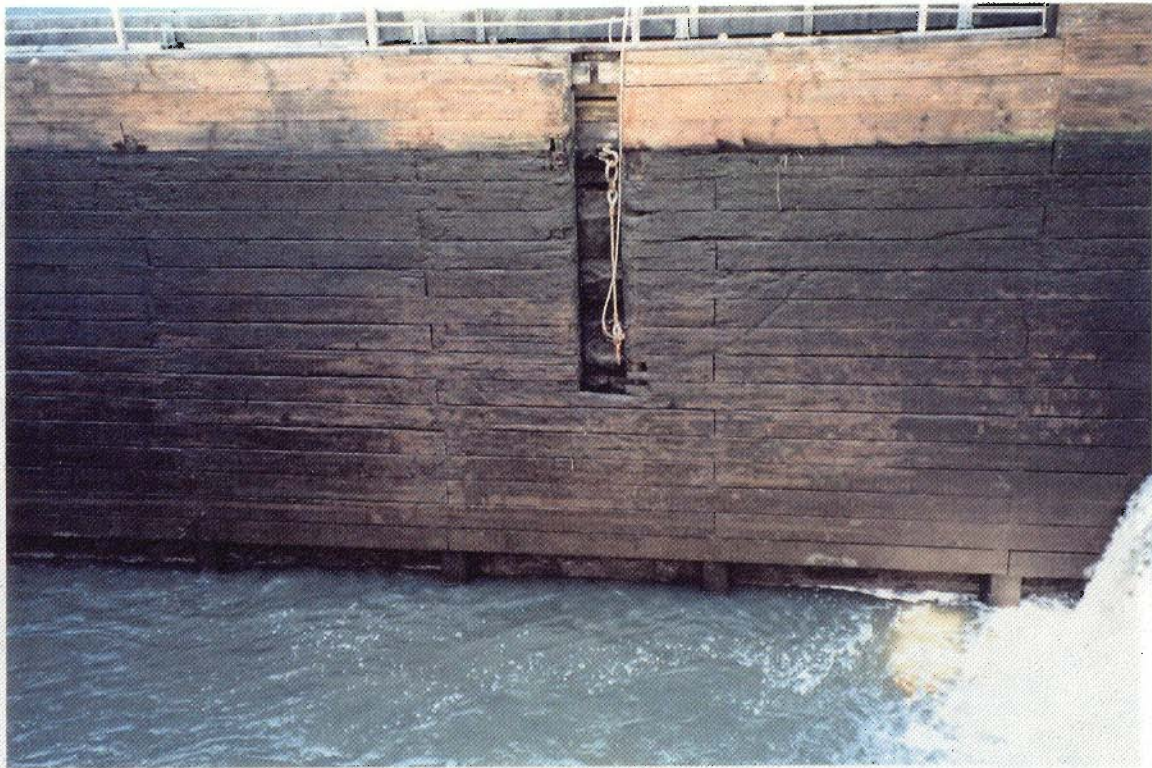
22. Chamber 4, right wall upstream from bascule bridge.

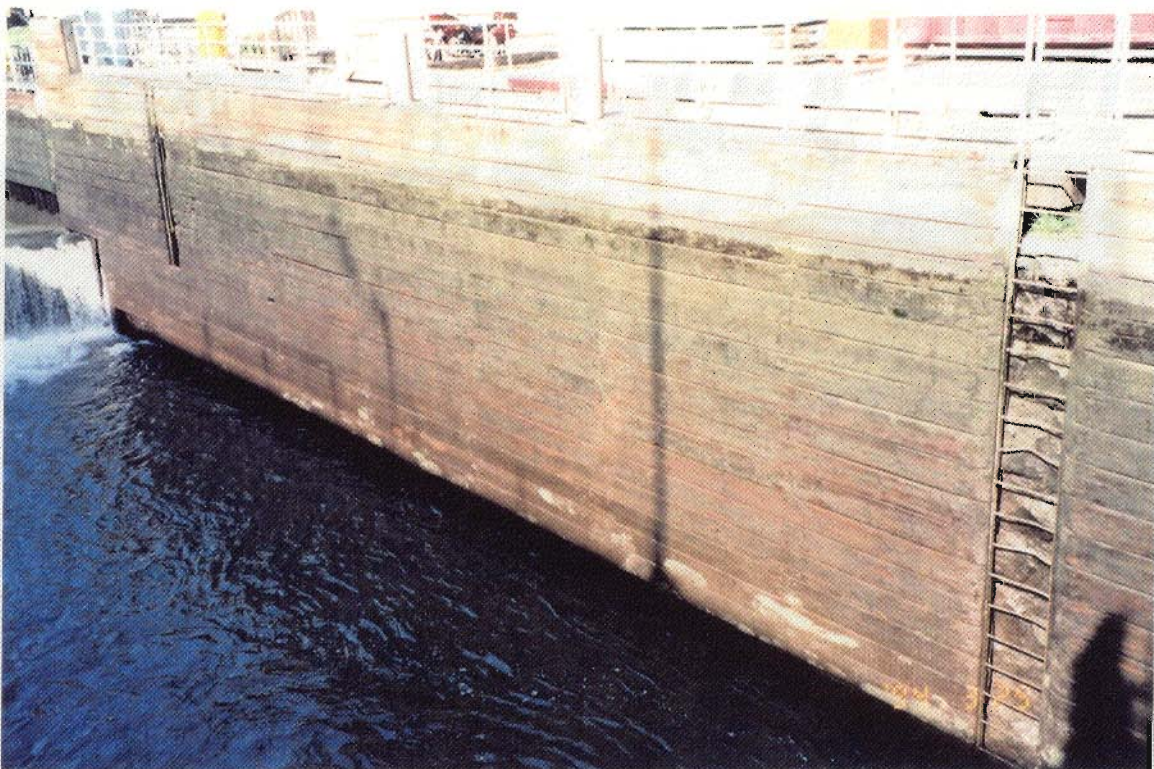
23. Chamber 4, left wall upstream from bascule bridge.

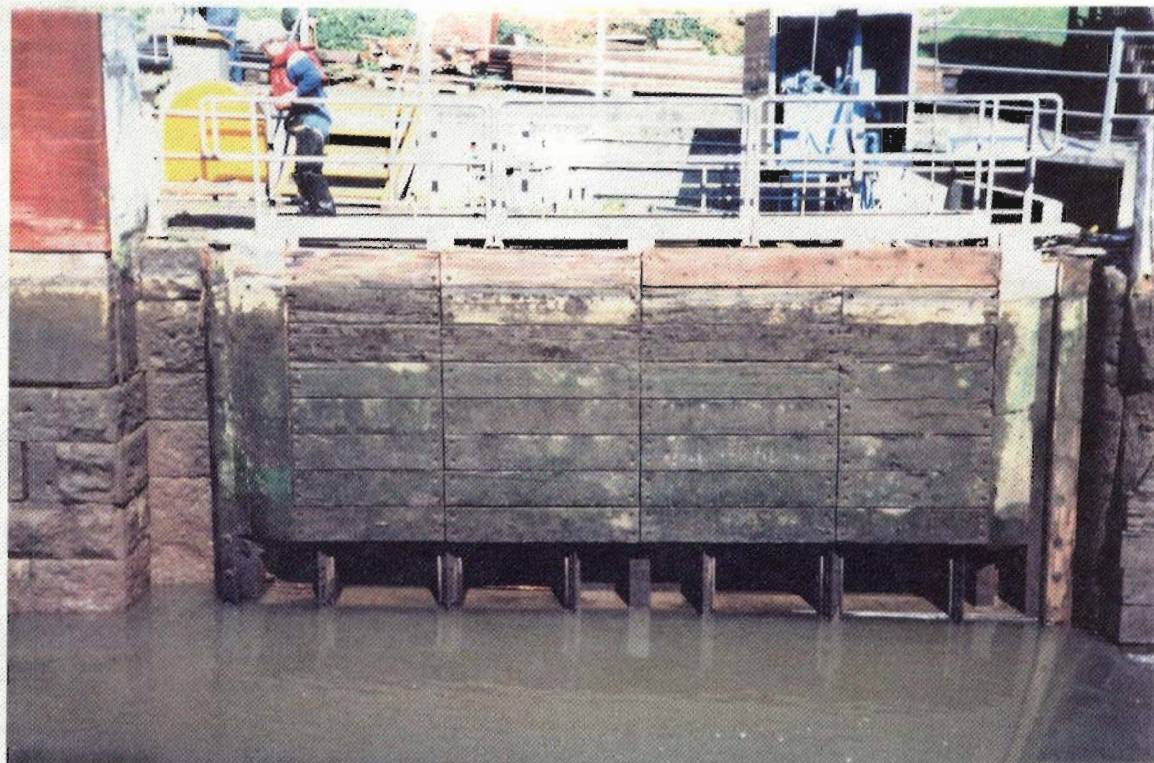
24. Gate 5, left side (leaf open).

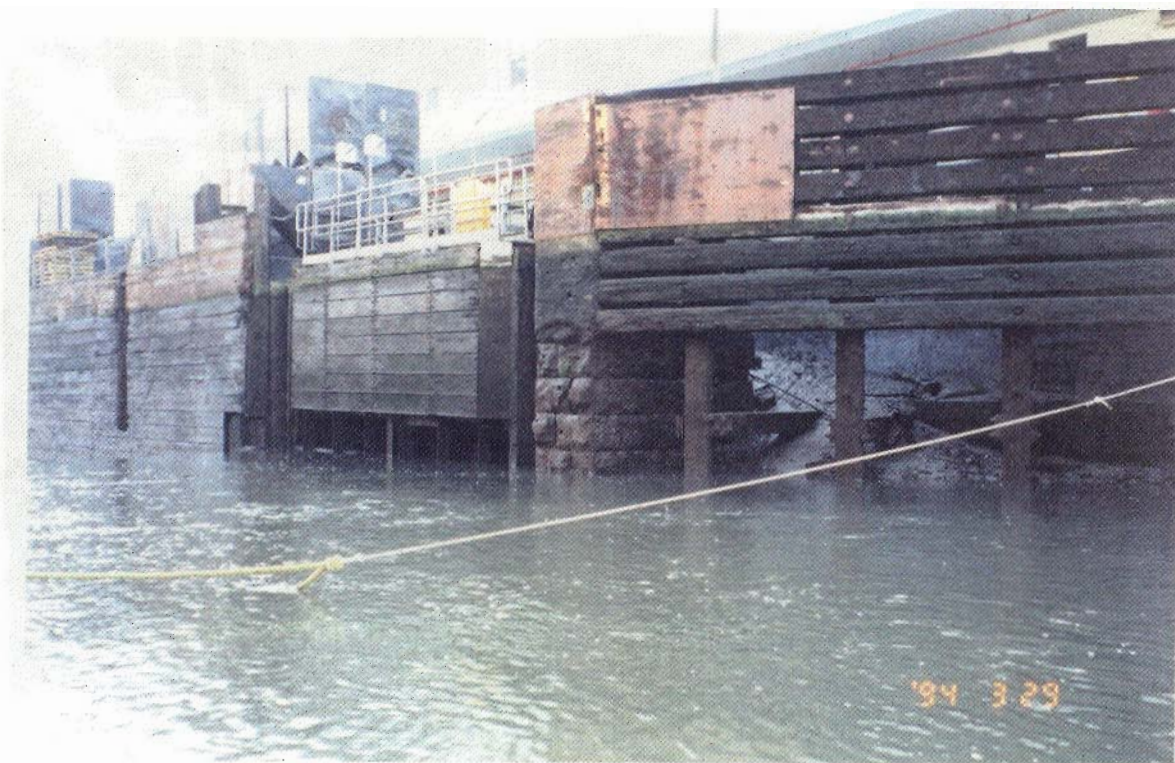
25. Gate 5, right side (leaf open).

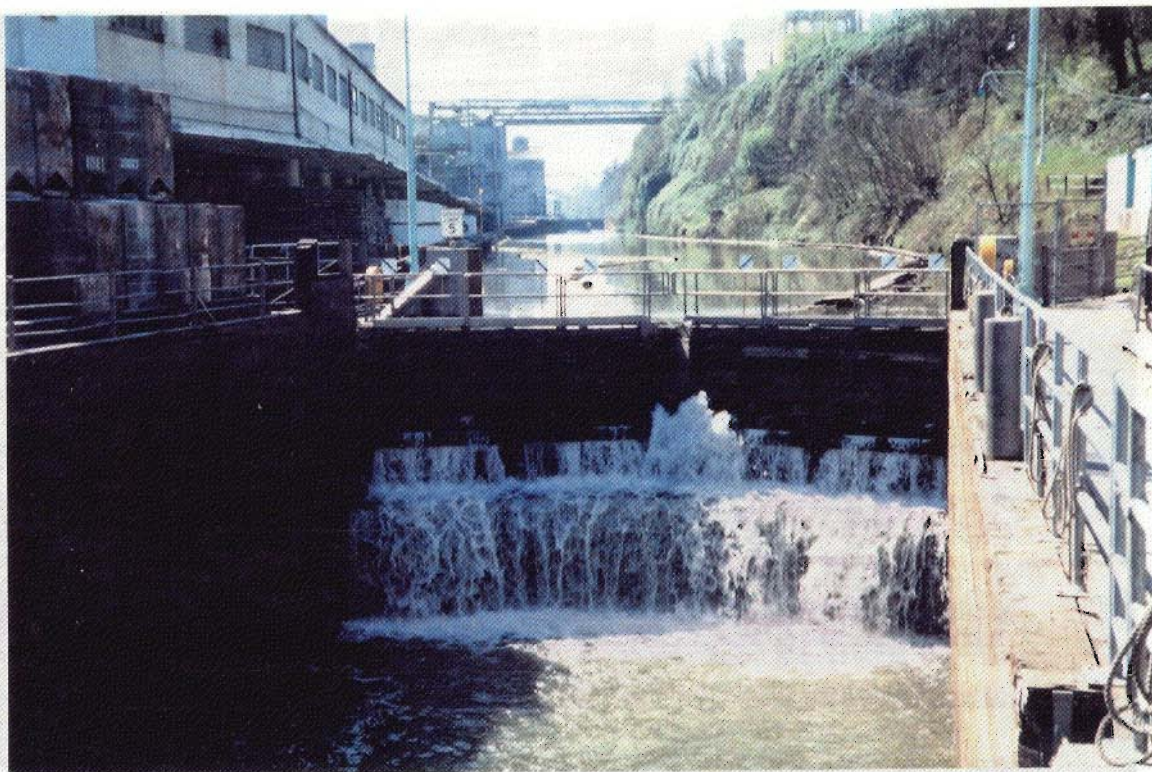
26. Gate 5, downstream face after closing, water level rising upstream of gate.

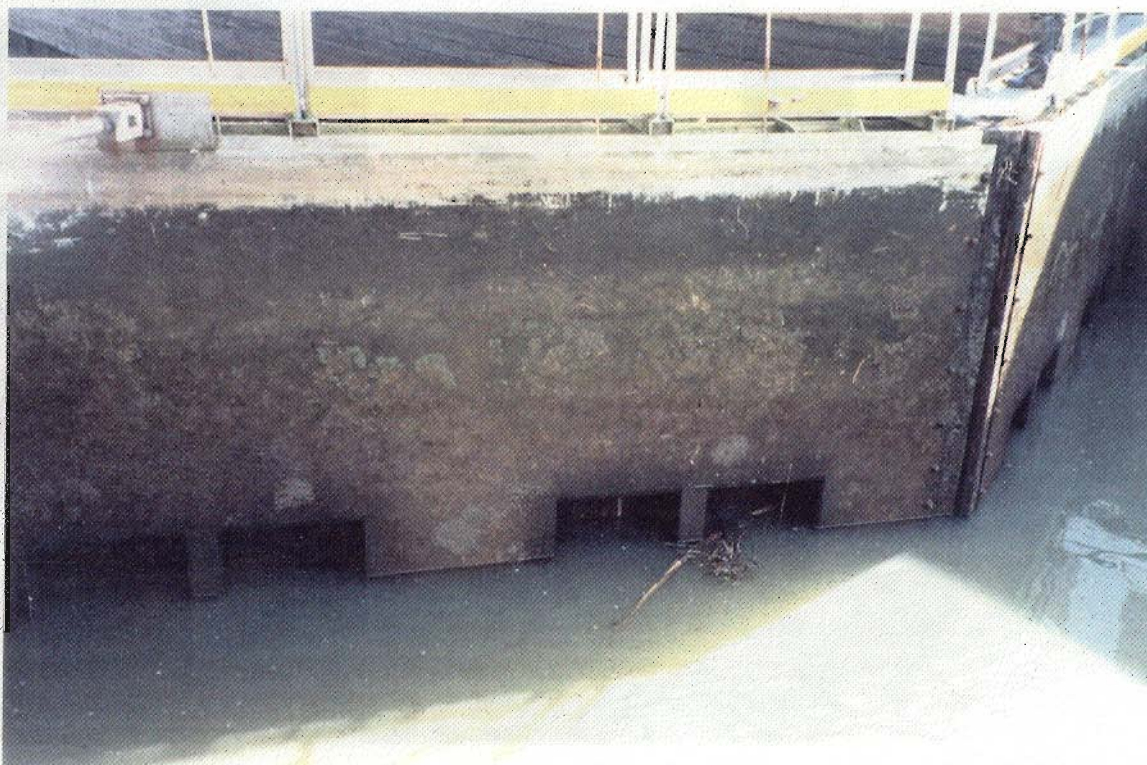
27. Gate 5, upstream face after closing.

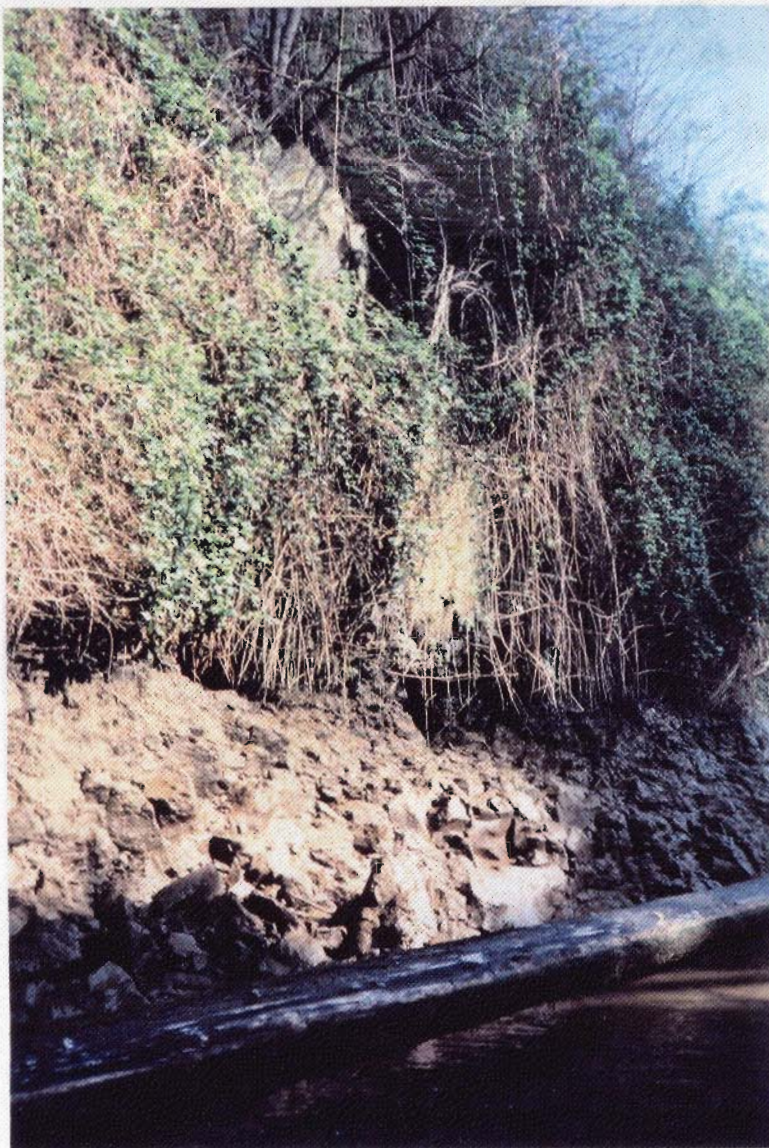
31. Left bank of
canal, basalt
undercut.

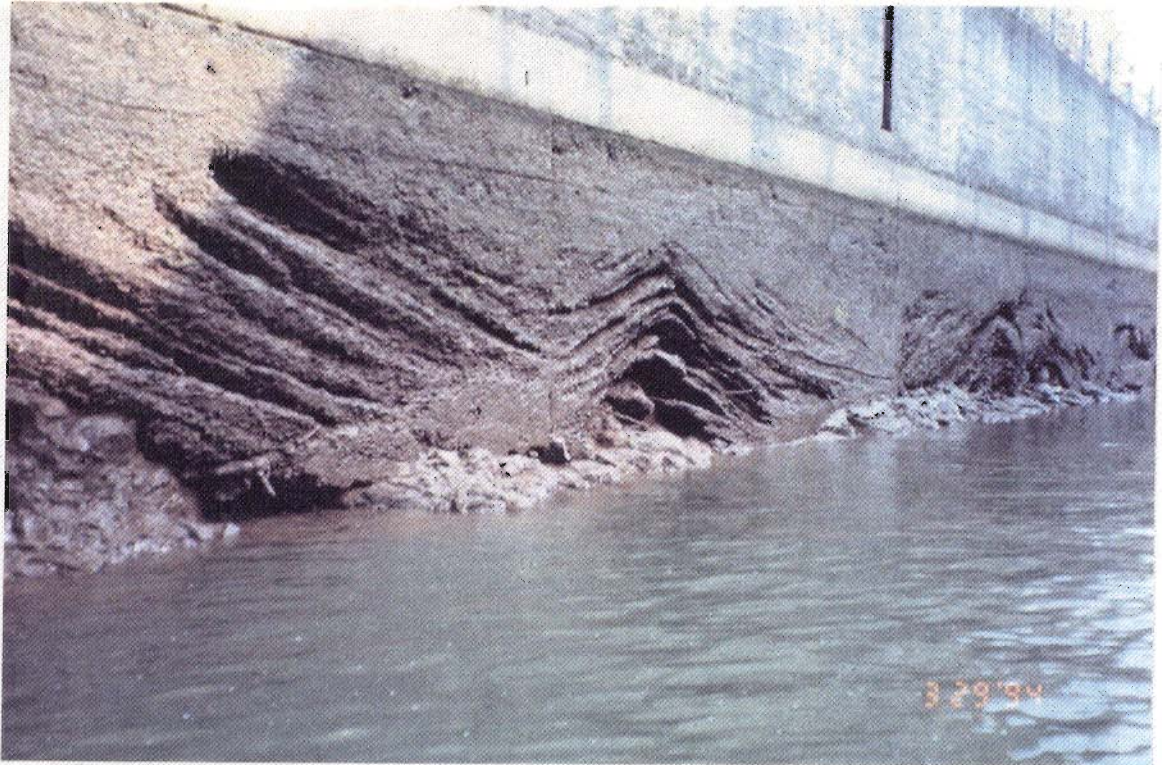
36. Left wall of guard lock, lower part of wall (ripples).

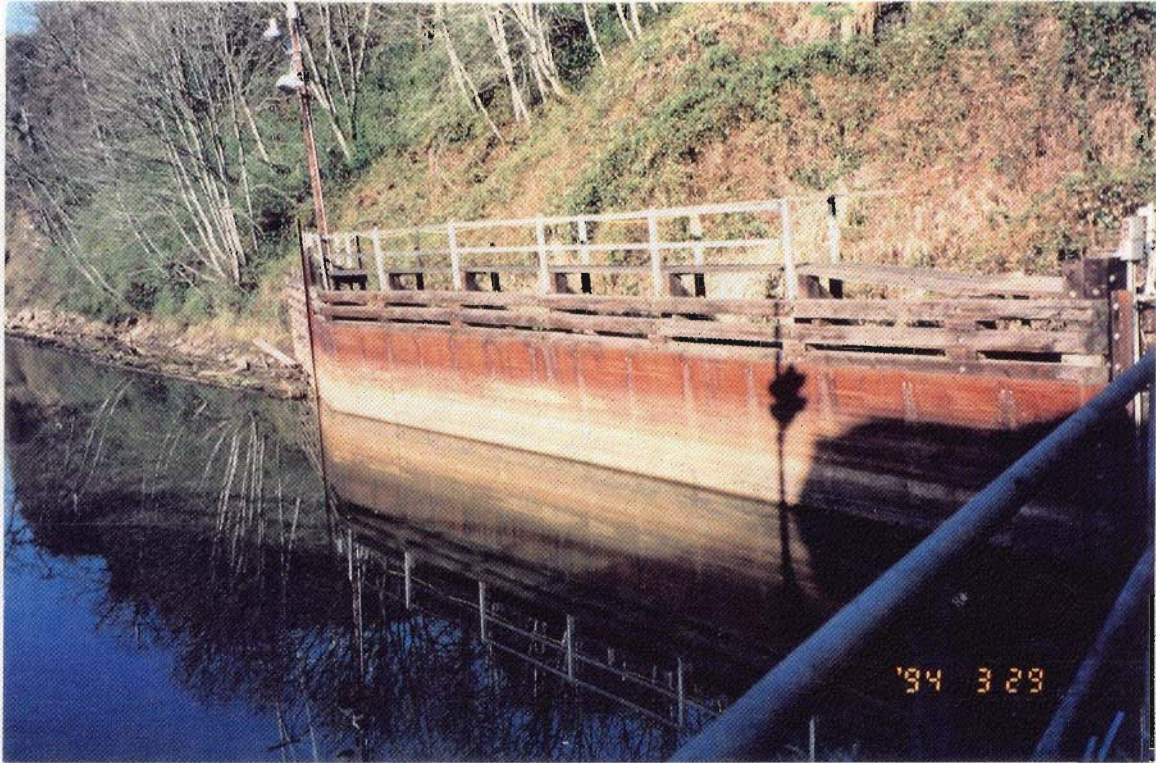
38. Upstream guide wall, left side.

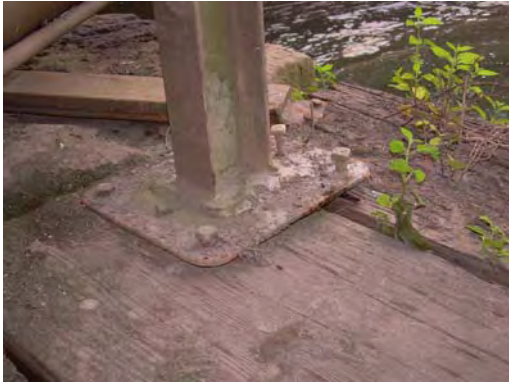
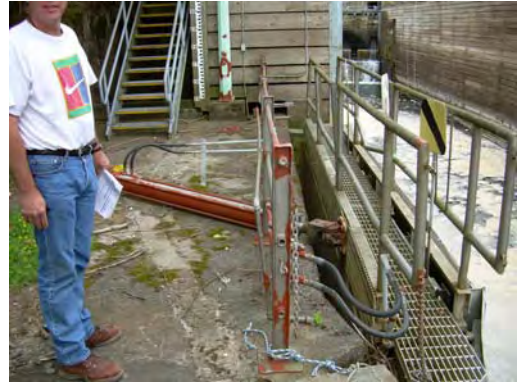
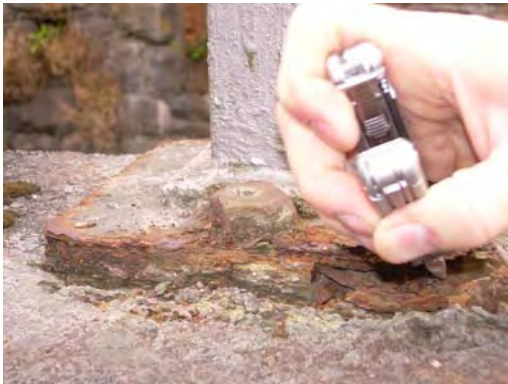
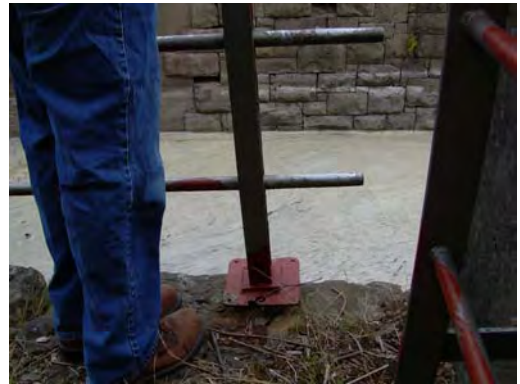
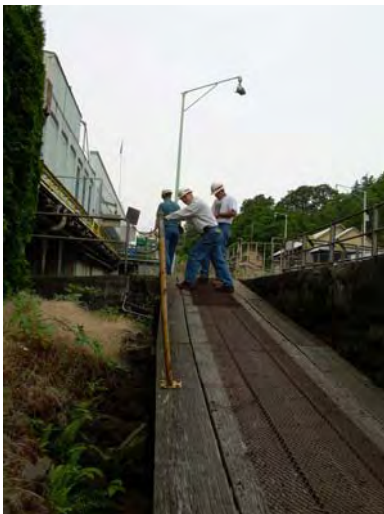
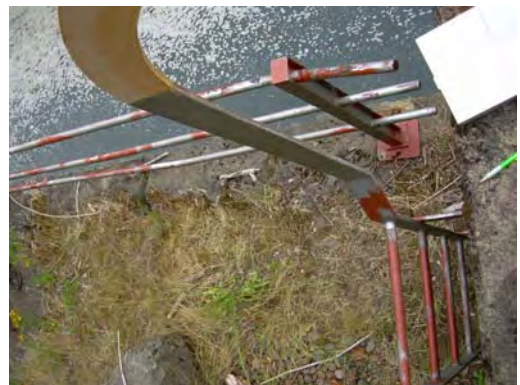
Various Handrail deficiencies at the Willamette Falls Locks
