**Subject: Final Submittal, Willamette Falls Locks Engineering Study
Large Scale Capital Costs**

Name of Project: Willamette Falls Locks Engineering Study
INCA Job No.: 07-013

Willamette Falls Lock Engineering Study
Large Scale Capital Costs
Final Submittal

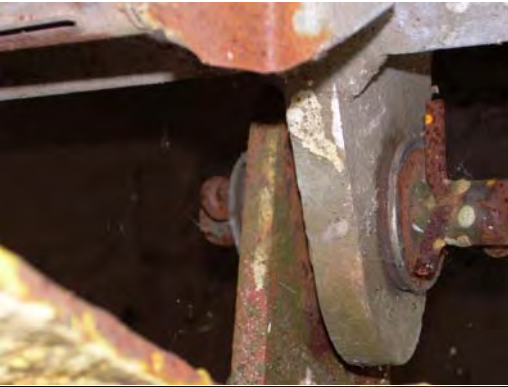
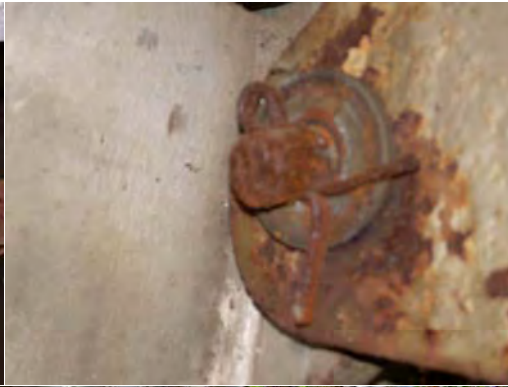
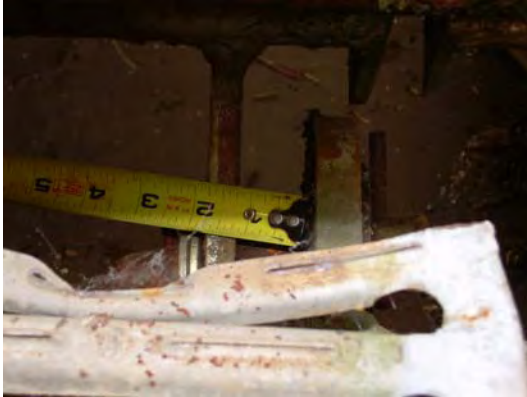
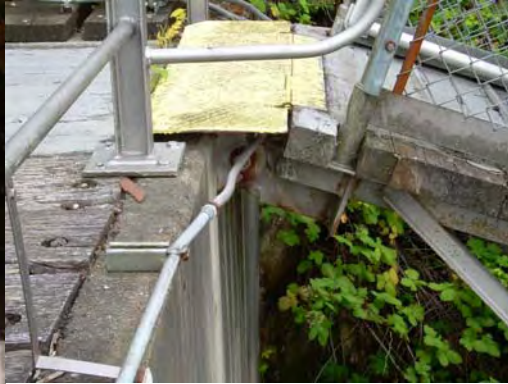
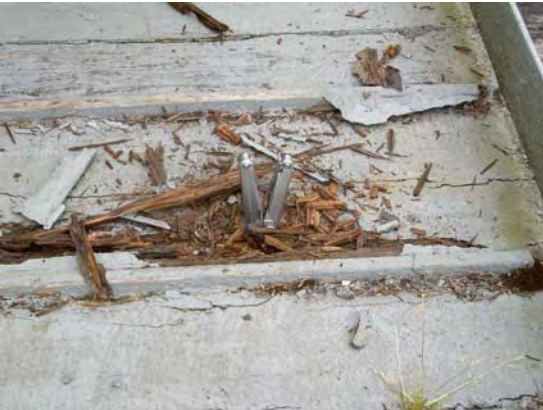
- West side gangway, pin and deck planks. Float casing cracking and corrosion

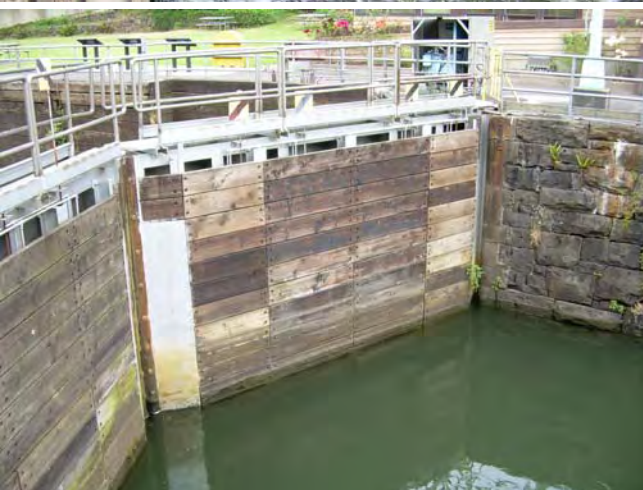
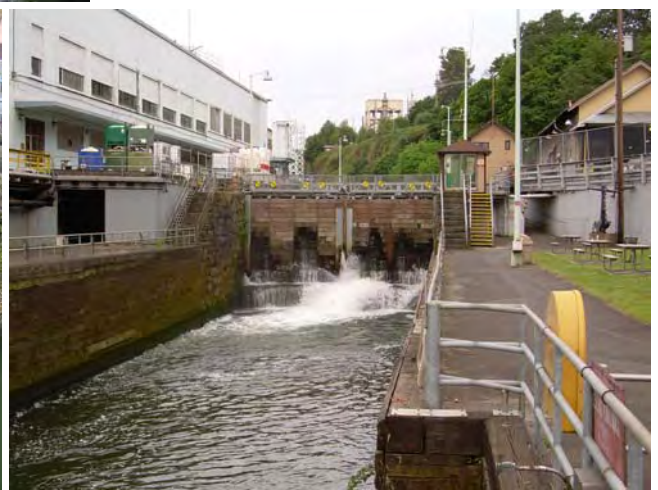
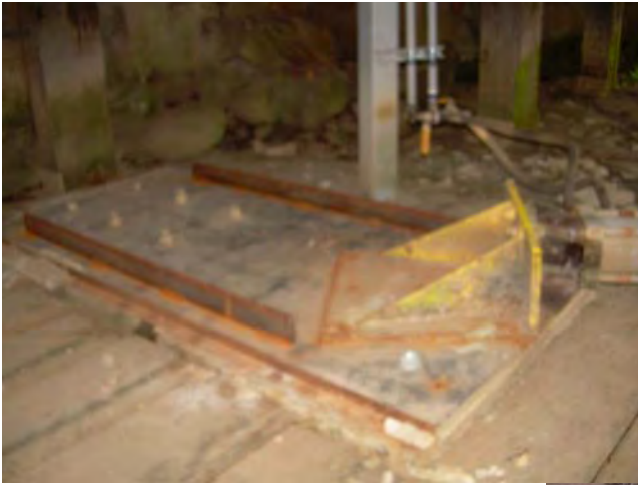
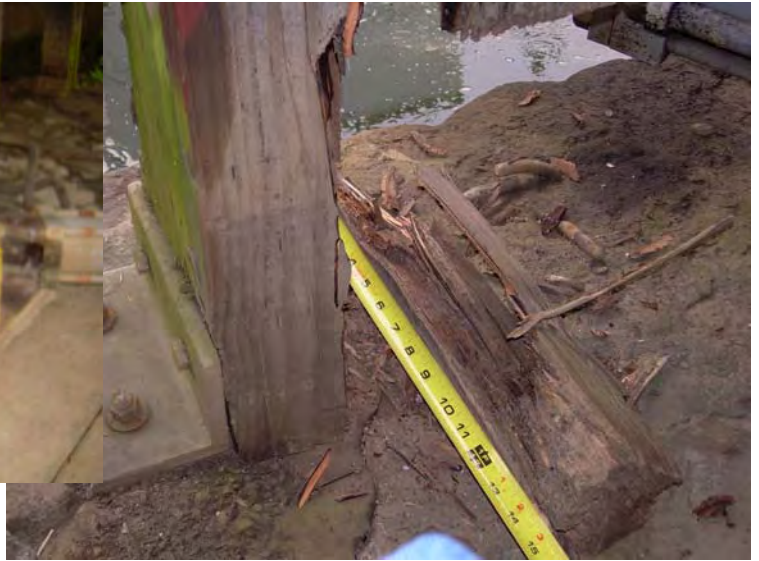
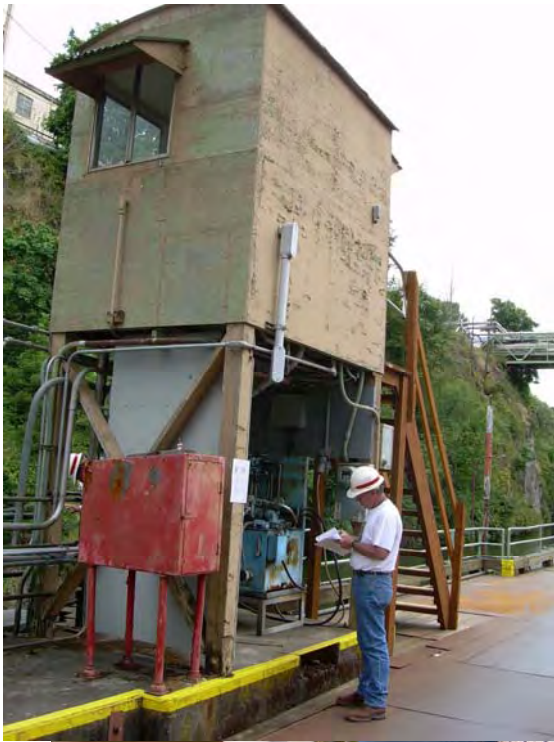
- Various Miter gate photos - chambers and operations

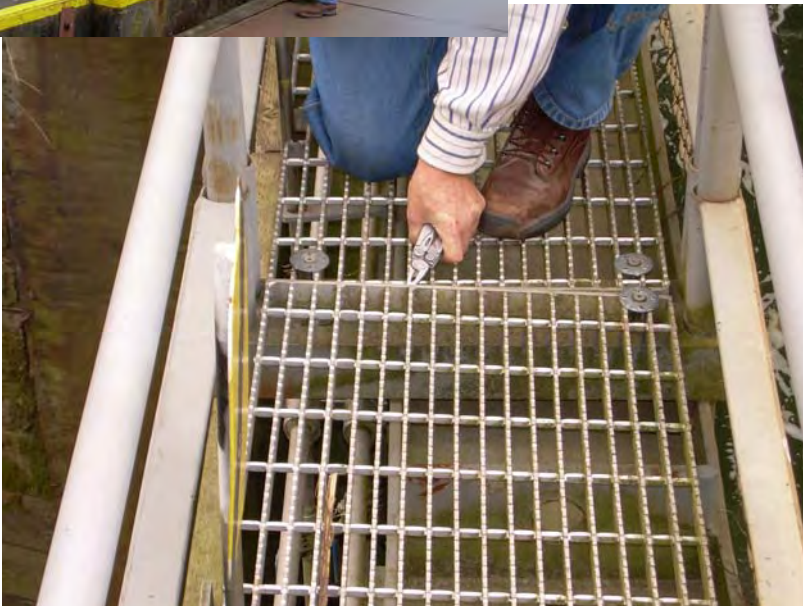
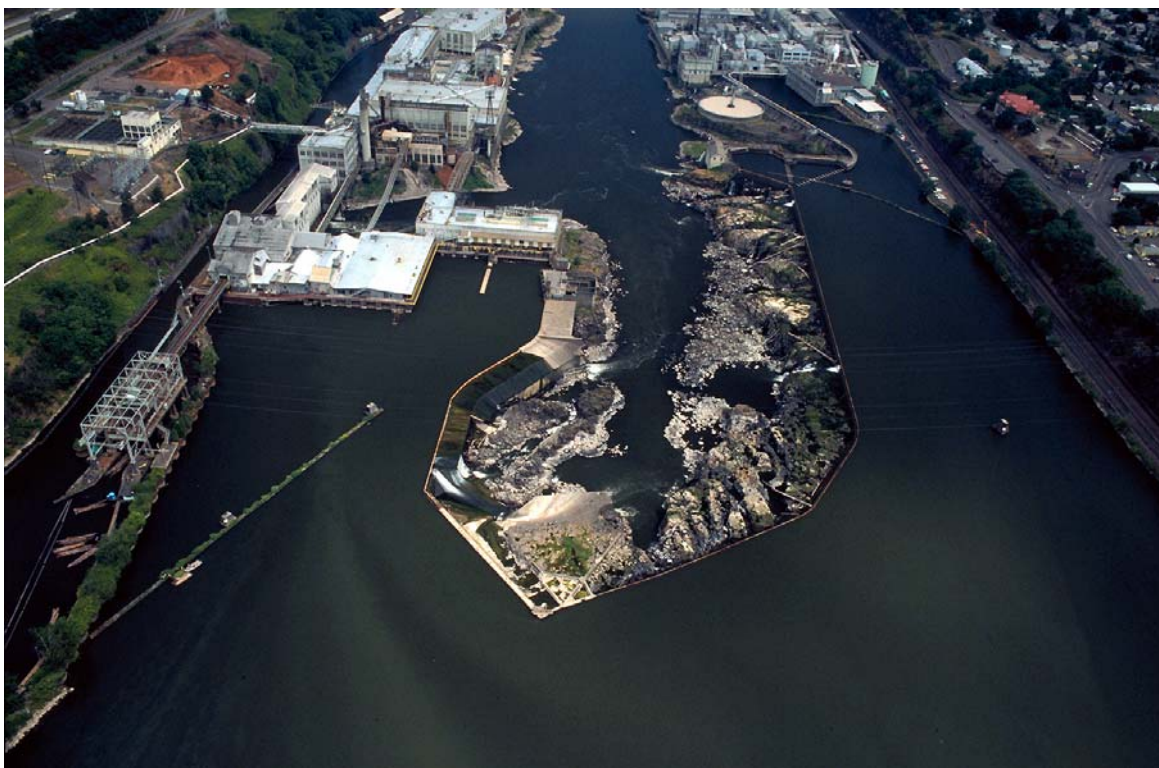
Miscellaneous issues:

- Moving gudgeon anchor block
- Rotted walkway support
- Insufficient lateral bracing
- Missing grating support
